# SAMPLE LEVEL 2 HOME SURVEY

An anonymised example showing the structure, condition ratings, photographs and practical advice included in a Level 2 Home Survey.

Prepared by Gary Bates ACABE MRPSA BCI  
G&L Residential Building Surveys UK Ltd  
Company No. 16992416

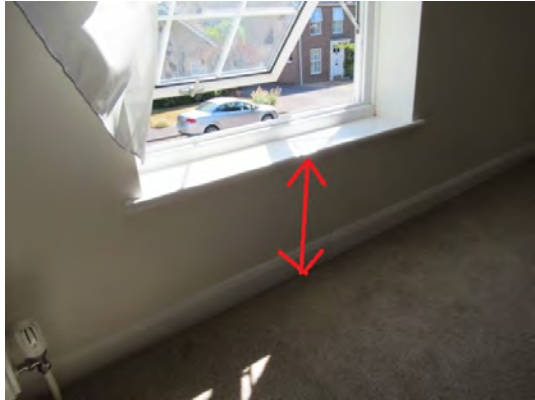
| <b>Risk of Falls</b> | <p>Window sills on the first floor are low to the floor for example in bedroom 1, increasing the risk of falls, especially for the very young. You should consider fitting window opening restrictors.</p> <p>Low sill in bedroom 1</p> |

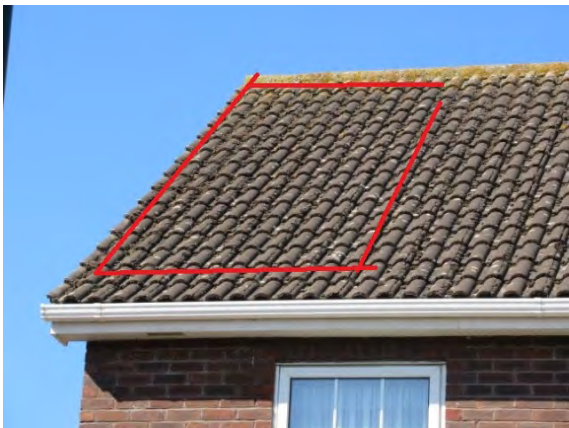
| <b>Condition</b> | <p>No significant defects were noted and the roof was found to be structurally stable. No evidence was seen of unusual sagging or other movement which might indicate that the structure is failing.</p> <p>No significant numbers of slipped, chipped, cracked or missing tiles were noted. Some moss growth was evident, for example at the front, and this should be cleared as a matter of routine maintenance to prevent over-weighting the roof structure.</p> <p>Carry out normal maintenance including removal of moss build-up. Any slipped, missing or broken tiles on the roof pitches should be repaired and replaced. You should carry out a thorough visual inspection at least once a year, ideally in the Spring to identify and repair any damage that could have been caused by winter weather.</p> | |
| | <p>Moss growth on the front roof pitch</p> | <p>Roof Elements</p> |

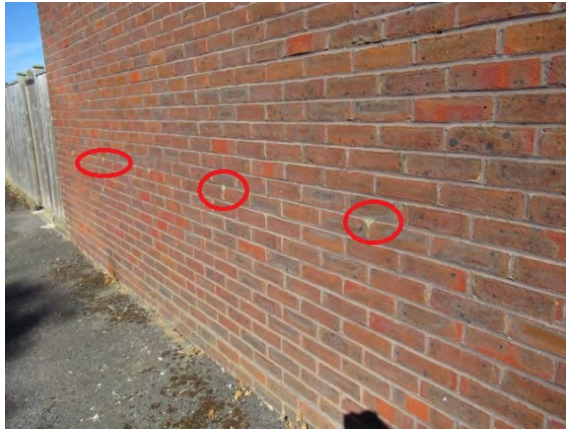
Cavity Wall Insulation drill marks

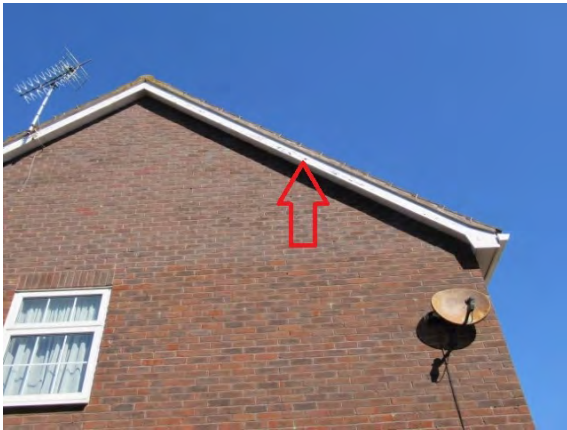
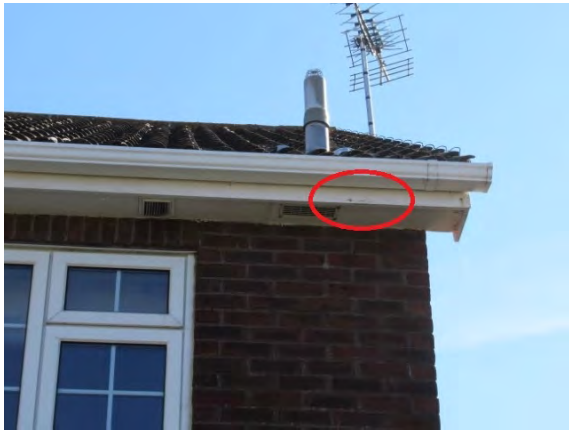
| | 4.6 External Joinery and Finishes | Condition rating | 2 |
|---|---|---|---|
| Condition | <p>No significant defects were noted.</p> <p>However, the joinery is in a poorly maintained condition requiring stripping and redecorating to all sides of the property. In such circumstances, many new owners would consider replacing the existing fascias, soffits and bargeboards with low maintenance PVC.</p> | | |
| | <p>Poorly maintained bargeboards on the left side</p> | <p>Poorly maintained fascia at the back</p> | |

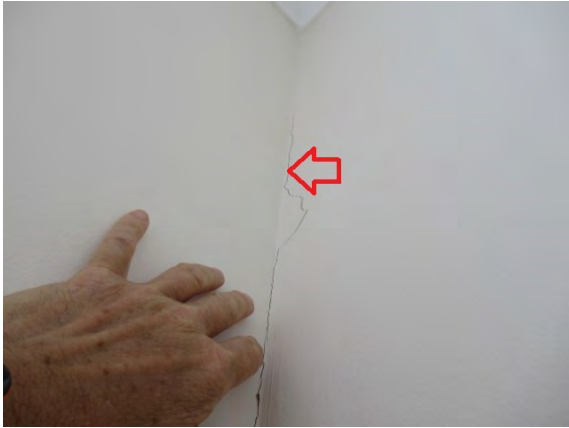
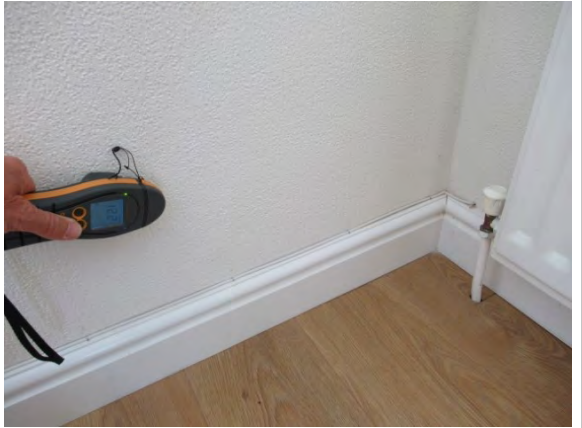
| <b>Condition</b> | <p>No significant defects were noted during my inspection and the internal walls were found to be structurally sound.</p> <p>No evidence was seen of any cracking which might indicate that the property is subject to subsidence or unusual settlement.</p> <p>All moisture meter readings recorded around the property were found to be within a normal range indicating that, in those areas that could be accessed, it is not affected by rising or penetrating damp.</p> <p>Normal maintenance is required, including filling and redecorating cracks as necessary.</p> |
| | <div data-bbox="343 521 914 947"> </div> <div data-bbox="360 956 895 1019"> Cracking of the plaster to the front left corner of bedroom 3 </div> <div data-bbox="935 521 1519 947"> </div> <div data-bbox="951 956 1498 1019"> Normal moisture reading on the front wall of the living room </div> |

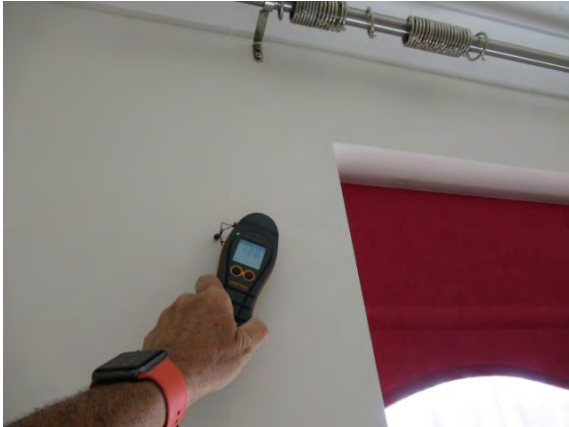
| | <div data-bbox="343 1037 914 1462"> </div> <div data-bbox="349 1471 904 1505"> Normal moisture reading on the wall of bedroom 1 </div> |

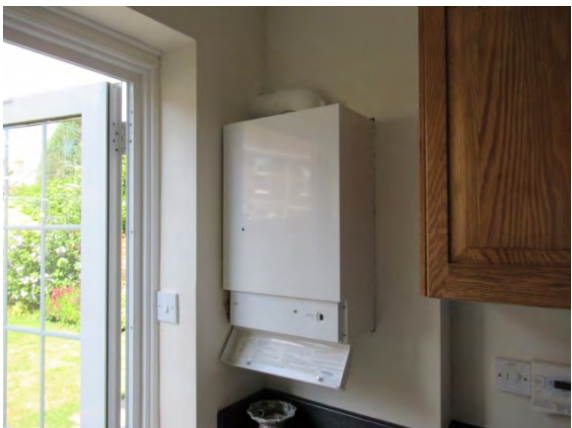
| <b>Condition</b> | <p>The boiler is believed to be approximately 5 years old and, therefore, around one third of the way through its normal expected service life. Under normal circumstances a modern boiler will last for 15-20 years before requiring replacement.</p> <p>No evidence was seen to suggest that an inhibitor has been added to the heating system recently to prevent a build-up of sludge in the pipework and radiators, and it is therefore recommended that the system be flushed through and an inhibitor added.</p> <p>Gas Safe recommends that all gas appliances and boilers are inspected and serviced according to manufacturer's guidance, but at least once a year. A gas installation can look to be in a safe condition, but serious defects may be hidden, some of which can kill. It is therefore considered to be essential that you commission an inspection of the gas/heating installation prior to purchase of the property, unless you are provided with verifiable evidence that such an inspection has recently been carried out by a competent person. You can get more information, or find a Gas Safe registered engineer <a href="https://www.gassaferegister.co.uk/find-an-engineer/">https://www.gassaferegister.co.uk/find-an-engineer/</a></p> |
| | <div data-bbox="343 728 917 1153"> </div> <div data-bbox="593 1167 663 1193">Boiler</div> <div data-bbox="933 728 1508 1153"> </div> <div data-bbox="1145 1167 1291 1193">Programmer</div> |

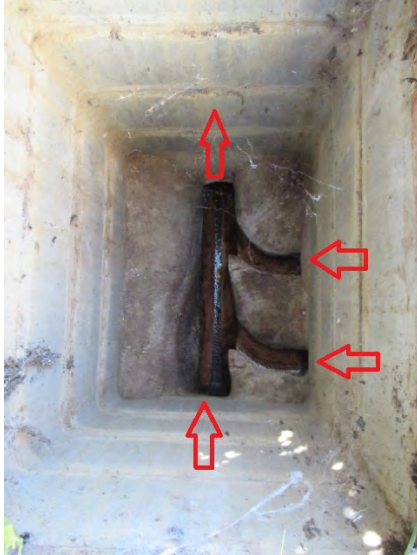
| <b>Condition</b> | <p>Water was seen to run through the chamber with no blockages or undue levels of silt being apparent. The flow is from the house and forwards to the chamber at the front, whereupon it is directed to the left within a shared drain, presumably to a main sewer.</p> <p>Drains should be regularly inspected to ensure they remain free from blockages, tree root damage or other obstructions.</p> | |
| | | <p>Inspection chamber in the front garden with the house to the right of the picture and the flow direction indicated</p> |

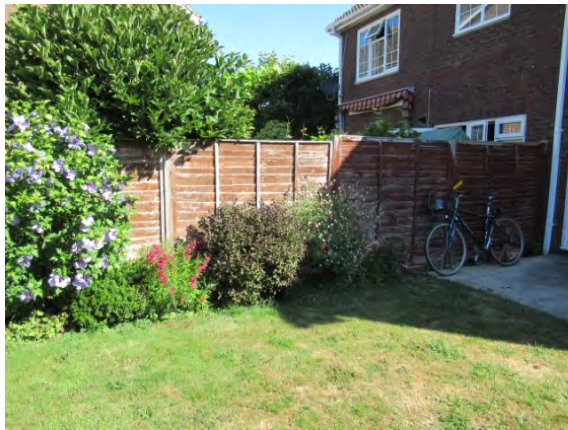
Boundary fence to the right side at the back is worn

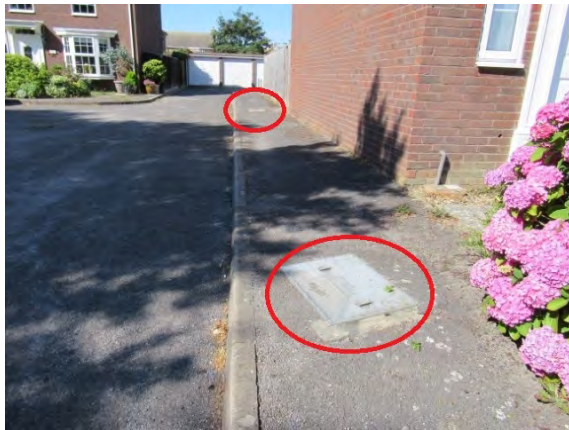
It was noted that the manhole covers in the footpath to the left side of the house are slightly raised and could be a trip hazard.

Raised manholes in the footpath to the left side
