# SAMPLE LEVEL 3 BUILDING SURVEY

A comprehensive example showing detailed construction analysis, condition ratings, photographs, risks and practical repair recommendations.

Prepared by G&L Residential Building Surveys UK Ltd  
Gary Bates ACABE MRPSA BCI  
Company No. 16992416

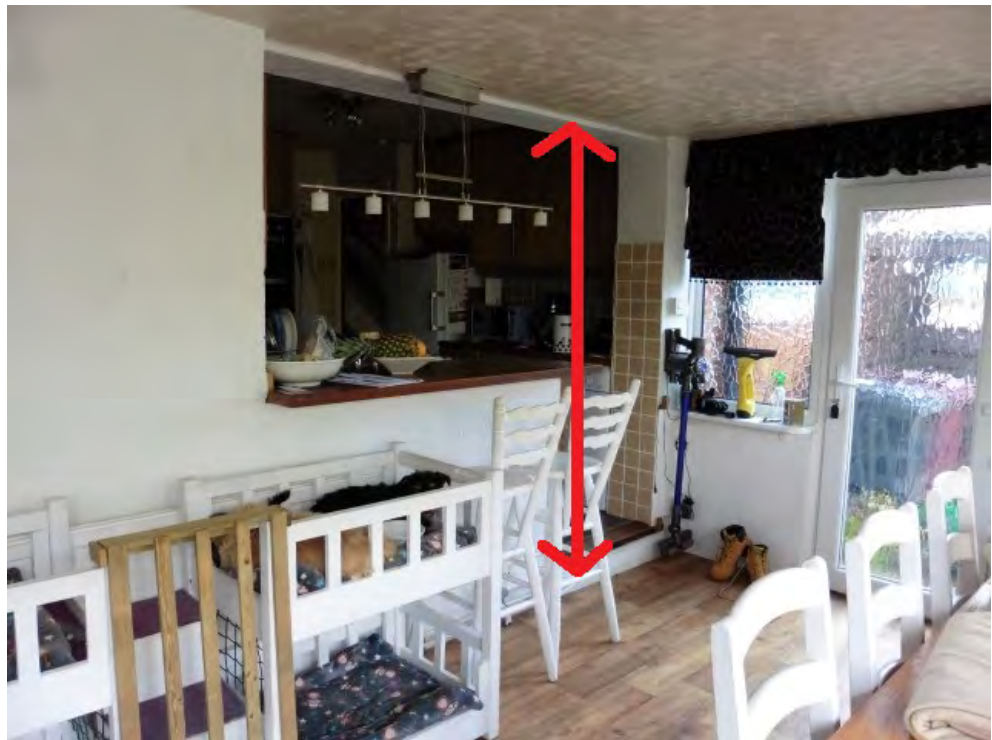
Wall partially removed between the kitchen and sun room

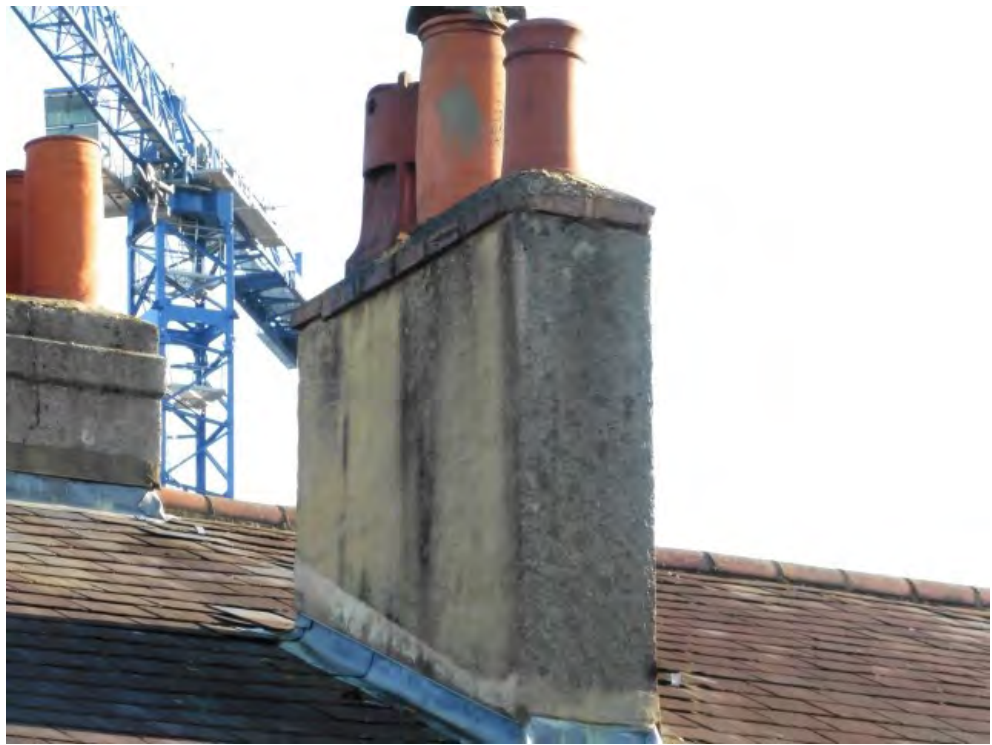
| <b>Condition</b> | <p>No significant defects were noted and the chimney stacks were found to be structurally stable. No evidence was seen of any unusual cracking or other failure, or of unusual wear of the bricks or mortar pointing between the bricks.</p> <p>The flashings at the base of the stacks are, as far as can be seen, in a serviceable condition.</p> | | |

Rear stack viewed from the rear

| <b>Action Required</b> | <p>The chimney stacks should be regularly monitored for any indications of damage, instability or other defects. You should carry out a thorough visual inspection at least once a year, ideally in the Spring, and ideally at roof level, to identify and repair any damage that could have been caused by winter weather.</p> <p>Missing, loose or defective mortar should be repointed as necessary.</p> <p>It is advisable to fit cowls on the top of the pots of any open flues.</p> | | |

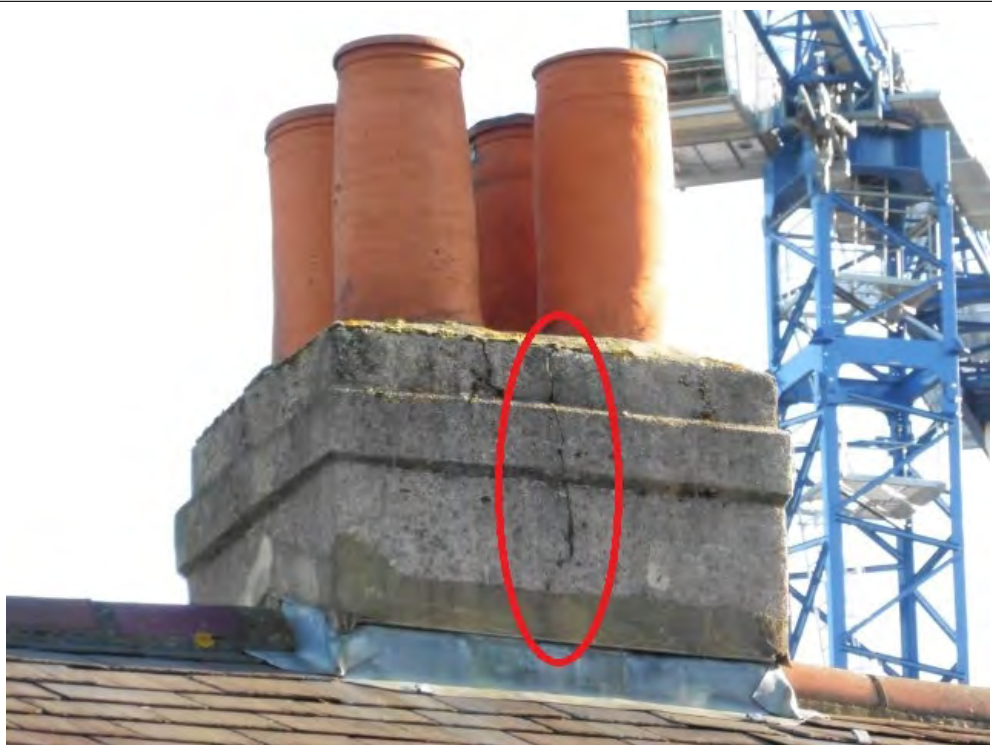
Central stack viewed from the front

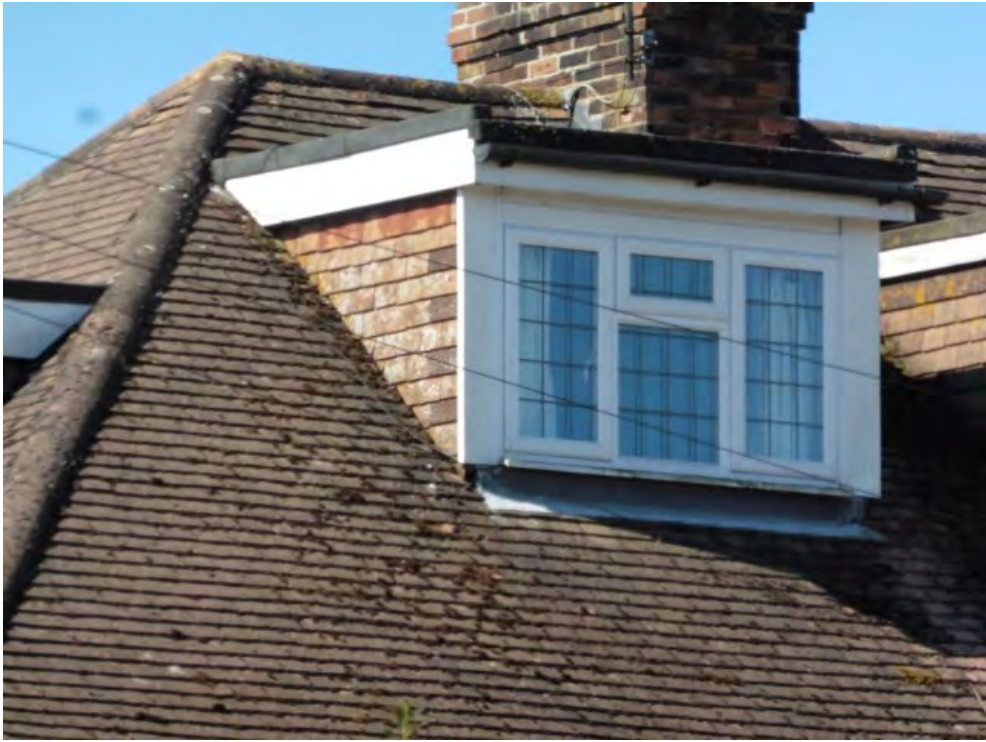
| | <b>4.2 Roof Coverings</b> | <b>Condition<br/>rating</b> | <b>1</b> |
|---|---|---|---|
| <b>Condition</b> | <p>No significant defects were noted and the main roof was found to be structurally stable. No evidence was seen of unusual sagging or other movement which might indicate that the structure is failing.</p> <p>No evidence was seen of any unusual amounts of moss growth, or of slipped, chipped or cracked tiles.</p> | | |
| | <div data-bbox="416 1093 1406 1832"> </div> <p>Front roof and dormer</p> | | |

| | <b>4.2 Roof Coverings</b> | <b>Condition<br/>rating</b> | <b>1</b> |
|---|---|---|---|
| <b>Action Required</b> | <p>Carry out normal maintenance including removal of moss build-up.</p> <p>Any slipped, missing or broken tiles on the roof pitches should be repaired and replaced.</p> <p>You should carry out a thorough visual inspection at least once a year, ideally in the Spring to identify and repair any damage that could have been caused by winter weather.</p> | | |

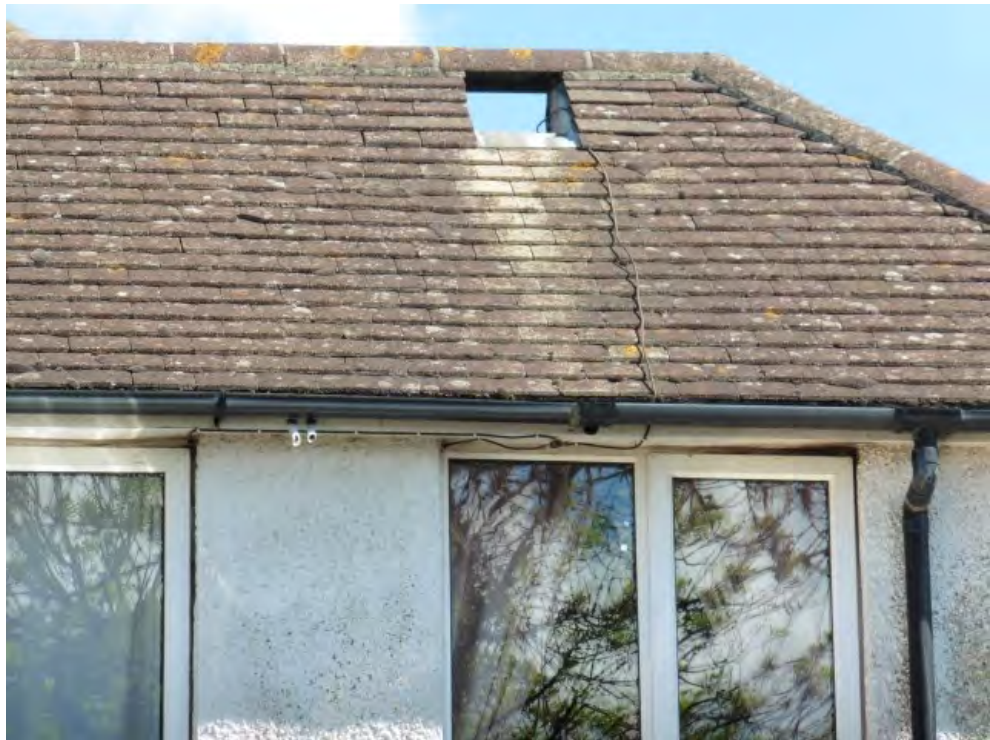
Rear roof pitch

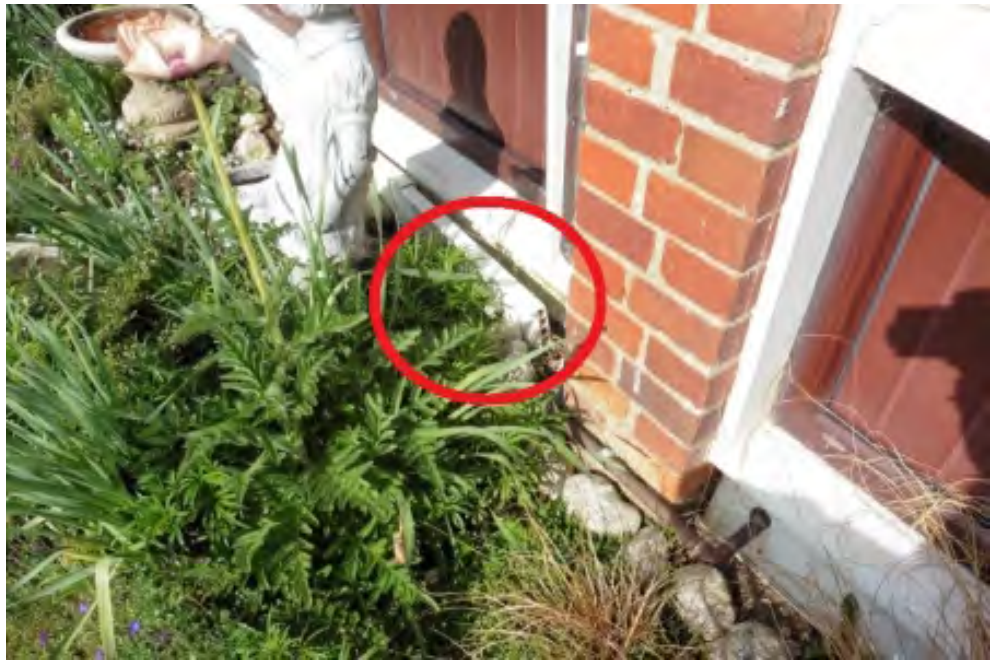
| <b>Condition</b> | <p>No significant defects were noted and the walls were found to be structurally stable. No evidence was seen of any cracking which might indicate that the property is subject to subsidence, unusual settlement, or other exceptional movement of the ground. There is no evidence of unusual wear of the brickwork or mortar pointing between the bricks. At the front, there is some plastic trim in the areas beneath the windows, part of which is loose.</p> <p>In most walls there is a damp proof course (DPC) just above ground level.....</p> <p>There is evidence that the wall cavities have been filled with insulation (cavity wall insulation), though the exact nature, quality, and quantity of insulation inserted can only be determined by an invasive examination with the use of cameras. The evidence is a series of filled drill holes, for example at the top of the wall near to the front downpipe.</p> <p>Wall ties are metal linking plates .....</p> <p>The walls of a house are normally supported on foundations .....</p> | | |

Loose plastic trim at the front

| <b>Action Required</b> | <p>Walls should be examined regularly to inspect for changes in the nature of any cracking or other defects that may become apparent.</p> <p>You should carry out a thorough visual inspection at least once a year, ideally in the Spring to identify and repair any damage that could have been caused by winter weather.</p> <p>The plastic trim at the front should be repositioned.</p> | | |

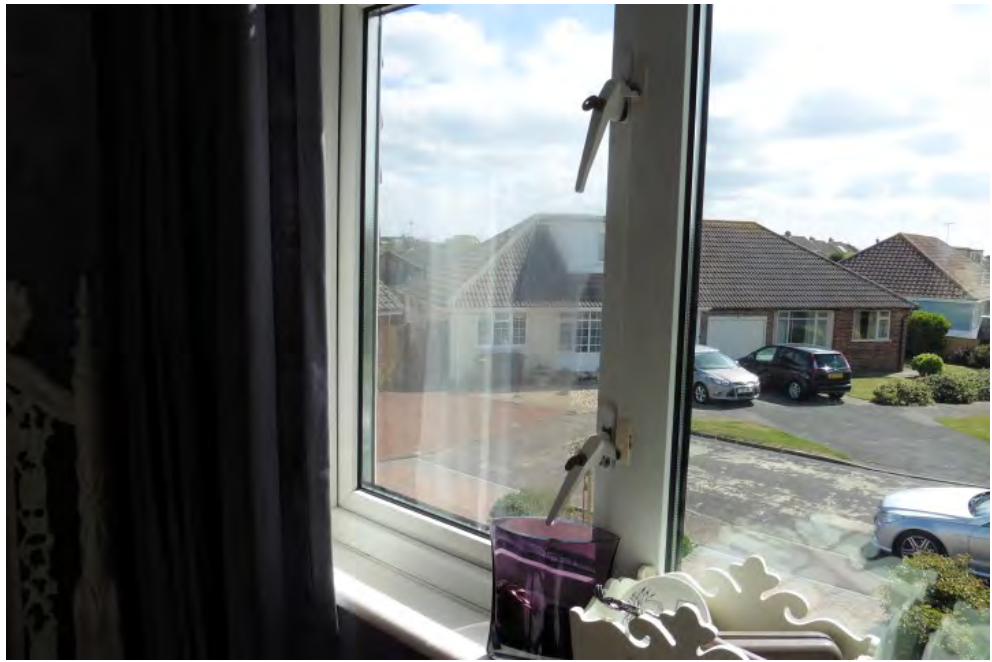
| <b>Condition</b> | <p>No significant defects were noted and most of the windows and doors checked were found to operate normally. However, some were found to be quite difficult to operate, probably due to a lack of lubrication of locks and hinges.</p> <p>The handle of the bathroom window on the ground floor is stuck in the open position.</p> <p>A failed sealed window unit was noted in bedroom 1, and other weather conditions may highlight the presence of more. This occurs .....</p> | | |

Bedroom 1 casement window panel blown

| <b>Action Required</b> | <p>Under normal circumstances sealed double glazed units can be expected to last between 15-20 years before the seals begin to .....</p> <p>Failed sealed double glazing units require replacement. It should also be considered that, where some sealed units within a window have failed, others may also fail in due course.</p> <p>Normal maintenance of frames, hinges and locks is required. This includes repair of the bathroom window and the bedroom 1 seal and frame.</p> | | |

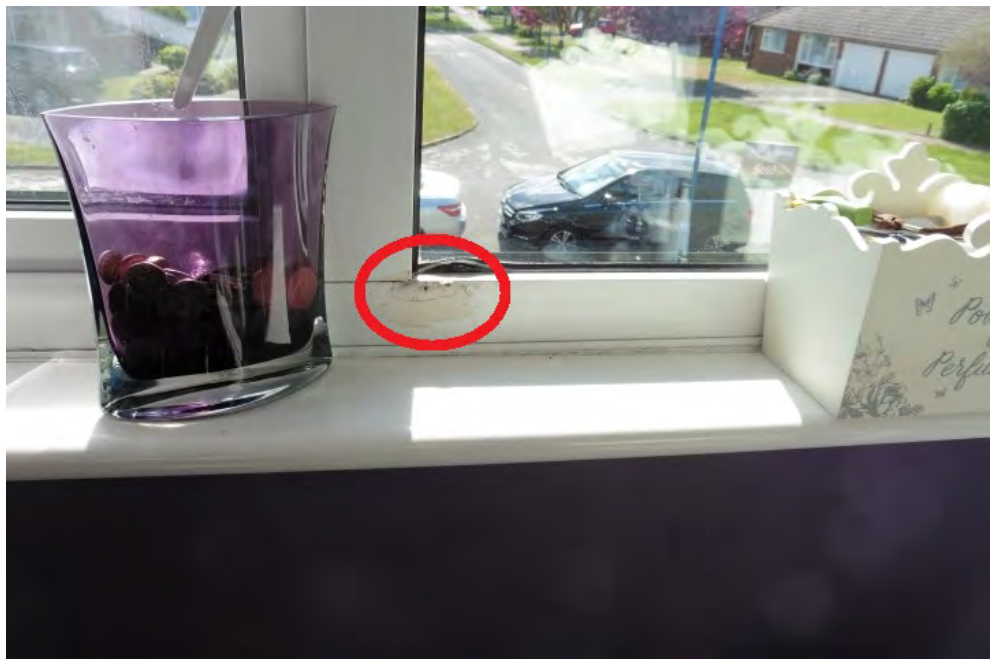
Damage to frame and seal in bedroom 1

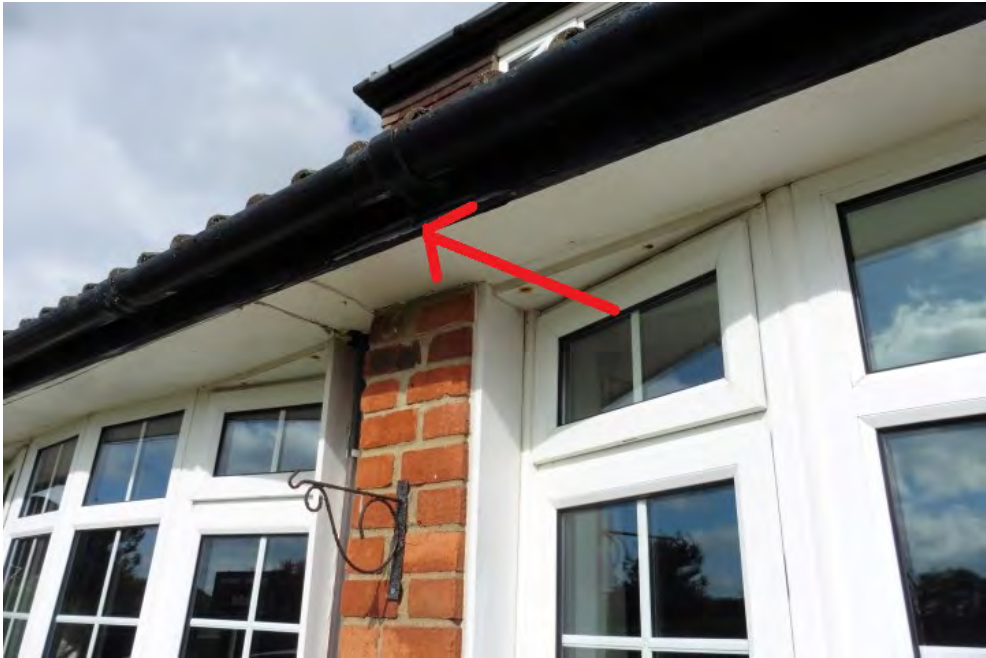
| <b>Condition</b> | <p>Widespread evidence was found of rot in the external joinery, including both the fascias at the front and the soffits at the back.<br/>The timber is failing and what we have spread to other parts of the building.</p> | | |
| | <div data-bbox="416 1122 1406 1778"> </div> <p>Rot in the fascia at the front</p> | | |

| <b>Action Required</b> | <p>Urgent repairs are required to replace rotten timbers around the edges of the roof.<br/>Although some areas of rot were identified, others may be present, and it is possible that the ends of the roof rafters may have been affected.<br/>A thorough investigation should be carried out to identify all rotten timber, which should be cut out and replaced.<br/>This work is considered to be of an urgent nature and should be carried out immediately upon occupation of the property.</p> | | |

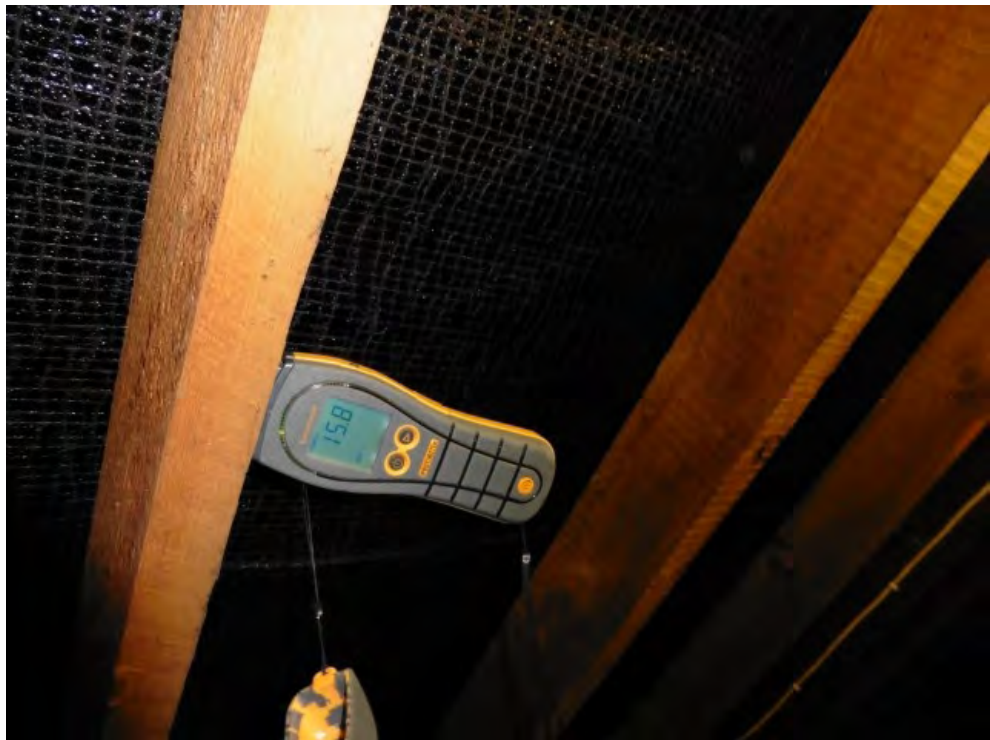
| <b>Condition</b> | <p>No significant defects were noted during my inspection and the roof was found to be structurally sound.</p> <p>No evidence was seen of any unusual movement or stress of the supporting timbers within the roof, and there have been no obvious significant alterations to the structure which might have resulted in it becoming substantially weakened.</p> <p>The roof space is laid with 200-300mm of .....<br/>.....</p> <p>High moisture levels within roof spaces are responsible for the promotion of the development of timber defects such as rot and infestations by wood boring insects (commonly known as woodworm). Wood moisture content readings taken were found to be well within normal limits and below the levels normally required for this type of defect.</p> | | |

Normal moisture reading in roof timber

| <b>Action<br/>Required</b> | Although no evidence of active infestations of wood boring insects was identified, it is important to remain vigilant and be aware that such infestations can become active after long periods of inactivity. | | |

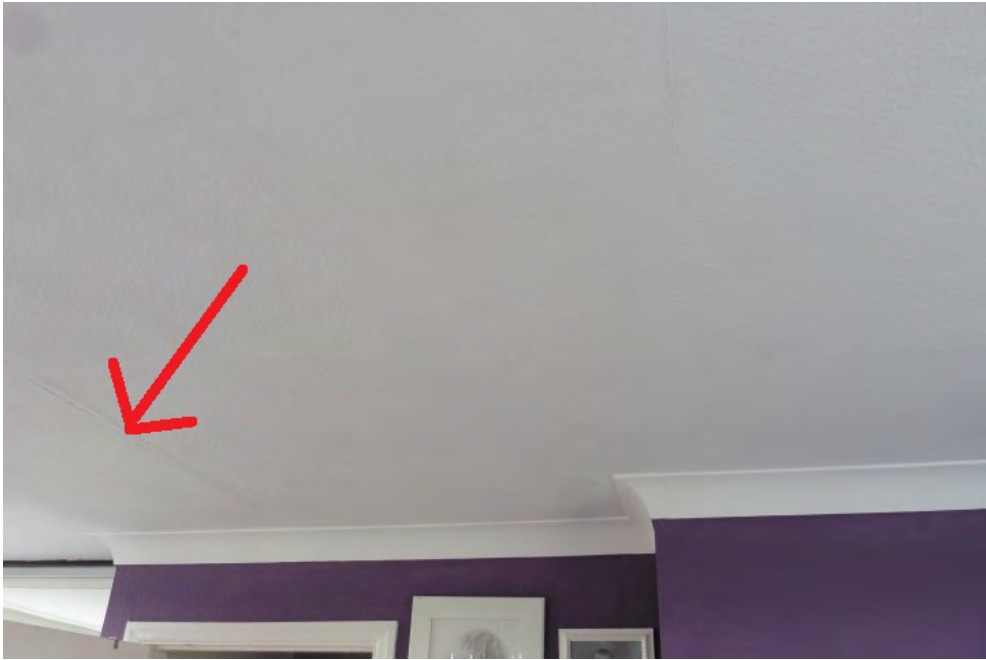
| <b>Condition</b> | No significant defects were noted.<br>Some cracking of the ceiling finishes was noted, for example in bedroom 1. These cracks are primarily along the lines of plasterboard joints and are unlikely to be symptomatic of undue movement of the property. | | |
| | <div data-bbox="416 911 1406 1568"> </div> <div data-bbox="692 1585 1129 1615"> Straight cracks on the bedroom 1 ceiling </div> | | |

| <b>Action Required</b> | Normal maintenance is required, including filling and redecorating cracks as necessary. | | |

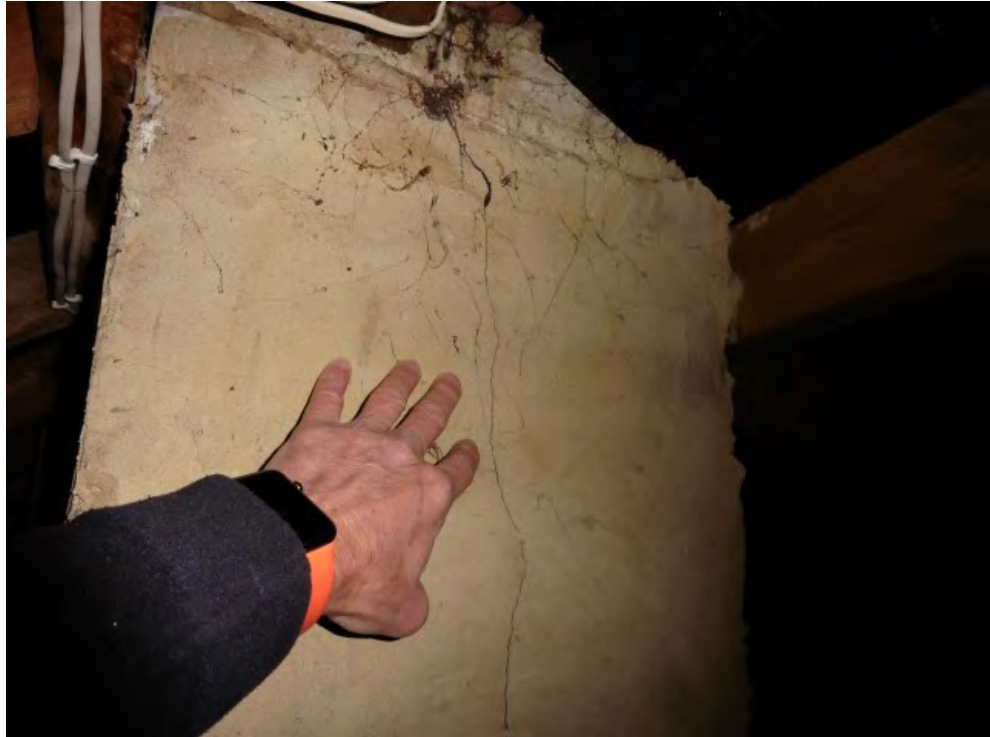
| <b>Condition</b> | <p>Although no specific evidence of any structural defects was identified, it is possible that some changes have been made to the right side chimney breast which have the potential to lead to structural failure.</p> <p>Within the kitchen there is no lower part to the chimney breast. Although this type of arrangement is not unusual and was usually accompanied by a flue pipe leading to a boiler or stove beneath, without knowing the history of the building it is impossible to confirm that this is how it was constructed and that is not been altered. In the roof space above there is some light cracking of the chimney breast, and although it is unlikely that this is due to any structural failure, from a single visual inspection it is impossible to be completely sure that this is the case.</p> <p>The left side chimney breast, serving the fireplace in the living room is, as far as can be determined, in a stable condition.</p> | | |

Light cracking of the right side chimney breast in the roof space

| <b>Action<br/>Required</b> | <p>Enquiries should be made to determine whether any alterations have been carried out to the chimney breast in the past.</p> <p>A structural engineer.....</p> <p>.....</p> | | |

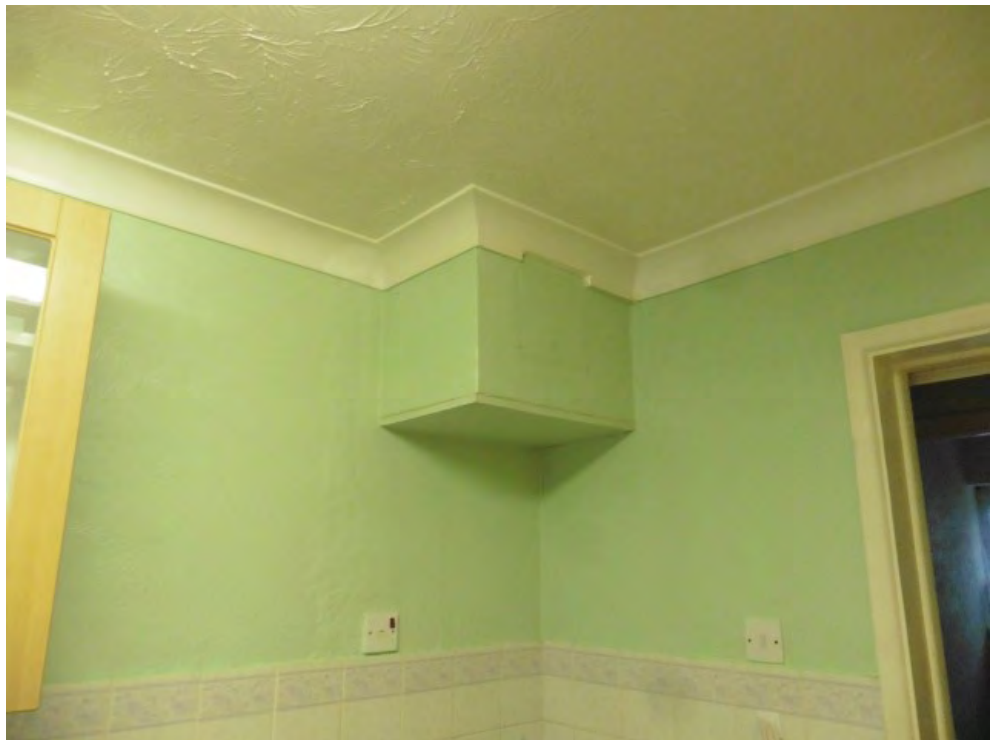
Right side chimney breast in the kitchen has been truncated

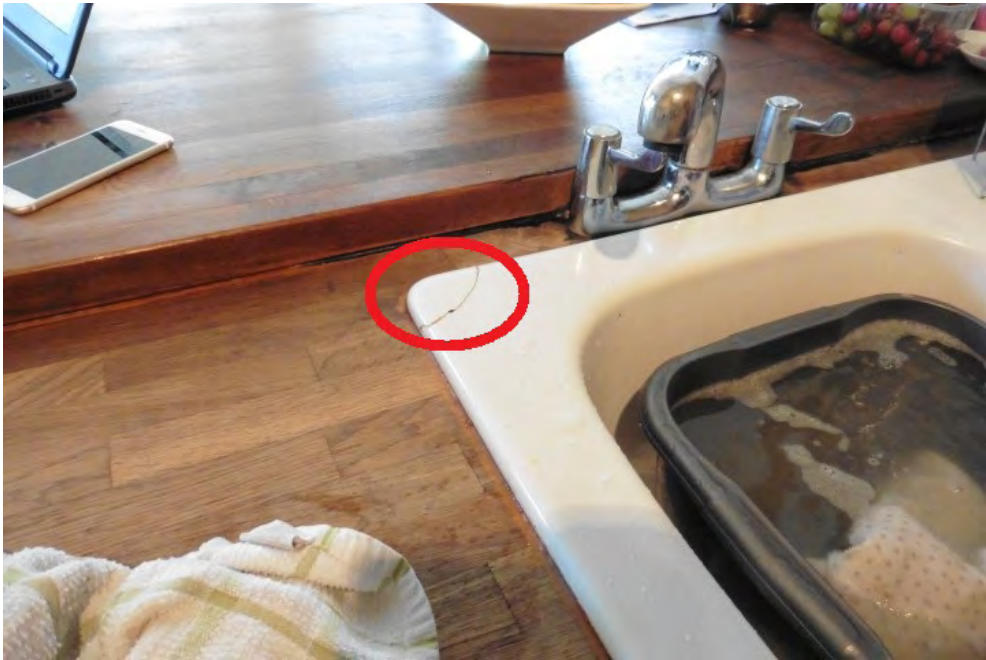
| <b>Condition</b> | <p>The kitchen fittings are of a modern style and in a serviceable condition. It is understood that they were installed by the current owners.</p> <p>The flow of water at the sink was checked and was within a normal range and considered to be suitable for the intended use.</p> <p>Hot water was obtained from the kitchen hot tap.</p> <p>Fitted cupboards and wardrobes are of a basic style and, generally in a serviceable condition.</p> <p>The cooker hood was found to be noisy in operation.</p> <p>The edge of the kitchen sink is cracked and will require repair.</p> | | |
| | <div data-bbox="416 1151 1406 1809"> </div> <p>Cracked edge to the kitchen sink</p> | | |

| <b>Action Required</b> | <p>Maintain, repair or replace units as necessary.</p> <p>The fan within the cooker hood should be replaced.</p> <p>The kitchen sink will require replacement as it is cracked.</p> | | |

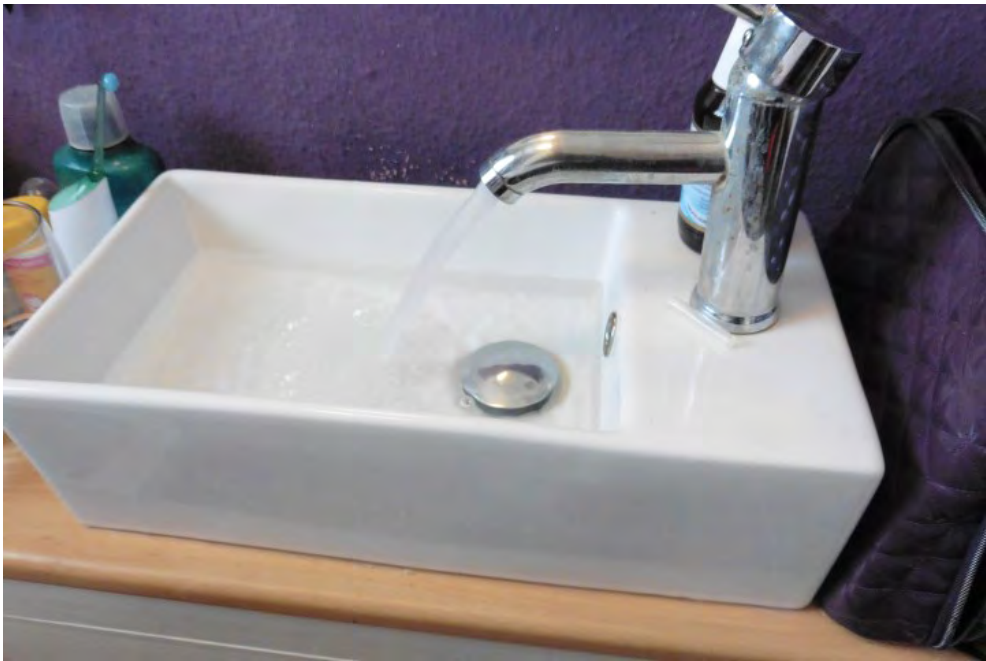
| | <b>5.8 Bathroom and Sanitary Fittings</b> | <b>Condition rating</b> | <b>1</b> |
|---|---|---|---|
| <b>Condition</b> | All of the fittings checked were found to operate normally.<br>They are of a basic style and in a serviceable condition.<br>The flow of water at all outlets checked was within a normal range and considered to be suitable for the intended use.<br>Hot water was obtained from all hot tap outlets, except for the first floor WC hand basin when no hot supply was available. It is not known if one is connected.<br>It was also noted that water was slow to drain from this basin. The reason for this is not known. | | |
| | <div data-bbox="416 1030 1406 1688" data-label="Image"> </div> <div data-bbox="614 1706 1204 1736" data-label="Caption"> First floor WC basin has no hot flow and poor drainage </div> | | |

| | <b>5.8 Bathroom and Sanitary Fittings</b> | <b>Condition rating</b> | <b>1</b> |
|---|---|---|---|
| <b>Action Required</b> | Maintain, repair or replace units as necessary. | | |

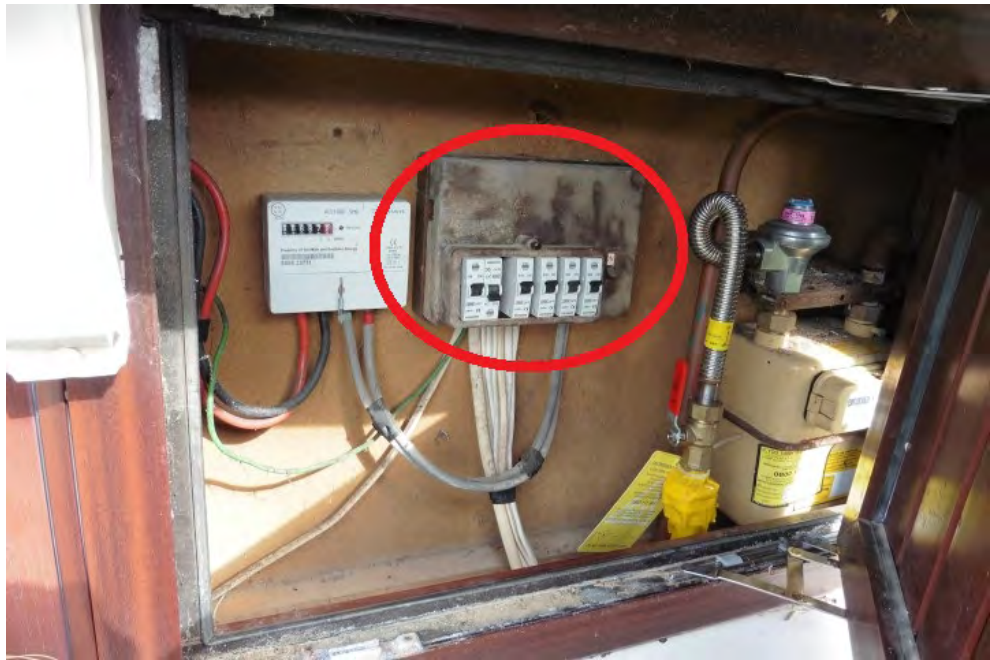
| <b>Condition</b> | <p>The fuse board is of an older type without the more modern RCD protection devices installed, suggesting that it has not been upgraded recently. It must be assumed, therefore, that much of the installation dates from the 1970s or before and is, therefore, out of date.</p> <p>Although it was impossible to see most of the sockets in the rooms around the house, extension leads suggests that there are insufficient outlets for modern purposes.</p> <p>Power supplies to the sheds within the garden are, clearly, of an amateur nature and unlikely to meet reasonable safety standards. These supplies were noted to be of non-armoured cable.</p> | | |

Fuse board

| <b>Action<br/>Required</b> | <p>The NICEIC recommends that electrical installations are subjected to an Electrical Installation Condition Report (EICR) by a competent person at least every .....</p> | | |

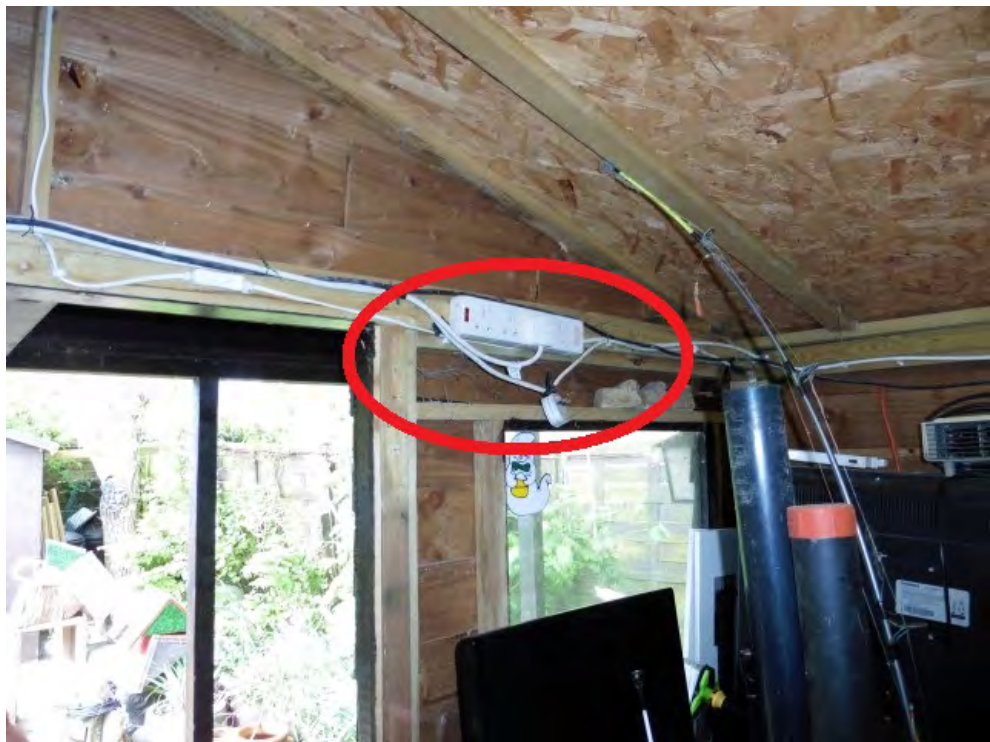
Poorly managed wiring in shed 4

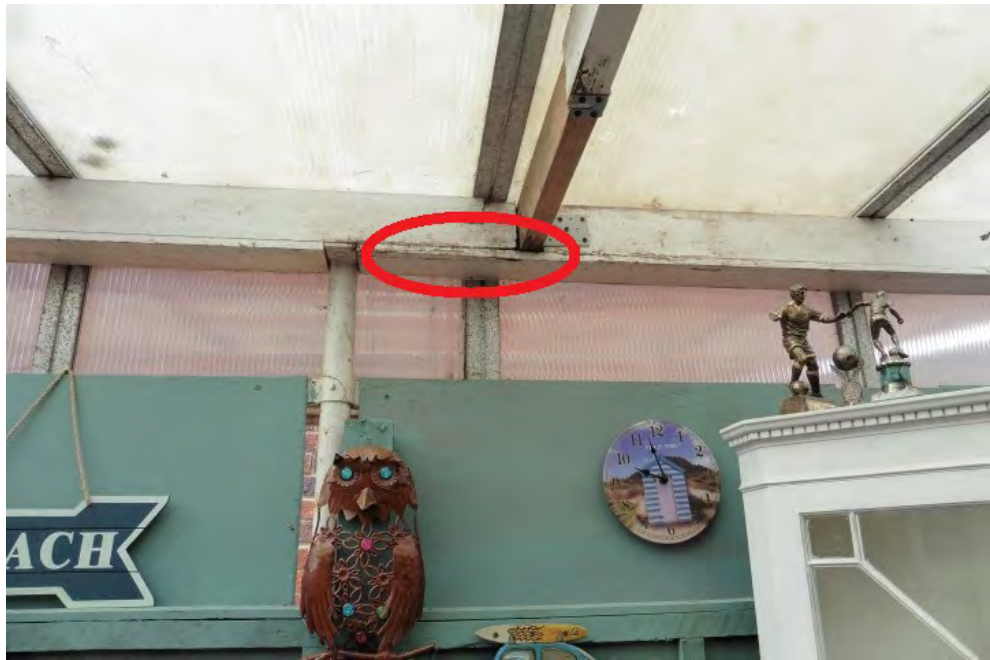
Possibly rotten timbers in the lean-to

| <b>Action<br/>Required</b> | <p>Normal maintenance, including regular retreatment of the walls, is required.</p> <p>Foliage and debris should be removed from the outside walls.</p> <p>Compared to traditional coverings such as tiles and slates, most felt roofs have .....</p> <p>.....</p> | | |

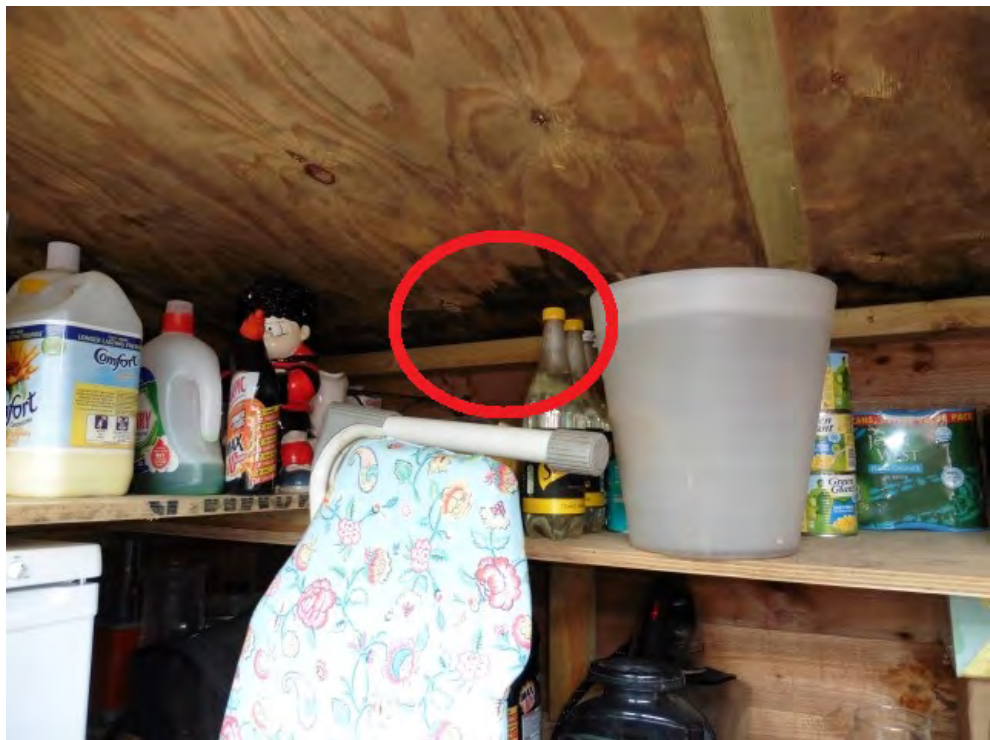
Staining on the underside of the roof of shed 2
