# SAMPLE SNAGGING SURVEY

An anonymised example demonstrating the scope, photographic evidence and practical detail included in our new-build inspections.

Prepared by Gary Bates ACBE MRPSA BCI  
G&L Residential Building Surveys UK Ltd

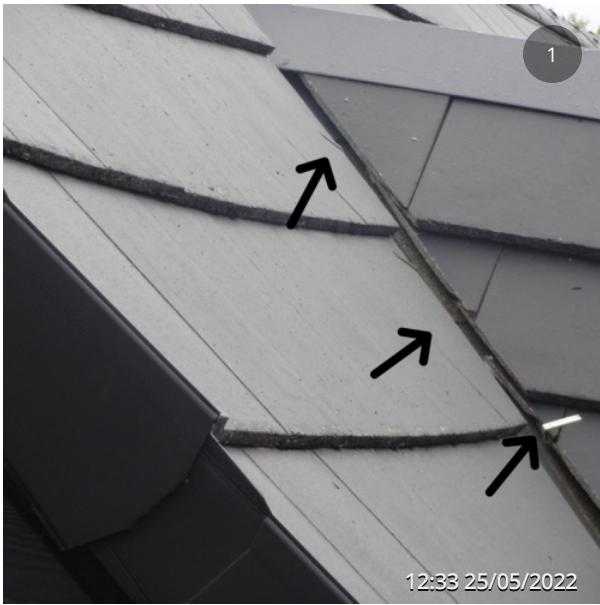
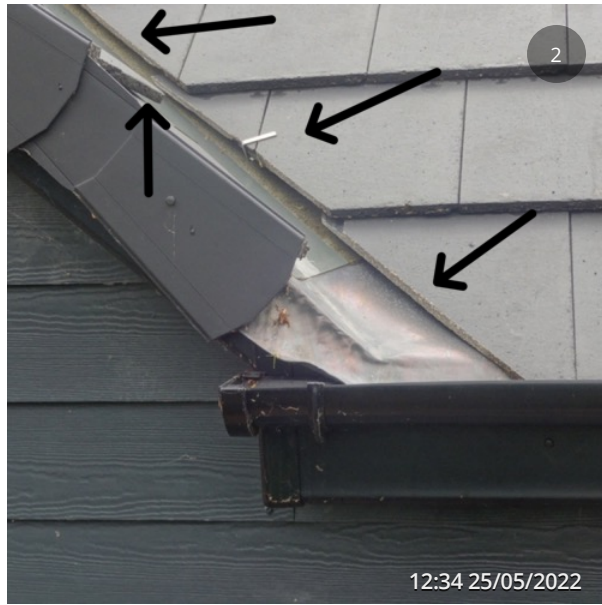
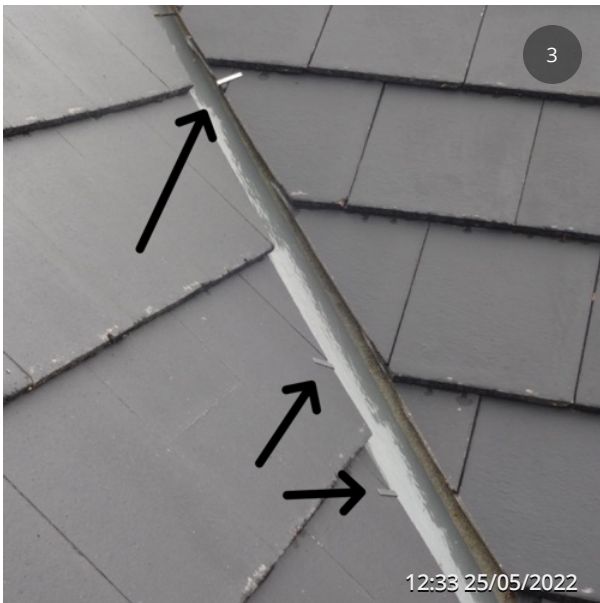
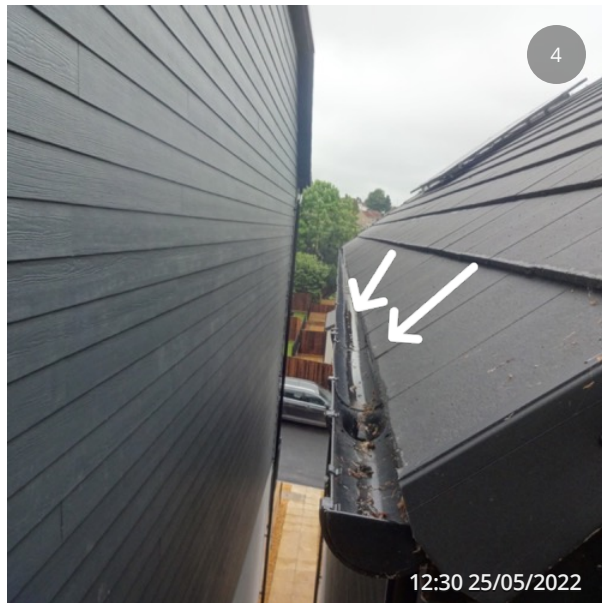
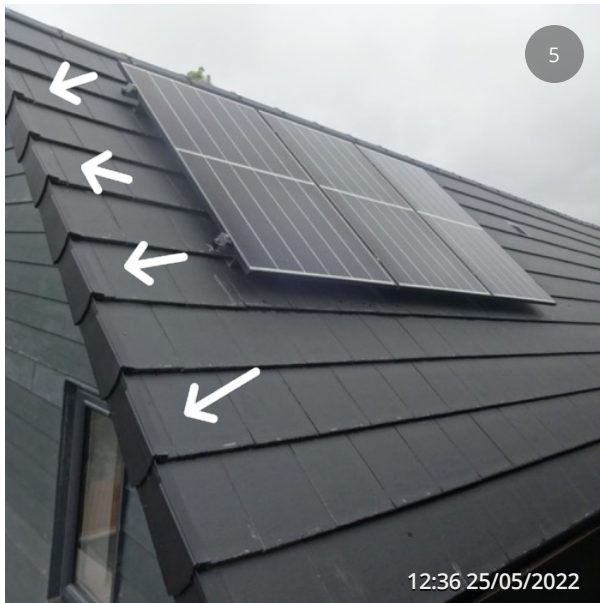
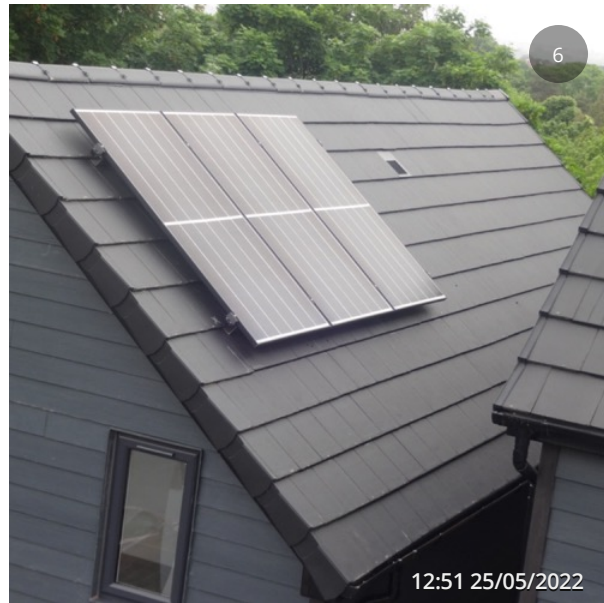
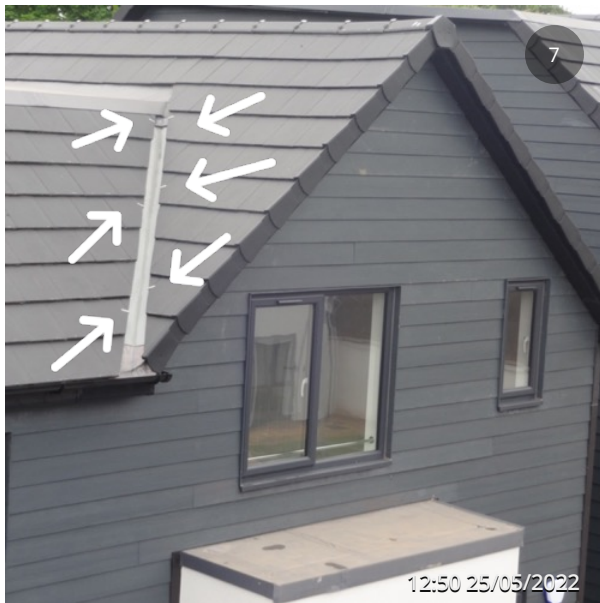
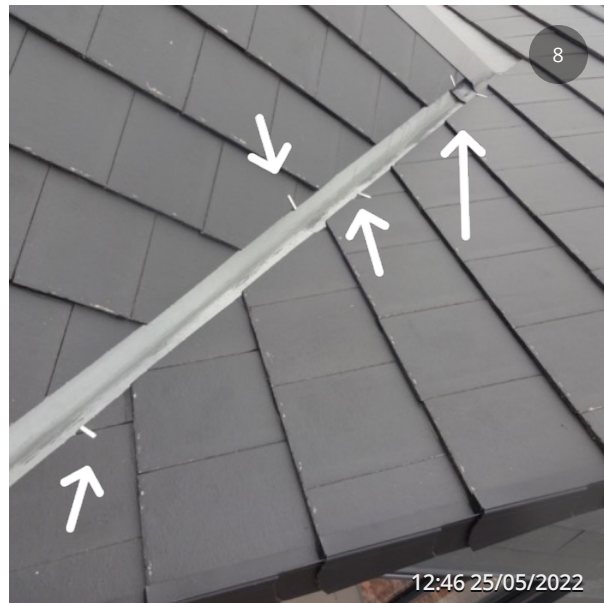
Location: Roof

The valley gutters seem to have been constructed to a poor standard. They had various metal clips that hold the cut tiles into the surrounding tiles of the valleys. We recommend that manufactures guidance is obtained to ascertain if the clips are suitable for this purpose.

There were areas where the tiles are not sitting fully flat that may potentially lead to water ingress to the property.

Minor standing water was noted in the gutters. This suggests either blockage or that they are set to poor falls.

There was some evidence of ponding to the EDPM type flat roof covering that is connected to the main roof and is on the party wall line with the neighbouring property suggesting potentially a defect with the substrate beneath, this can cause irregular stress around the perimeter of the pond causing premature failure.

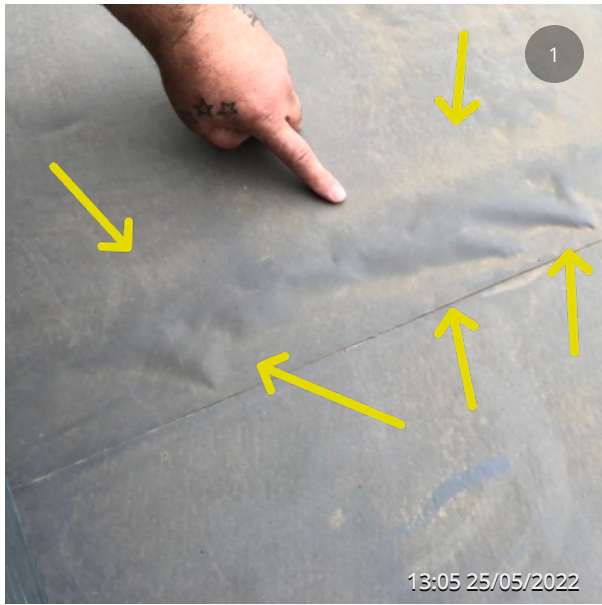
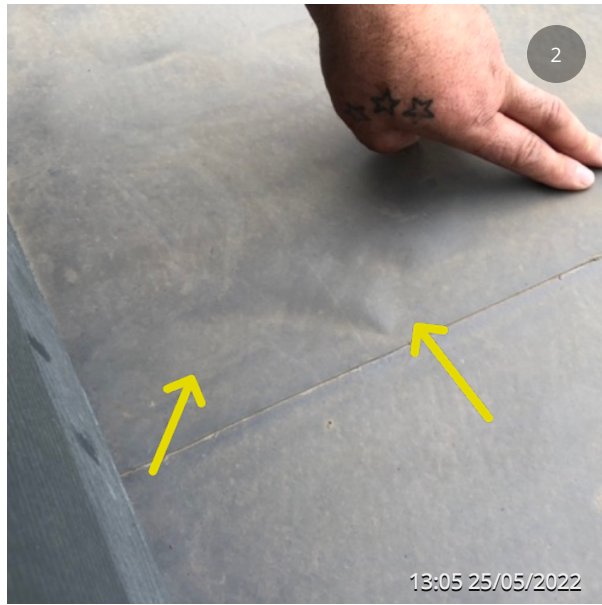
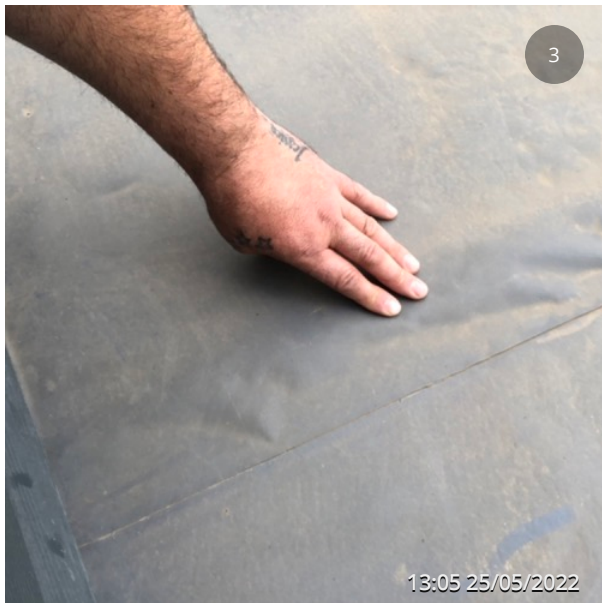
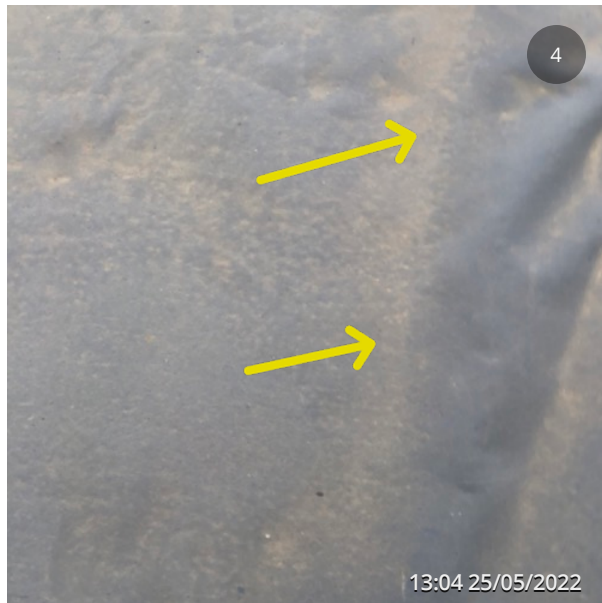
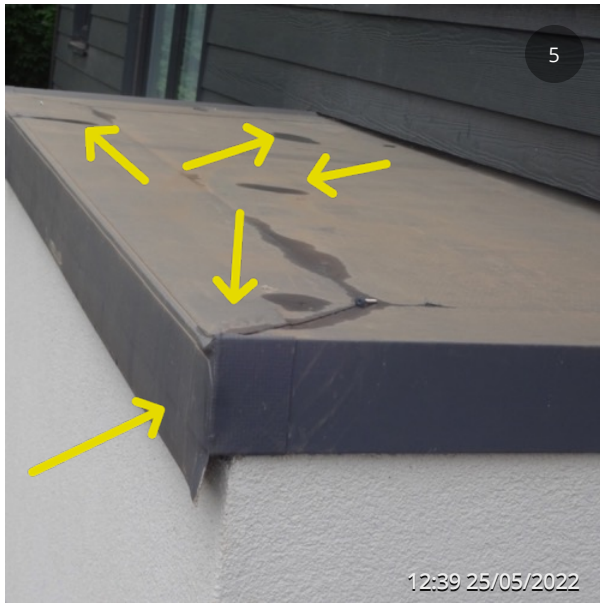
Location: Front Elevation Lower Level Flat Roof

The EPDM type flat roof on the front elevation has air pockets below the finished layer that may be from trapped water or incorrect installation and sealing and will need repair or replacement as necessary

Areas of standing water were also noted on the flat roof.

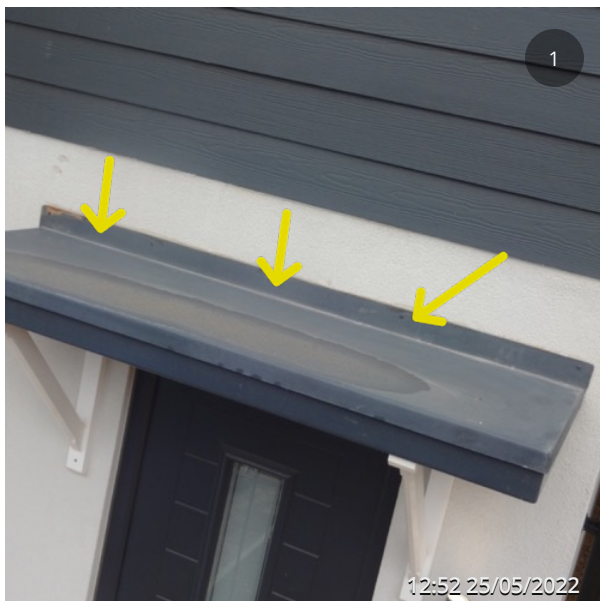
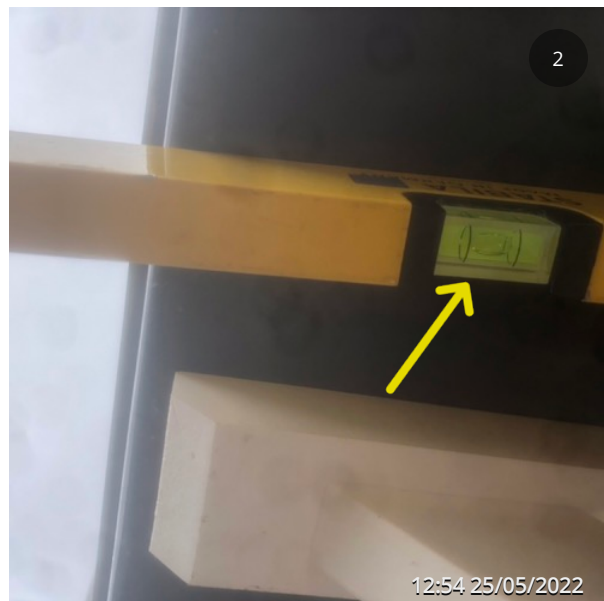
Location: Front Door Porch Roof

The GRP canopy/ porch on the front elevation has standing water on the roof and is not level with a fall back towards the house, this could cause damp issues to the property after a prolonged period of time or potential failure of the canopy itself having prolonged excessive weight applied to it in relation to the constant standing water.

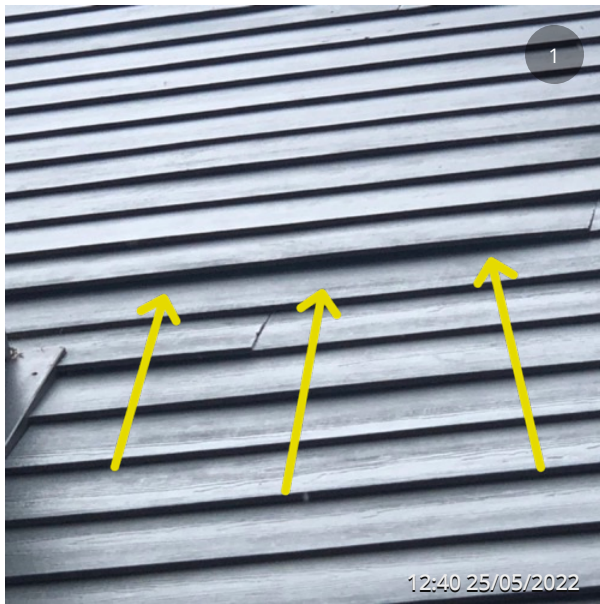
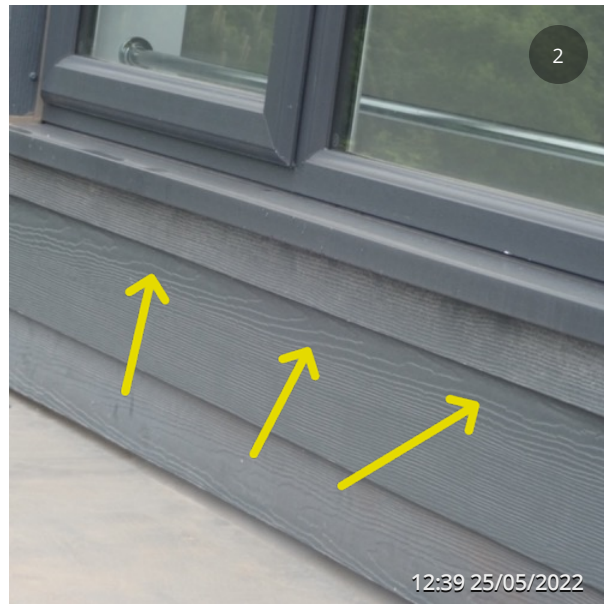
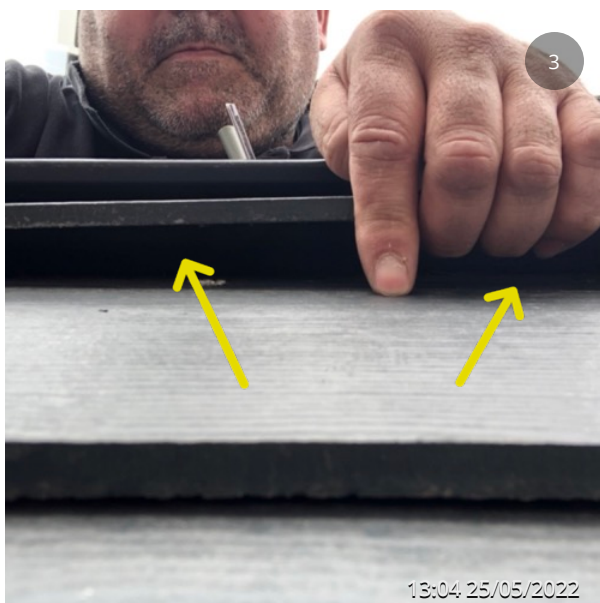
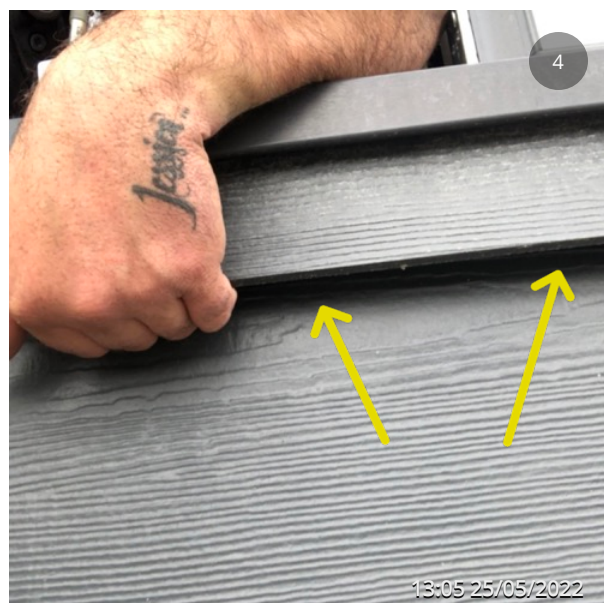
Location: All External Elevations

The cladding on the front elevation is not fully fixed especially under the windows and in other areas on the front elevation is starting to bow outwards and could potentially be pulled off during high winds, we recommend that the cladding is securely fixed back to the structure.

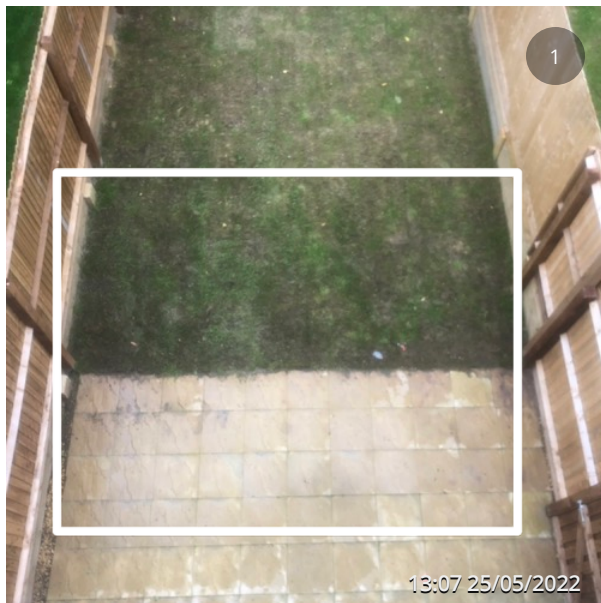
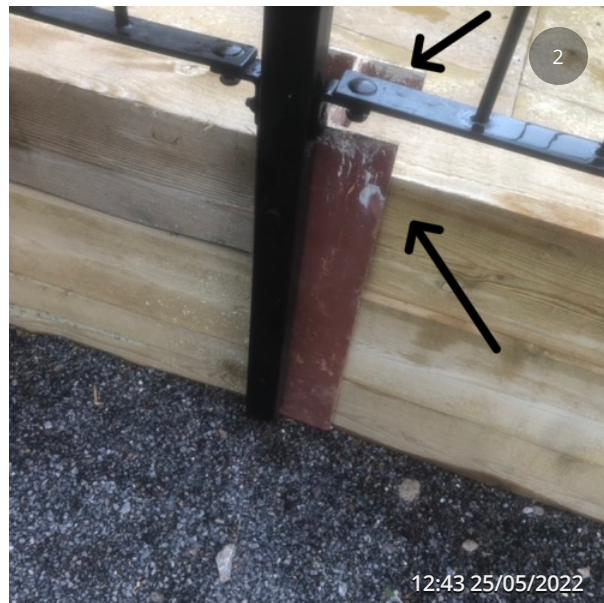
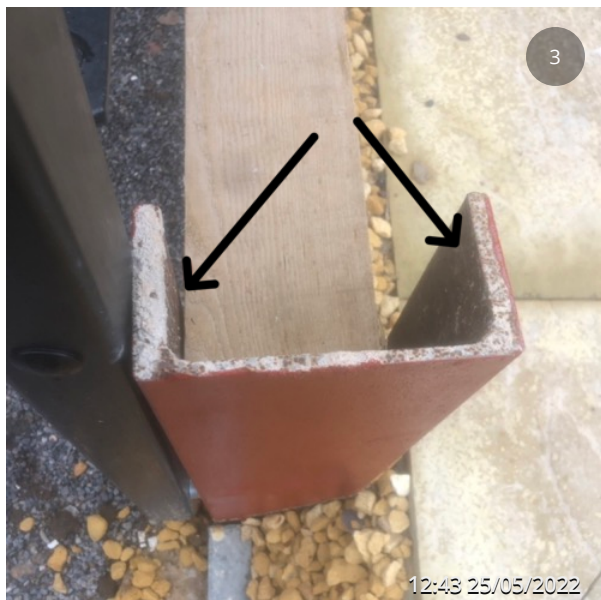
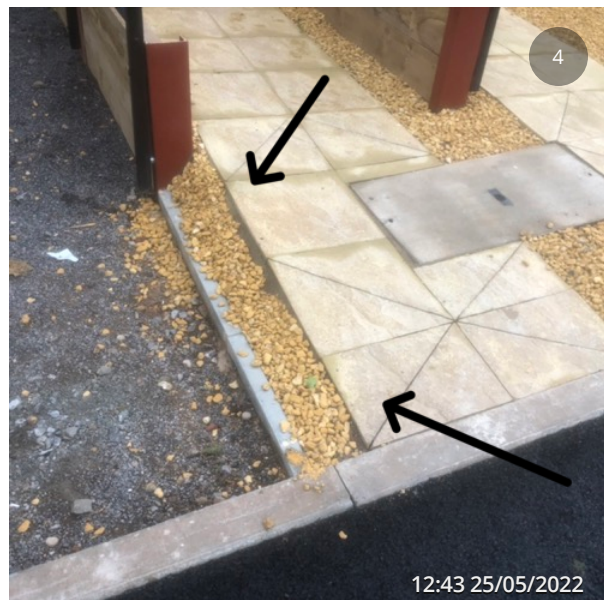
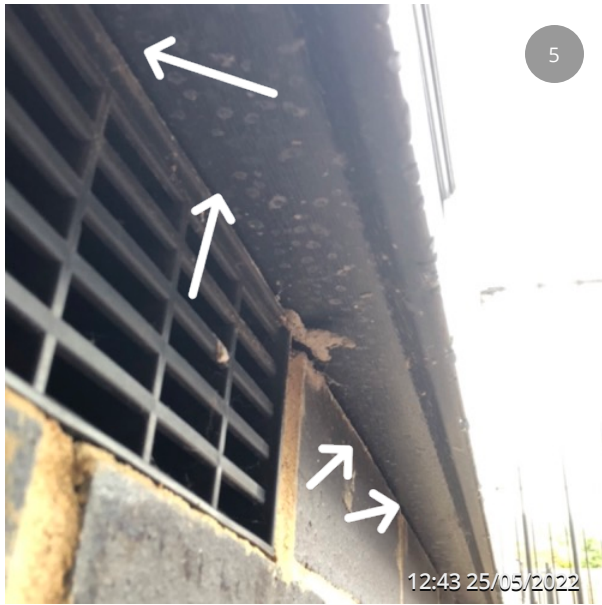
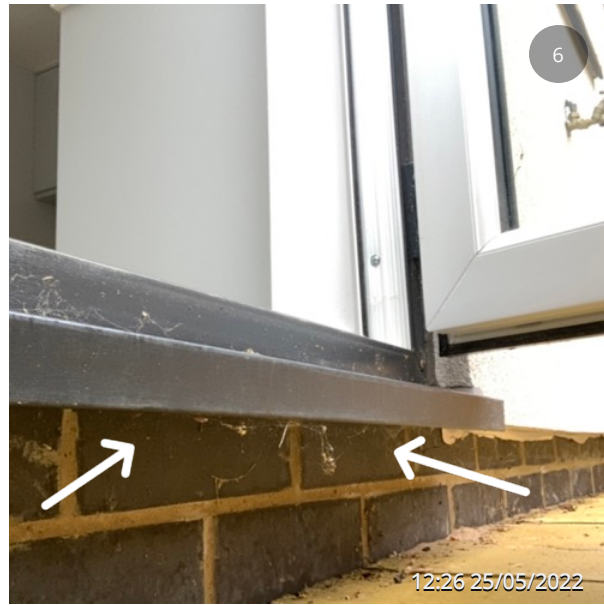
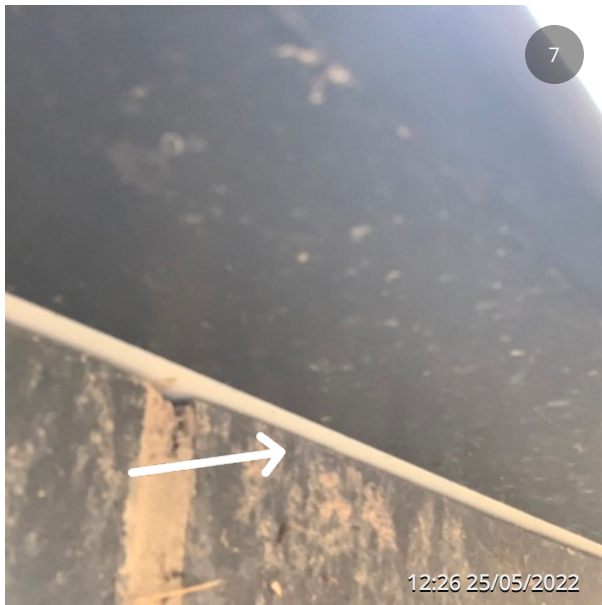
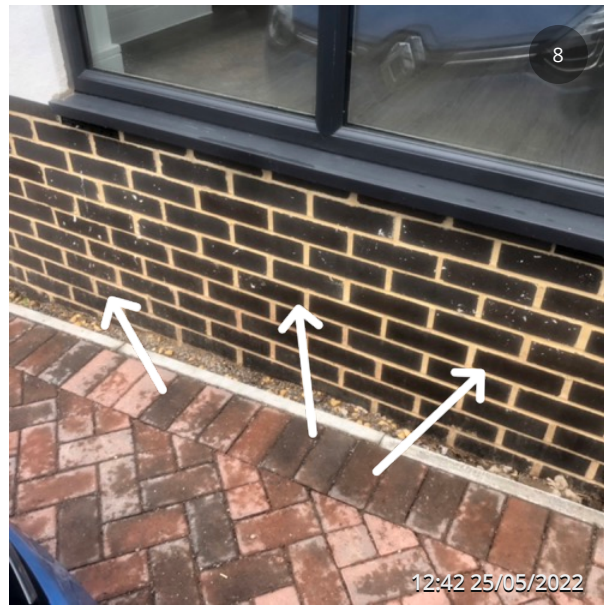
### Location: External Defects

There were no visible drainage inspection chambers (man holes) on site although the neighbouring property's either have visible inspection chambers in the back gardens.

We believe the inspection chambers for the property may have been covered with the patio or the lawn area.

The steel beams around the property that form the fencing and retaining walls have not all been treated and may quickly start to rust and degrade causing potential future failure to these areas.

The gravel area to the left hand side of the entrance path will constantly lose the gravel due to the slope we Recommend perhaps paving or concrete would be more suitable for this area.

There was no mastic seal under any of the ground floor windows and patio door that will allow water ingress into the property.

The front elevation brickwork was stained and needs an acid type brickwash.

There was no visible earth bonding on the gas box.

The guttering down pipe clips on the upper cladding parts of the building had excessive centres and would benefit from extra clips to secure the down pipe to the building.

The outside light to the rear of the property has already started to

show signs of rust around the screws (have the right screws been used for this fitting?)

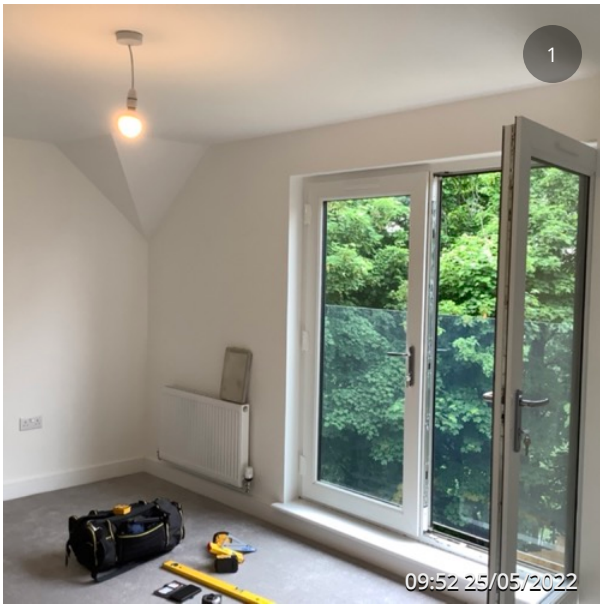
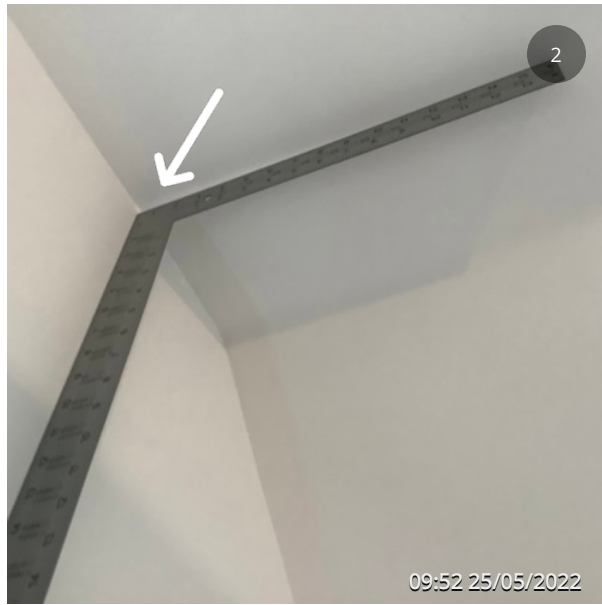
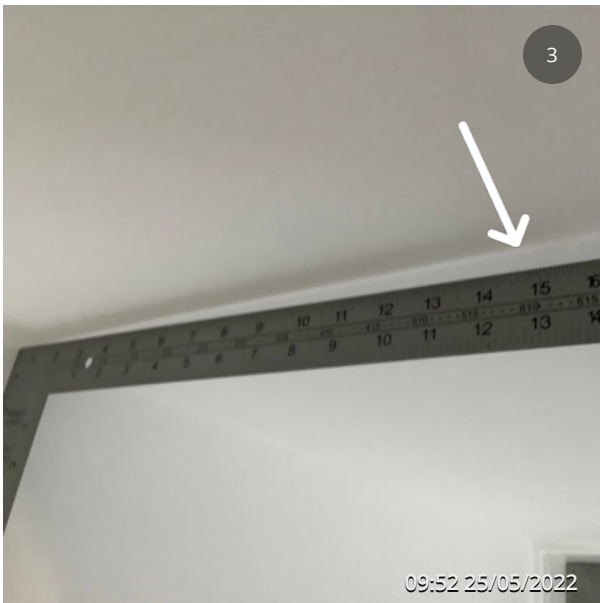
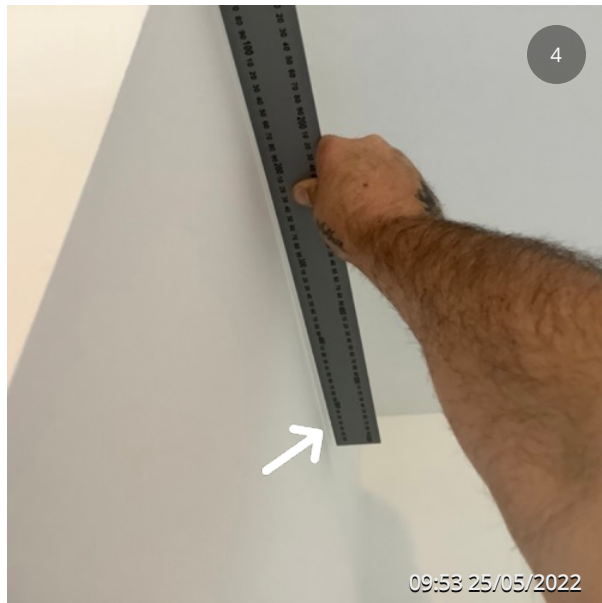
Location: 2nd Floor Bedroom 1

The main door to the bedroom 1 is a fire door with fitted intumescent smoke seals. They have unacceptable Gaps between the fire door and the door frame. These gaps should never be more than 4mm or less than 2mm. It's recommended to aim for a 3mm gap to ensure adequate room for the intumescent strips to activate in the event of a fire, and for the smoke seal strips to not get damaged by the opening and closing of the door. The bottom of the door had been cut off by an excessive amount (between 10/25mm above the carpet line) this is not acceptable for a fire door. In our opinion it will need replacing with a new fire door that is fitted to the manufactures recommendations. Then re inspected by a professional body after replacement to ensure that the door has been corrected fitted and complies with building regulations.

The door frame was not square at the time of inspection NHBC guidance 9.1.4

The door rattles in the keep once shut.

The top of the door is not painted and may allow moisture ingress into the door.

The door hinges were stained with paint and had rough areas where they had been installed to a poor standard.

At the time of inspection a large 90degree calibrated square was use on all internal and external angles of the walls and it was found the majority of the walls were not square at the time of inspection.

The window sill on the balcony door was not level.

The window revels on the patio door were not plumb.

The carpet has been fitted to a poor standard and there were areas around the perimeter of the room that were not fully attached to the carpet gripper.

There were numerous Sockets, light switches etc... around the room that were not level at the time of inspection.

The seal between the low level window cill and the balcony door was split and may cause water ingress.

There were general areas of patch painting around the room that would require decorating.

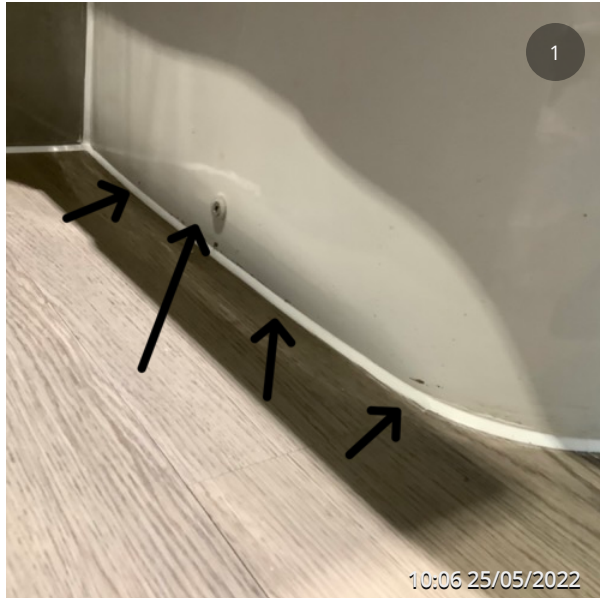
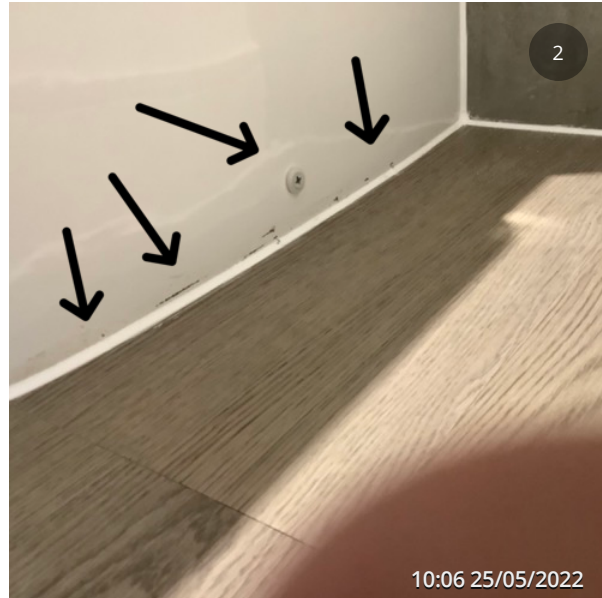
Location: En-suite Off Bedroom 1

Although the door is not required to be a fire door the door margins had unacceptable gaps between the door and the frame, the bottom of the door had been cut off by an excessive amount and in our opinion needs to be replaced with a new door to be cosmetically correct.

The door rattled in the keep once shut.

The door hinge sets were poorly installed and excessive amounts of the frame had been cut out to fit the hinges.

The cover caps were missing on either side of the WC that fixes the WC to the floor.

There were noticeable marks/scratches at the bottom of the WC.

The shower tray mastic was incomplete and will allow water ingress into the property.

The towel rail was not level.

The mastic seal on the corner of the wall below the sink was not complete.

There is a poor quality finish between the wall and the tile trim at the shower cubicle area.

The skirting boards around the shower tray has mastic that has not fully sealed to the floor and the end of the skirting is not sealed and will become defective with water ingress from the shower area.

Paint on tiles below the sink area.

Grout missing on tiles on the left hand side of the sink.

Poor quality finish on the decoration around the bathroom shaver socket.

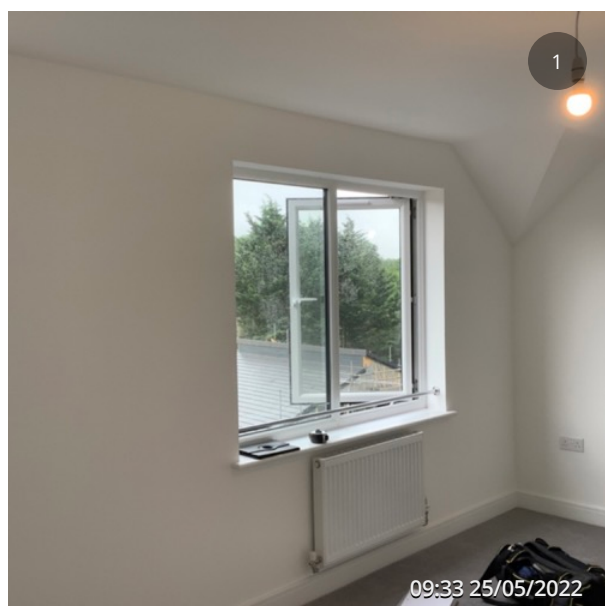
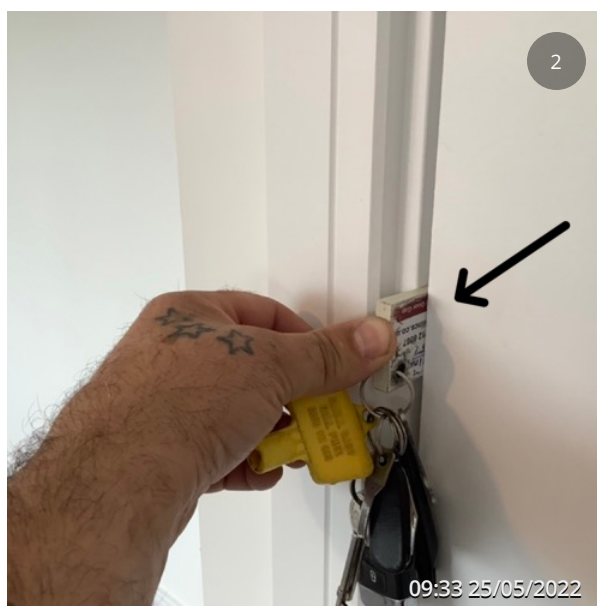
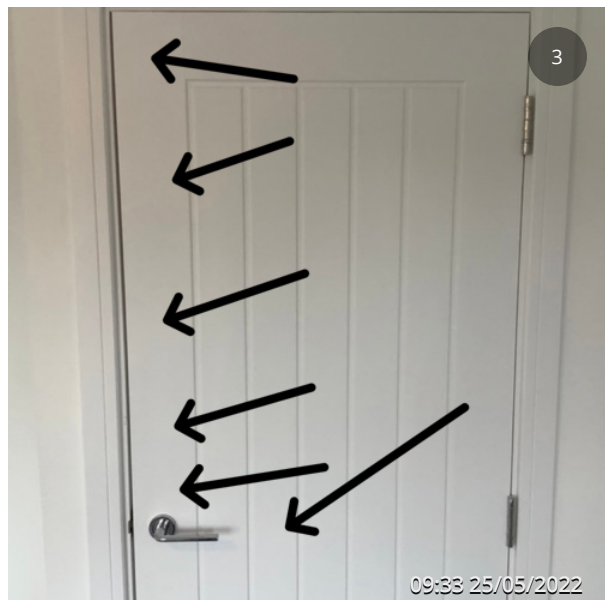
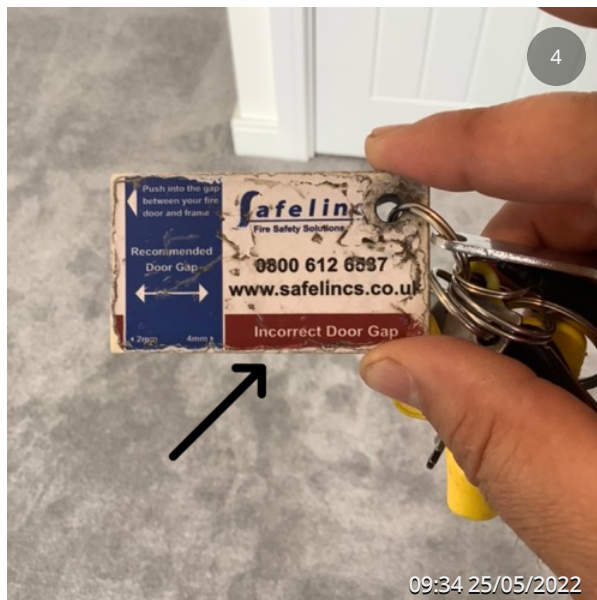
Location: Bedroom 2 Second Floor

The main door to the bedroom 2 is a fire door with fitted intumescent smoke seals and have unacceptable Gaps between the fire door and the door frame and should never be more than 4mm or less than 2mm. It's recommended to aim for a 3mm gap to ensure adequate room for the intumescent strips to activate in the event of a fire, and for the smoke seal strips to not get damaged by the opening and closing of the door, the bottom of the door had been cut off by an excessive amount (between 10/25mm above the carpet line) this is not acceptable for a fire door and in our opinion will need replacing with a new fire door that is fitted to the manufactures recommendations and re inspected by a professional body after replacement to ensure that the door has been corrected fitted and complies with building regulations.

The door frame was not square at the time of inspection.

The door rattles in the keep once shut.

The top of the door is not painted and may allow moisture ingress into the door.

The door hinges were stained with paint and had rough areas where they had been installed to a poor standard.

The door frame has some damage on the left hand side between the architrave and the frame.

At the time of inspection a large 90degree calibrated square was use on all internal and external angles of the walls and it was found the majority of the walls were not square at the time of inspection.

The carpet has been fitted to a poor standard and there were areas around the perimeter of the room that were not fully attached to the carpet gripper.

There were numerous Sockets, light switches etc... around the room that were not level at the time of inspection.

The window cill was not level.

The window cills were not fully sealed below the window cill and the wall.

The radiator is not level.

The skirting boards joints were splitting and need filling and re decorating.

Some areas of general decoration patching our required.

Due to the window height being to low and not meeting building regulations due to a risk of fall a rail has been fitted to try and comply with the regulations and in our opinion is not suitable as it is basically a clothes hanging rail that is not substantial enough and could be easily bent or broken with very little effort and allowing a serious risk of fall from the window.

The Approved Document to Part K provides guidance on the height above floor level at which guarding should be provided

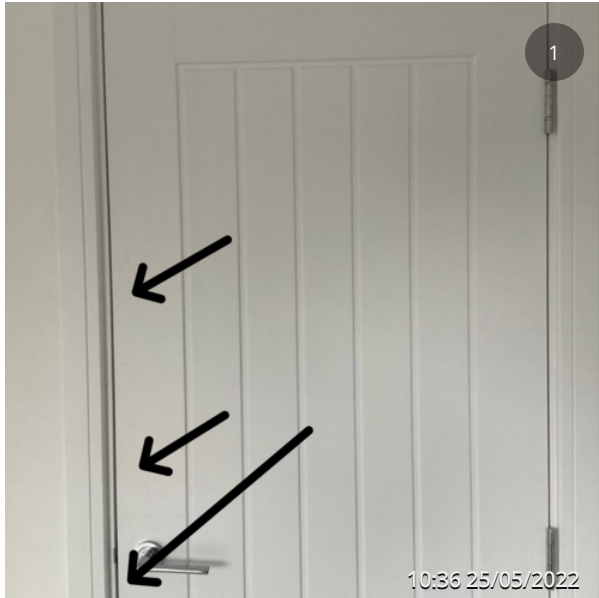
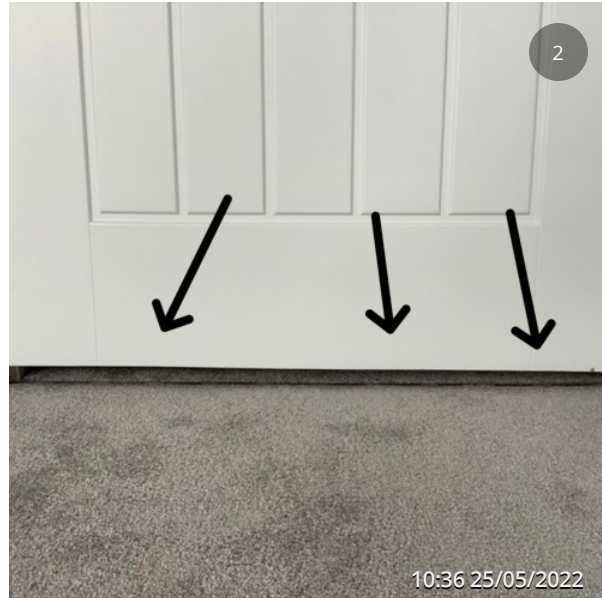
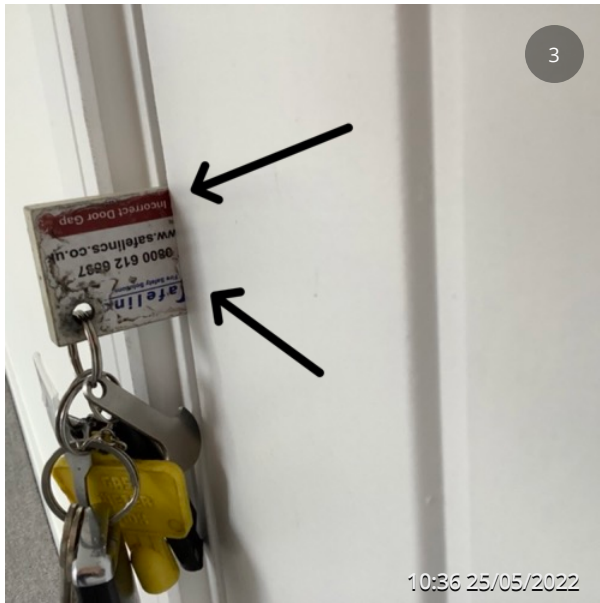
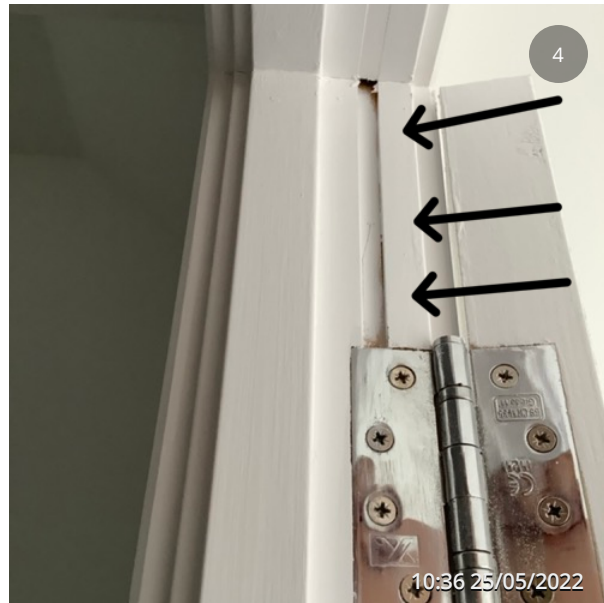
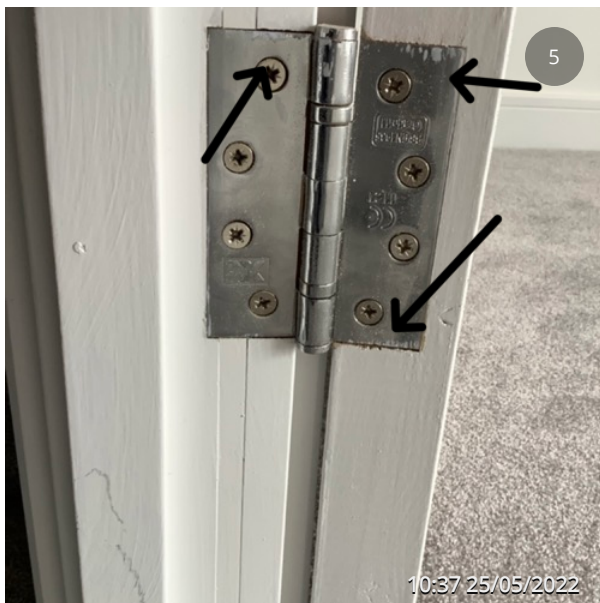
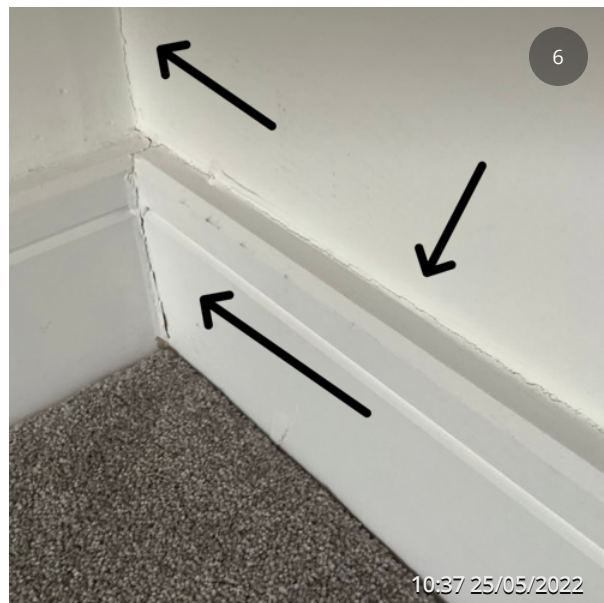
Location: Bedroom 4 First Floor

The main door to the bedroom 4 is a fire door with fitted intumescent smoke seals and have unacceptable Gaps between the fire door and the door frame and should never be more than 4mm or less than 2mm. It's recommended to aim for a 3mm gap to ensure adequate room for the intumescent strips to activate in the event of a fire, and for the smoke seal strips to not get damaged by the opening and closing of the door, the bottom of the door had been cut off by an excessive amount (between 10/25mm above the carpet line) this is not acceptable for a fire door and in our opinion will need replacing with a new fire door that is fitted to the manufactures recommendations and re inspected by a professional body after replacement to ensure that the door has been corrected fitted and complies with building regulations.

There was a section of intumescent smoke seal missing at the top left hand side of the door frame.

The door rattles in the keep once shut.

Poor quality finish on the cutting in of the door hinges.

Paint marks on the door hinges.

The top of the door is not painted and may allow moisture ingress into the door.

At the time of inspection a large 90degree calibrated square was use

on all internal and external angles of the walls and it was found the majority of the walls were not square at the time of inspection.

The joints between the skirting boards were cracking and need filling and re decorating.

There were numerous Sockets, light switches etc... around the room that were not level at the time of inspection.

Hairline cracking above the door and above the left hand side window lintel was noted that will need repair.

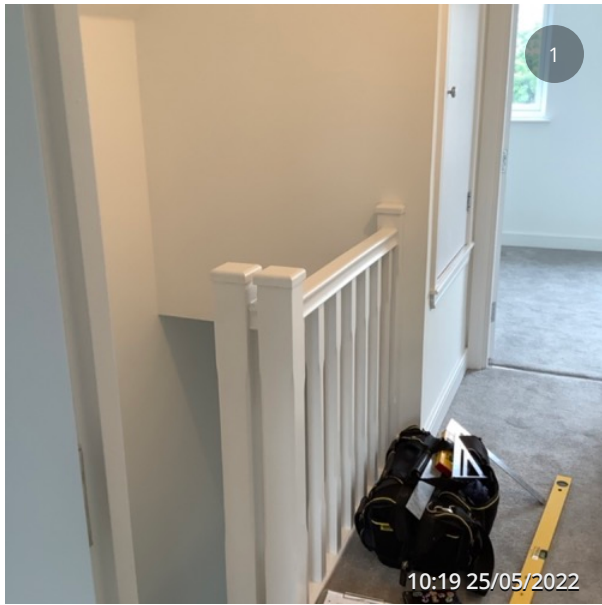
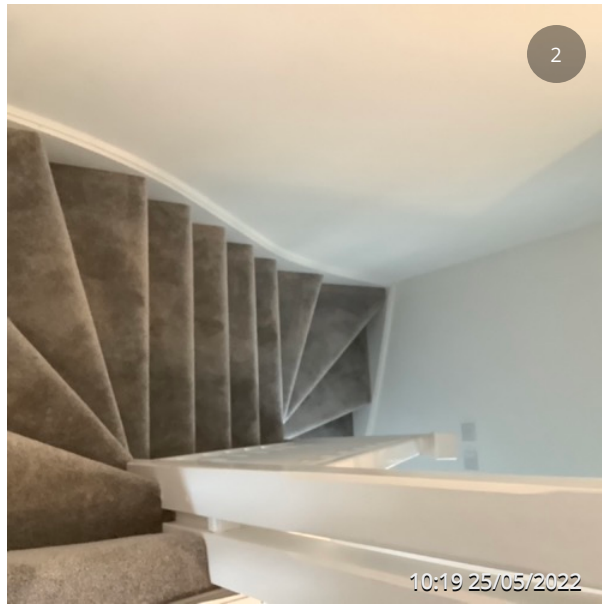
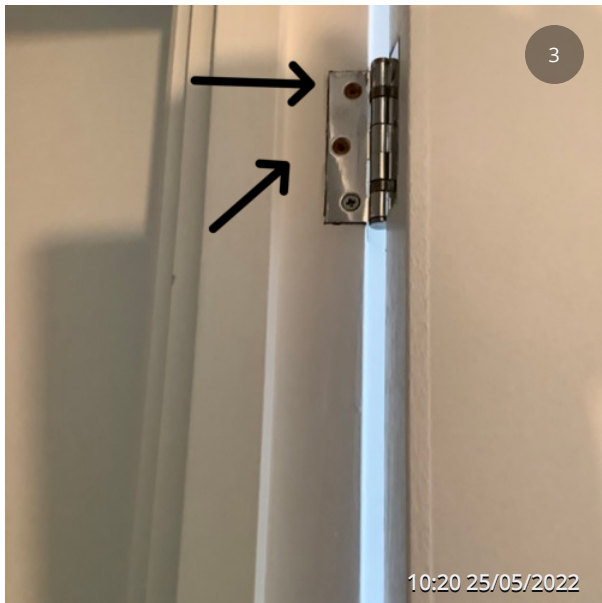
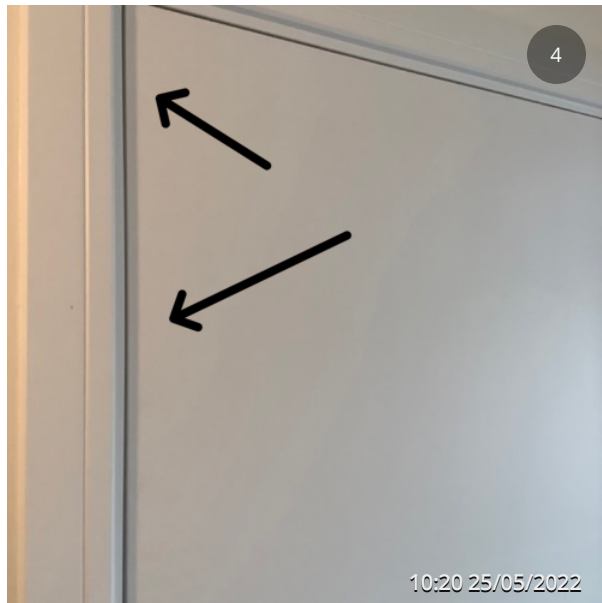
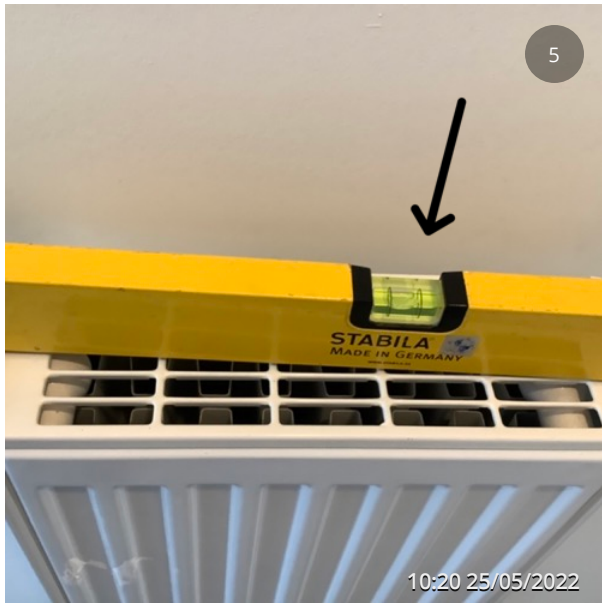
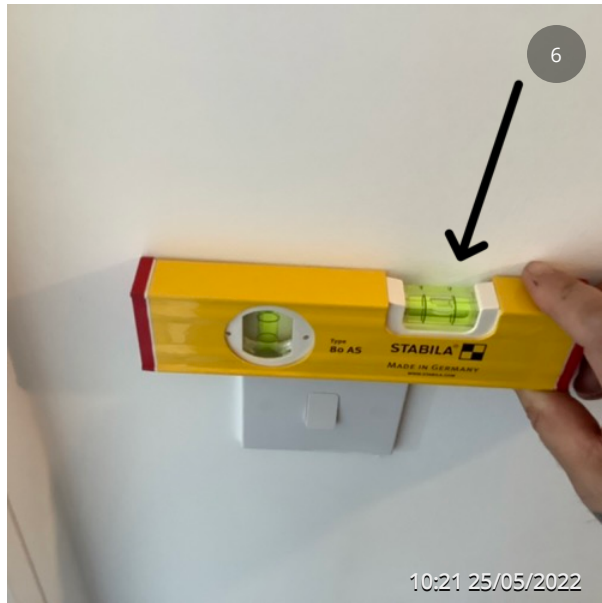
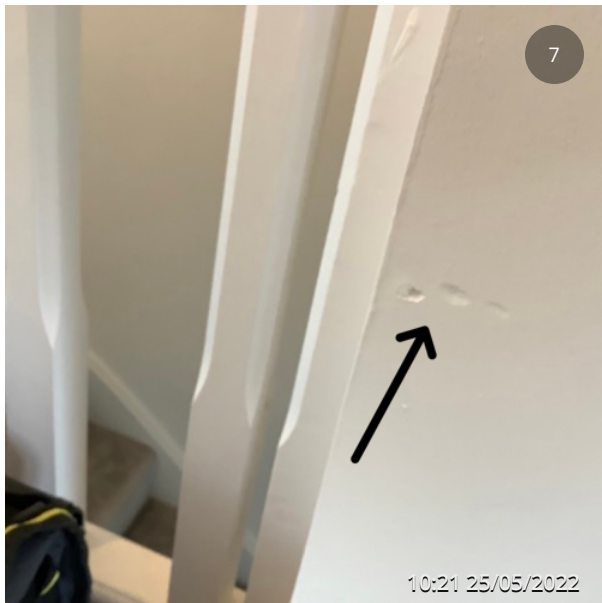
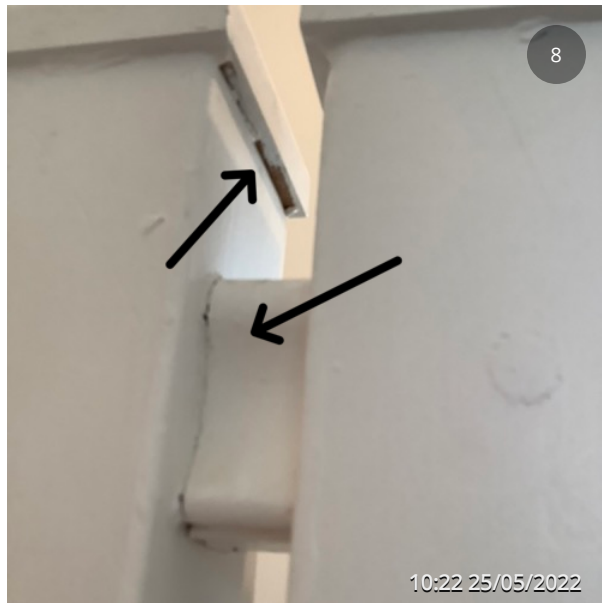
Location: Second Floor

Radiator not level.

There were numerous Sockets, light switches etc... around the room that were not level at the time of inspection.

At the time of inspection a large 90degree calibrated square was use

on all internal and external angles of the walls and it was found the majority of the walls were not square at the time of inspection.

The door to the over stairs cupboard has screws missing on the hinges.

The door margins around the over stairs cupboard were not even and had excessive gaps.

The top of the over stairs cupboard door is not painted and may allow moisture ingress into the door.

The carpet has been fitted to a poor standard and there were areas around the perimeter of the room that were not fully attached to the carpet gripper.

The newel post was not plumb.

Painting defects were noted especially around the newel posts and around the woodwork of the over stairs cupboard.

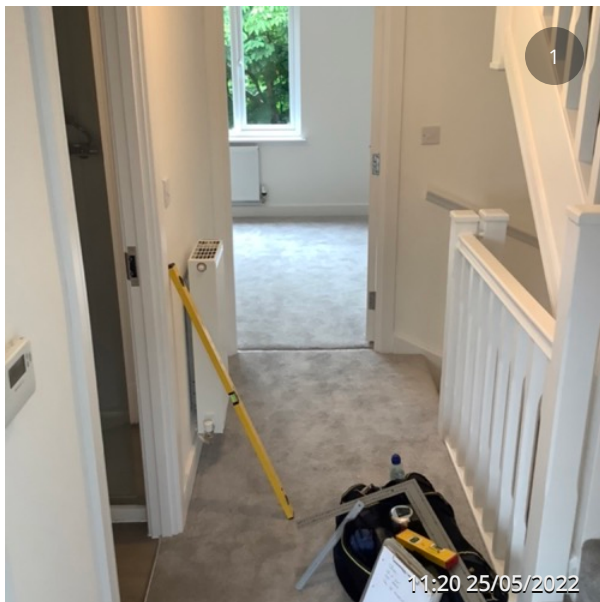
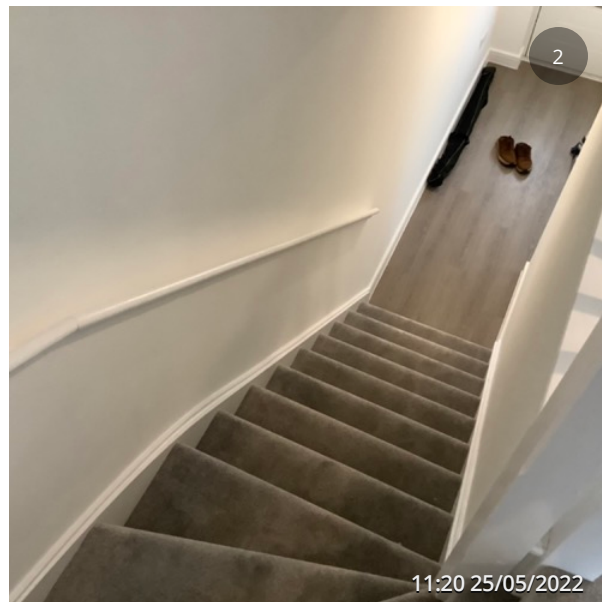
Location: First Floor

Radiator not level.

There were numerous Sockets, light switches etc... around the room that were not level at the time of inspection.

A screw cap is missing to the light switch at the top of the staircase.

Newel posts at the top and bottom of the stairs were not plumb.

Painting defects to the newel posts and handrails were noted.

The hand rail does not comply to building regulations and needs to be extended 300mm past the top and bottom steps of the staircase.
