# SAMPLE SNAGGING SURVEY

An anonymised example demonstrating the scope, photographic evidence and practical detail included in our new-build inspections.

Prepared by Gary Bates ACBE MRPSA BCI  
G&L Residential Building Surveys UK Ltd

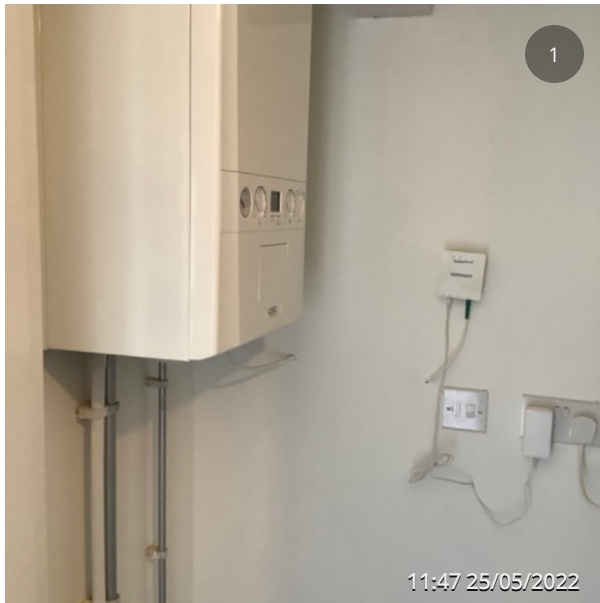
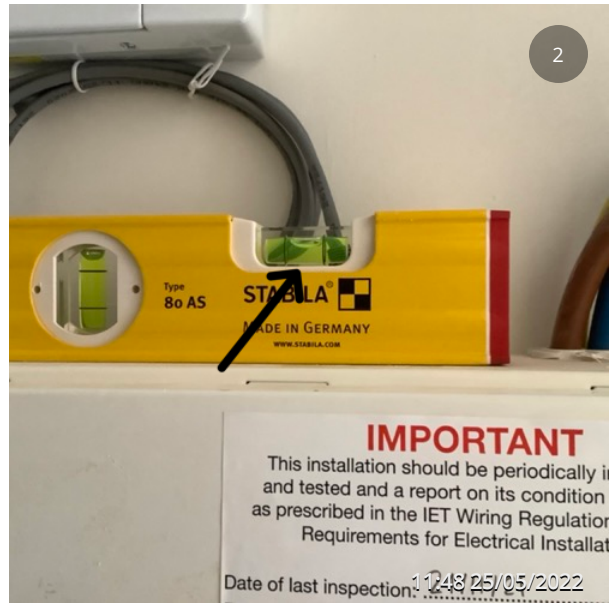
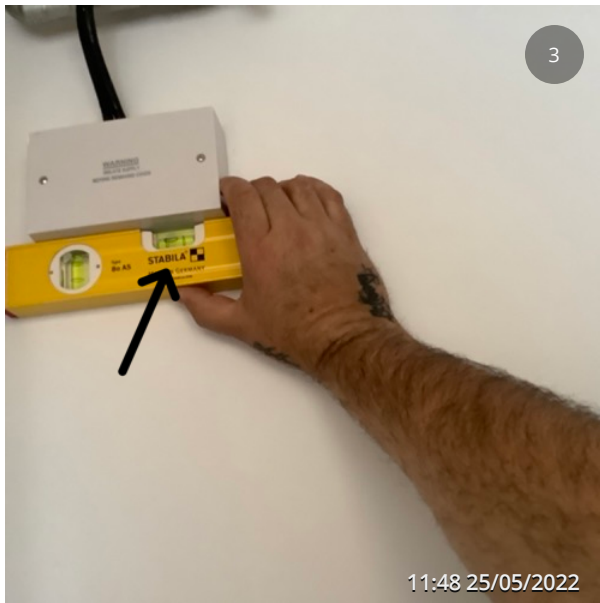
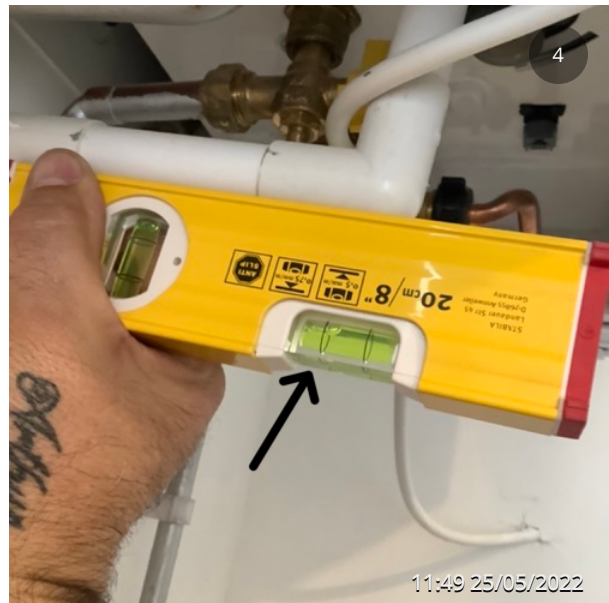
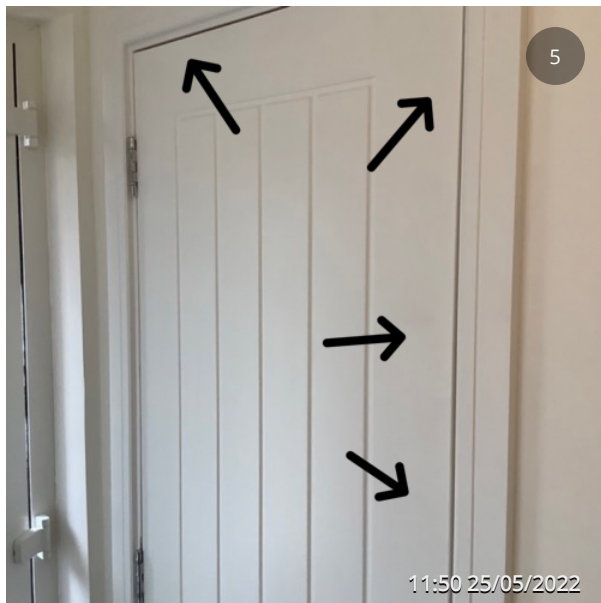
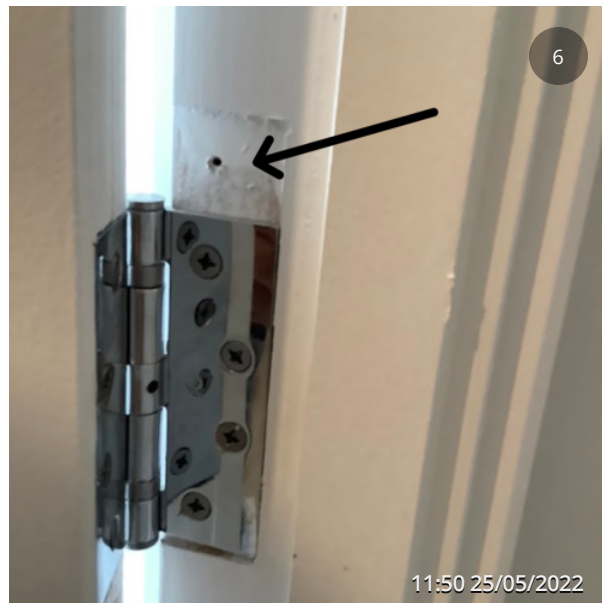
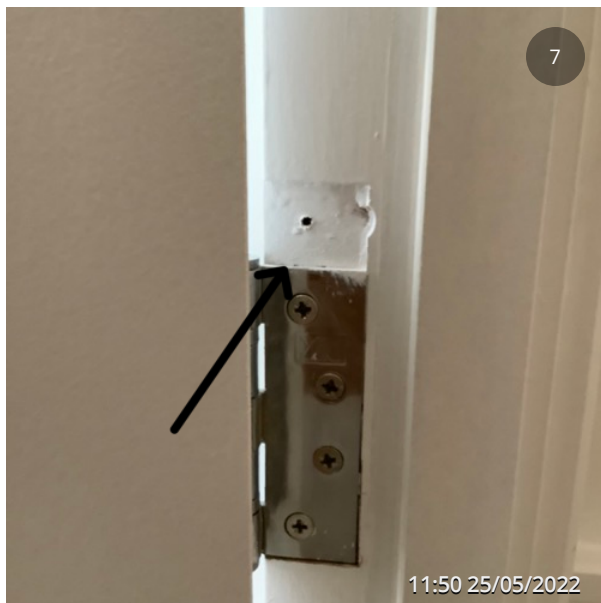
Location: Ground Floor

Although the door is not required to be a fire door the door margins had unacceptable gaps between the door and the frame, the bottom of the door had been cut off by an excessive amount and in our opinion needs to be replaced with a new door to be cosmetically correct.

The door rattled in the keep once shut.

The top of the door is not painted and may allow moisture ingress into the door.

The door hinges have been fitted incorrectly and excessive amounts of the door frame have been needlessly cut out.

There were numerous Control units and switches etc... in the cupboard that were not level at the time of inspection.

The Condensing boiler will produce a slightly acidic waste product called condensate which is removed via a white plastic pipe to an external drain the condense pipe has an unacceptable back fall towards the boiler and it can cause of the boiler to shut down, this will need repair or replacement.

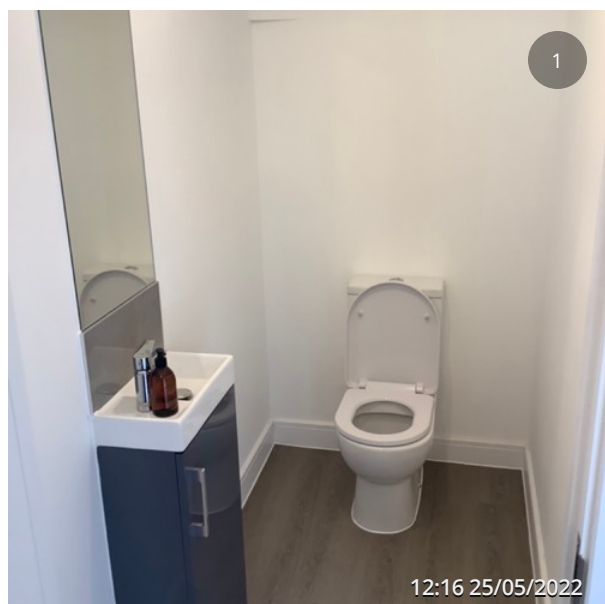
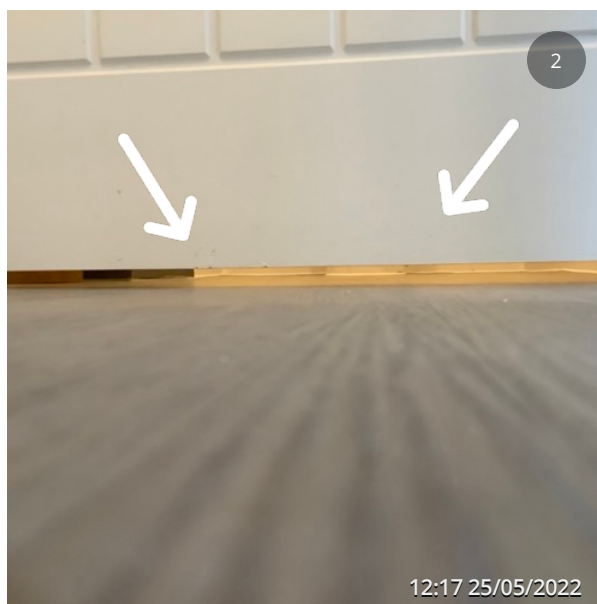
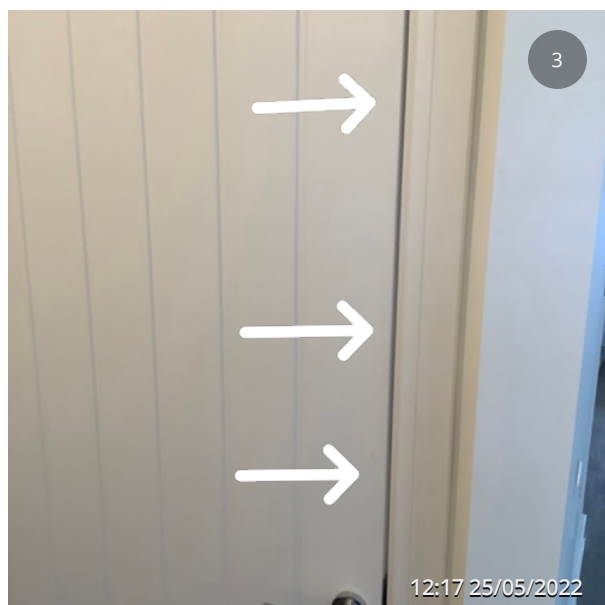
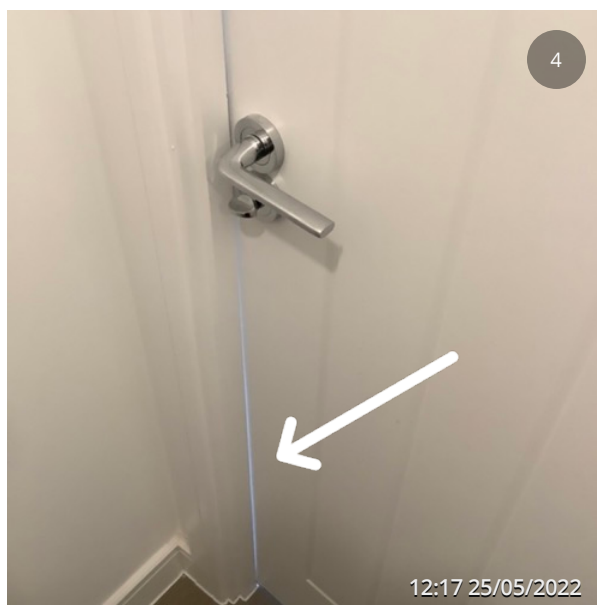
Although the door is not required to be a fire door the door margins had unacceptable gaps between the door and the frame, the bottom of the door had been cut off by an excessive amount and in our opinion needs to be replaced with a new door to be cosmetically correct.

The cover caps were missing on either side of the WC that fixes the WC to the floor.

There were noticeable marks/scratches at the bottom of the WC.

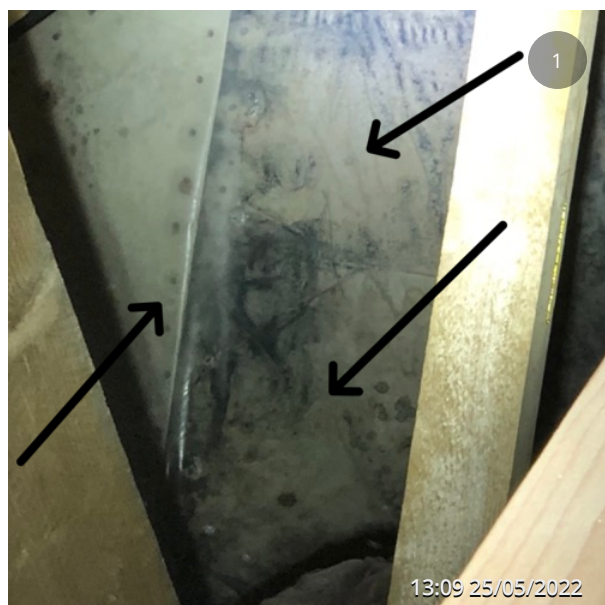
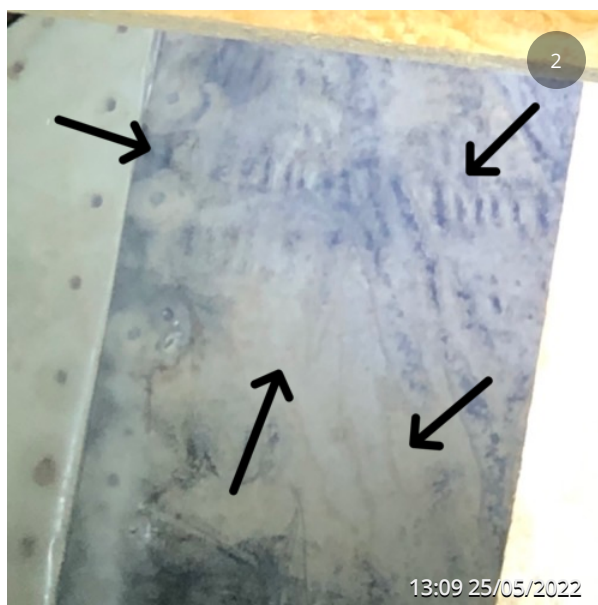
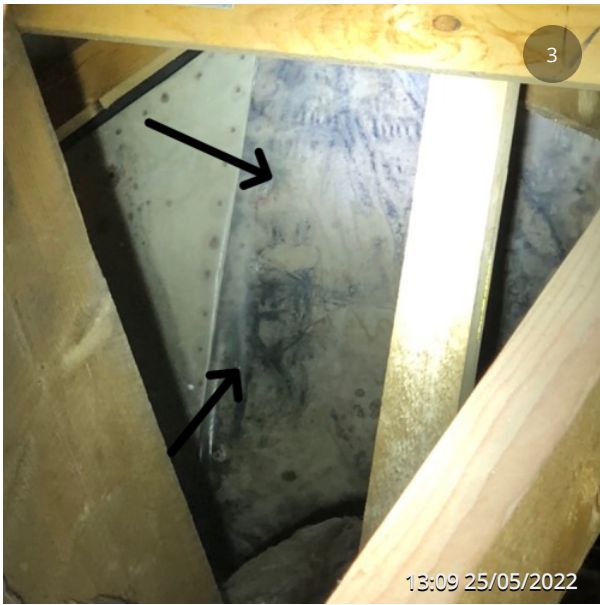
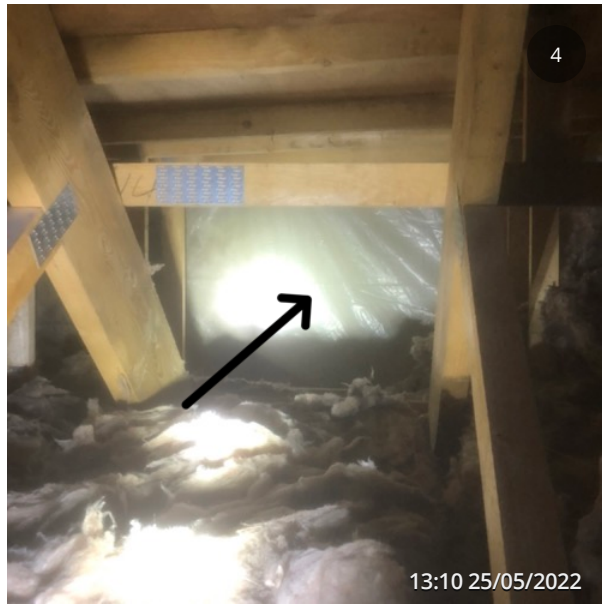
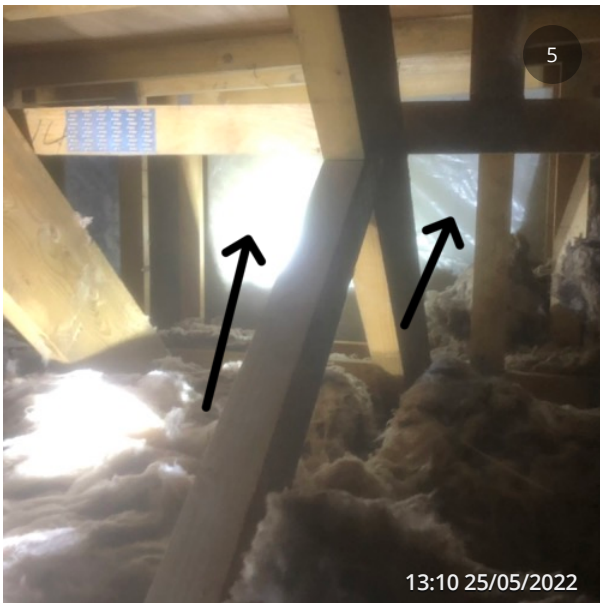
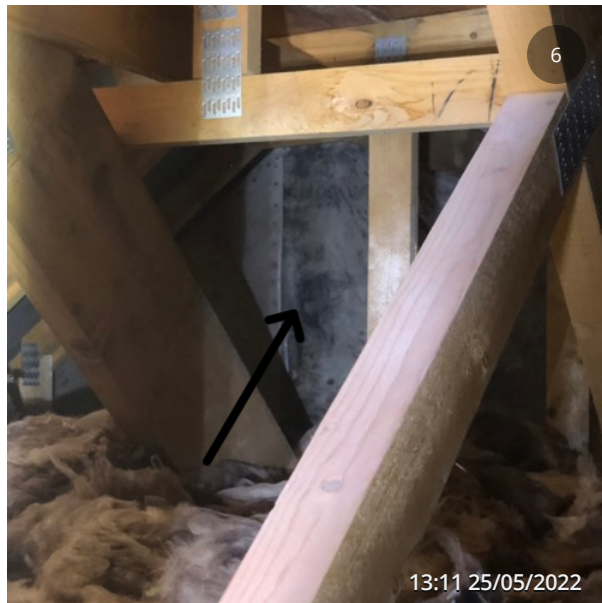
The spandrel panel (this is a fire break in between the neighbouring property's that need to provide substantial fire protection from fire spread in the loft space and is typically constructed of timber and then clad in multiple layers of plasterboard to provide a fire stop) was from the limited view from the attic hatch still wrapped in its plastic transportation material that should have be removed as soon as it is installed during the roof construction, this has not been removed and has caused excessive condensation to build up between the plasterboard and the plastic transportation covering

and has caused excessive mould growth and has damaged the plasterboard and is compromising the fire stopping ability of the spandrel panel and is a significant health and safety risk to both property's, a major repair to the panel is needed and must be carried out to the manufactures specifications and in our opinion re inspected by a competent building control professional.

(Due to the numerous different manufacturers of spandrel panels every manufacturer has different specifications and repair details) the builder will need to provide the panel manufactures details and confirm repair details needed.
