# SAMPLE LEVEL 2 HOME SURVEY

An anonymised example showing the structure, condition ratings, photographs and practical advice included in a Level 2 Home Survey.

Prepared by Gary Bates ACABE MRPSA BCI  
G&L Residential Building Surveys UK Ltd  
Company No. 16992416

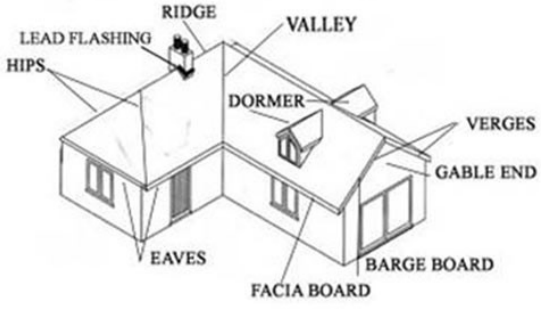
| <b>Condition</b> | <p>No significant defects were noted and the roof was found to be structurally stable. No evidence was seen of unusual sagging or other movement which might indicate that the structure is failing.</p> <p>No significant numbers of slipped, chipped, cracked or missing tiles were noted. Some moss growth was evident, for example at the front, and this should be cleared as a matter of routine maintenance to prevent over-weighting the roof structure.</p> <p>Carry out normal maintenance including removal of moss build-up. Any slipped, missing or broken tiles on the roof pitches should be repaired and replaced. You should carry out a thorough visual inspection at least once a year, ideally in the Spring to identify and repair any damage that could have been caused by winter weather.</p> | |
| | <p>Moss growth on the front roof pitch</p> | <p>Roof Elements</p> |

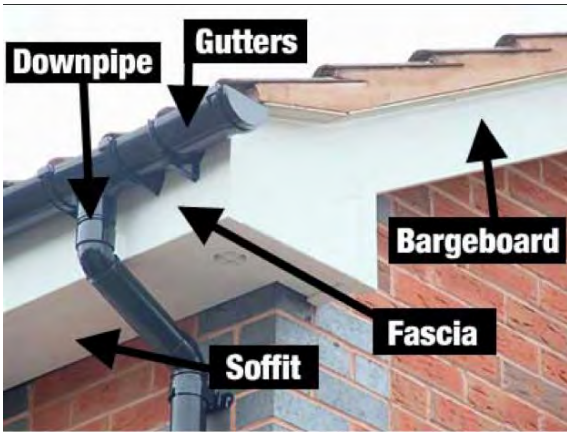
| | 4.6 External Joinery and Finishes | Condition rating | 2 |
|---|---|---|---|
| Condition | <p>No significant defects were noted.</p> <p>However, the joinery is in a poorly maintained condition requiring stripping and redecorating to all sides of the property. In such circumstances, many new owners would consider replacing the existing fascias, soffits and bargeboards with low maintenance PVC.</p> | | |
| | <p>Eaves detail</p> | | |

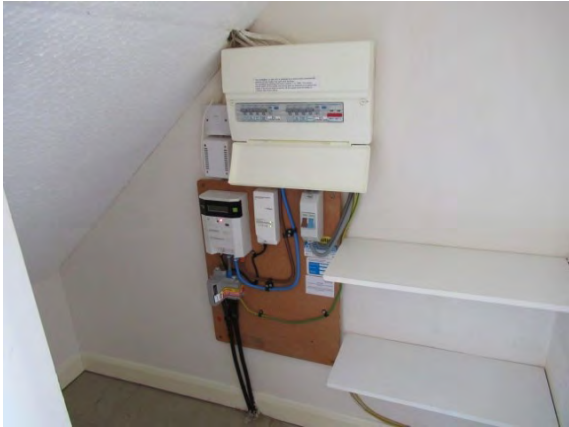
| | Consumer unit and meter | |

As far as could be seen the visible wiring is of a modern PVC type, and the nature of the consumer unit indicates that the installation has been upgraded in more recent years, though it is not known whether this included wiring within the walls, floors and ceilings..

NAPIT recommends that domestic electrical installations are inspected and tested every 10 years in line with IET (The Institution of Engineering & Technology) Guidance Note 3 covering Electrical Installation Condition Reports (EICR). This guidance also recommends that at any change of occupancy (such as a house sale, or change of tenant) an Electrical Installation Condition Report is carried out to prove the installation to be in a satisfactory or unsatisfactory condition. This report should cover all the fixed wiring and equipment within the property boundaries, including outbuildings.

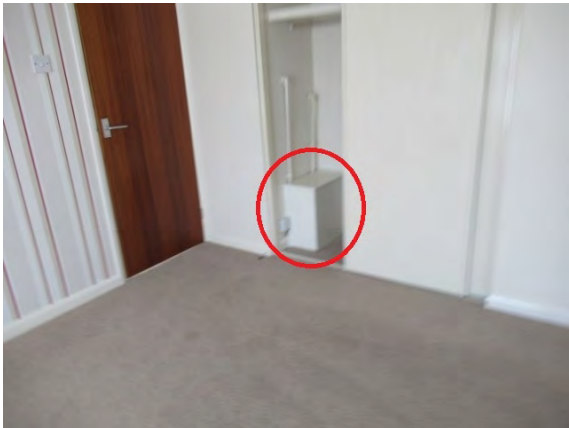
| <b>Condition</b> | <p>No significant defects were noted.</p> <p>The flow of water at all outlets checked was found to be within a normal range, though as the heating system was not running it was not possible to check the availability of hot water.</p> <p>The pump for the bathroom shower is in a boxed area within the wardrobe of bedroom 1. It may produce some noise disturbance when used.</p> <p>The water temperature in a hot water storage tank should be around 60°C in order to kill legionella bacteria (which can cause Legionnaires Disease), and no more than 50-55°C at taps in the property.</p> <p>Check the installation for evidence of leaks or other defects on a regular basis i.e. approximately every 6 months, or sooner. Leaks most often occur at pipe joints and where pipes are subject to movement or physical damage, such as airing cupboards, roof spaces and under sinks.</p> |
| | <div data-bbox="343 1220 914 1646" data-label="Image"> </div> <div data-bbox="381 1722 873 1753" data-label="Caption"> Shower pump in box in bedroom 1 wardrobe </div> <div data-bbox="1007 1155 1436 1711" data-label="Image"> </div> <div data-bbox="930 1722 1525 1753" data-label="Caption"> Water Meter under a flap in the footpath to the front </div> |

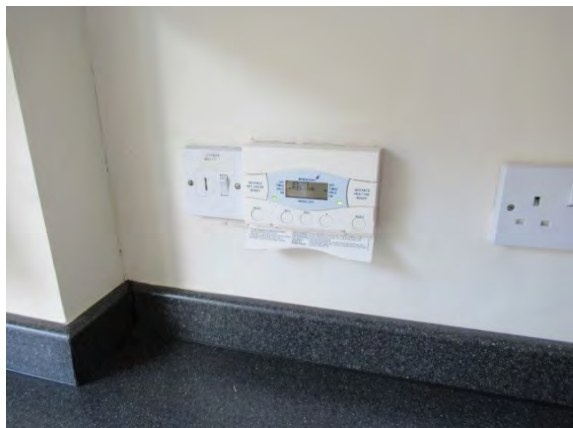
| <b>Condition</b> | <p>The boiler is believed to be approximately 5 years old and, therefore, around one third of the way through its normal expected service life. Under normal circumstances a modern boiler will last for 15-20 years before requiring replacement.</p> <p>No evidence was seen to suggest that an inhibitor has been added to the heating system recently to prevent a build-up of sludge in the pipework and radiators, and it is therefore recommended that the system be flushed through and an inhibitor added.</p> <p>Gas Safe recommends that all gas appliances and boilers are inspected and serviced according to manufacturer's guidance, but at least once a year. A gas installation can look to be in a safe condition, but serious defects may be hidden, some of which can kill. It is therefore considered to be essential that you commission an inspection of the gas/heating installation prior to purchase of the property, unless you are provided with verifiable evidence that such an inspection has recently been carried out by a competent person. You can get more information, or find a Gas Safe registered engineer <a href="https://www.gassaferegister.co.uk/find-an-engineer/">https://www.gassaferegister.co.uk/find-an-engineer/</a></p> |

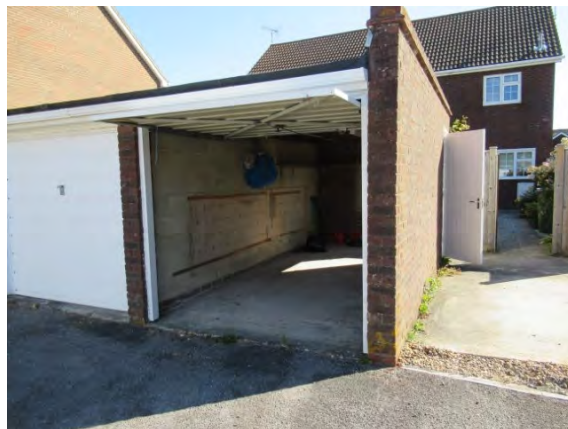
Garage

Compared to traditional coverings such as tiles and slates, most felt roofs have a typical life of 10-25 years. They are also prone to sudden failure and leakage. Periodic re-covering will therefore be necessary. When this is undertaken, the supporting structure may also need some attention.

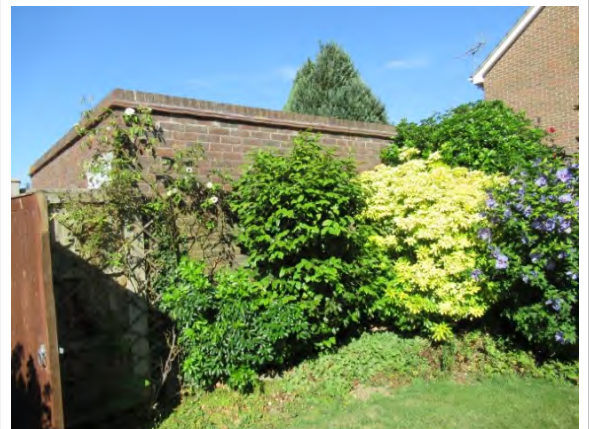
Garage garden view
