# SAMPLE LEVEL 3 BUILDING SURVEY

A comprehensive example showing detailed construction analysis, condition ratings, photographs, risks and practical repair recommendations.

Prepared by G&L Residential Building Surveys UK Ltd  
Gary Bates ACABE MRPSA BCI  
Company No. 16992416

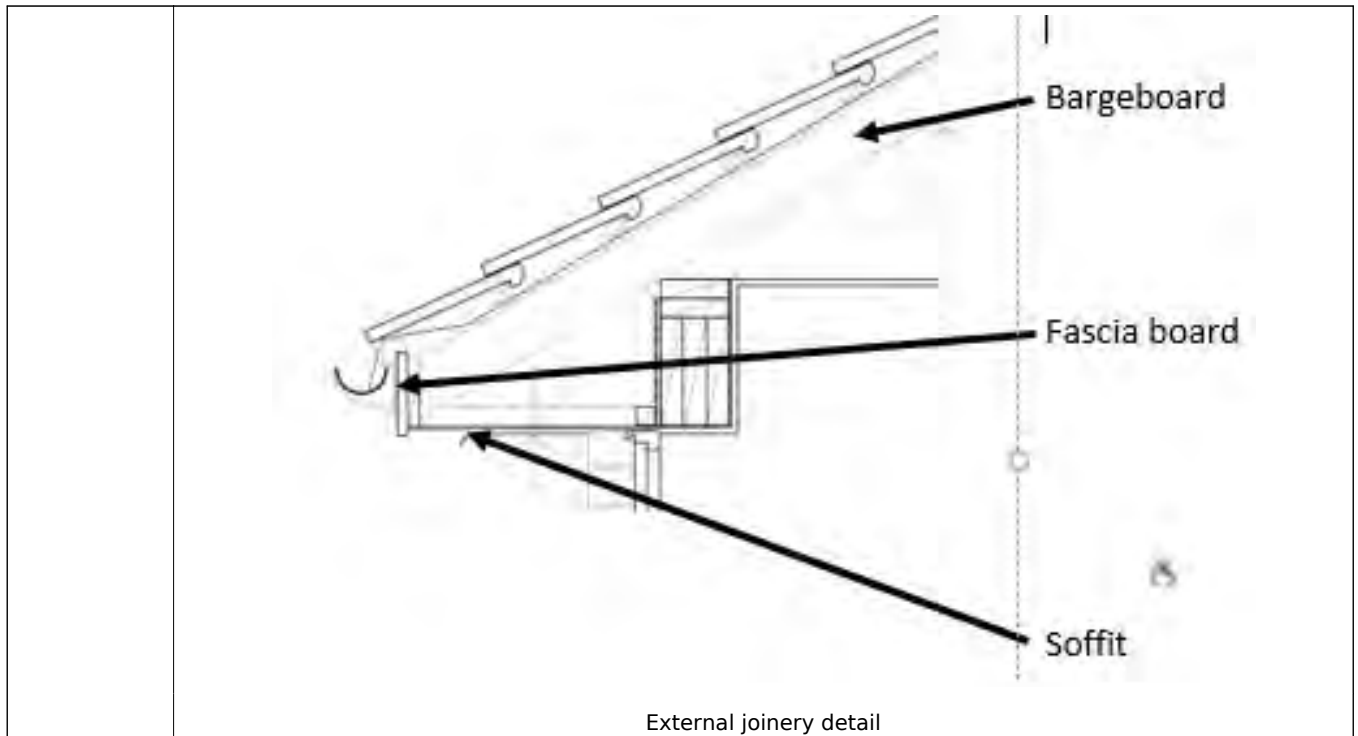
| | <div data-bbox="416 1122 1406 1778"> </div> <p>Rot in the fascia at the front</p> | | |

| <b>Action Required</b> | <p>Urgent repairs are required to replace rotten timbers around the edges of the roof.<br/>Although some areas of rot were identified, others may be present, and it is possible that the ends of the roof rafters may have been affected.<br/>A thorough investigation should be carried out to identify all rotten timber, which should be cut out and replaced.<br/>This work is considered to be of an urgent nature and should be carried out immediately upon occupation of the property.</p> | | |

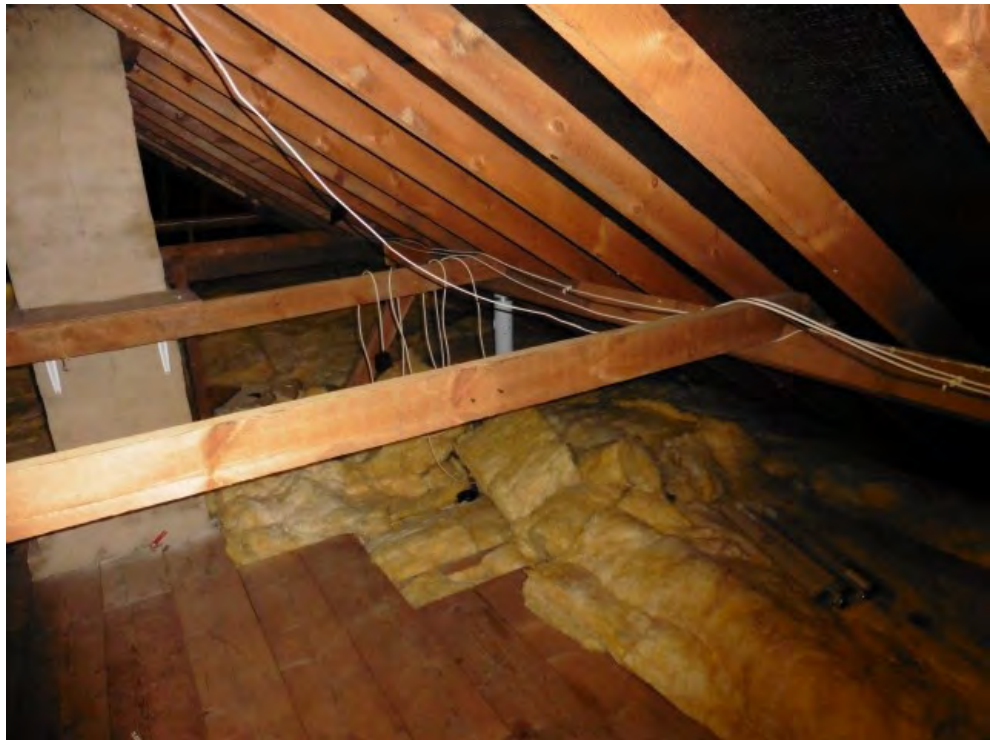
Looking towards the right

| <b>Condition</b> | <p>No significant defects were noted during my inspection and the roof was found to be structurally sound.</p> <p>No evidence was seen of any unusual movement or stress of the supporting timbers within the roof, and there have been no obvious significant alterations to the structure which might have resulted in it becoming substantially weakened.</p> <p>The roof space is laid with 200-300mm of .....<br/>.....</p> <p>High moisture levels within roof spaces are responsible for the promotion of the development of timber defects such as rot and infestations by wood boring insects (commonly known as woodworm). Wood moisture content readings taken were found to be well within normal limits and below the levels normally required for this type of defect.</p> | | |

| <b>Action<br/>Required</b> | Although no evidence of active infestations of wood boring insects was identified, it is important to remain vigilant and be aware that such infestations can become active after long periods of inactivity. | | |

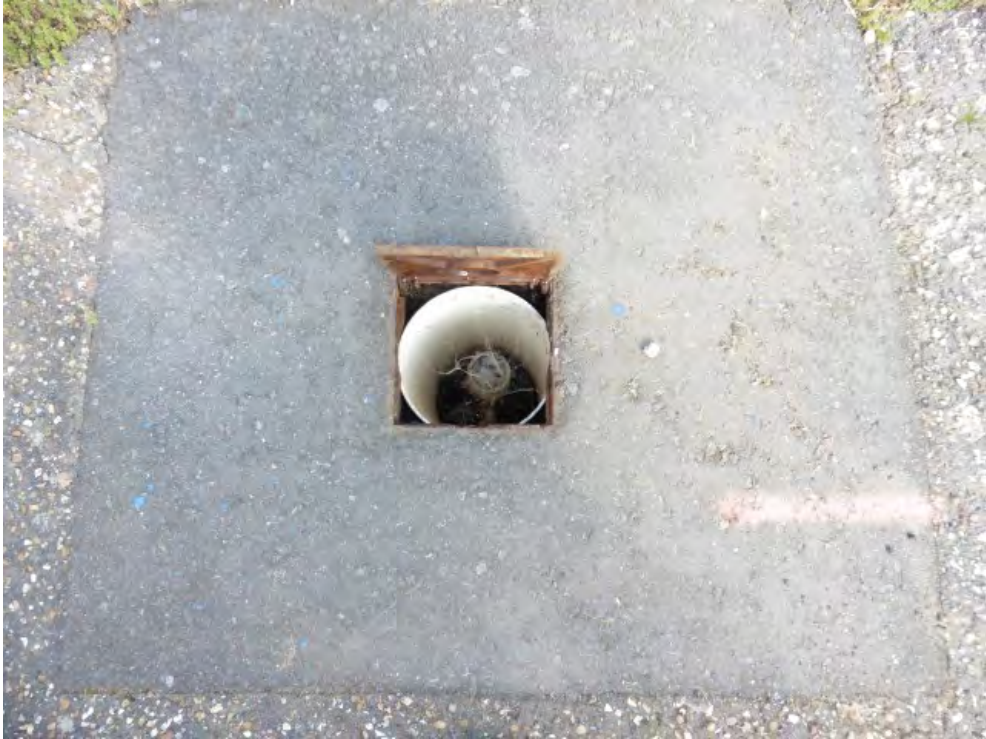
| | <b>6.3 Water</b> | <b>Condition<br/>rating</b> | <b>1</b> |
|---|---|---|---|
| <b>Condition</b> | <p>No significant defects were noted.</p> | | |

| | <b>6.3 Water</b> | <b>Condition<br/>rating</b> | <b>1</b> |
|---|---|---|---|
| <b>Action<br/>Required</b> | <p>Check the installation for evidence of leaks or other defects on a regular basis i.e. approximately every 6 months, or sooner. Leaks most often occur at pipe joints and where pipes are subject to movement or physical damage, such as airing cupboards, roof spaces and under sinks.</p> | | |

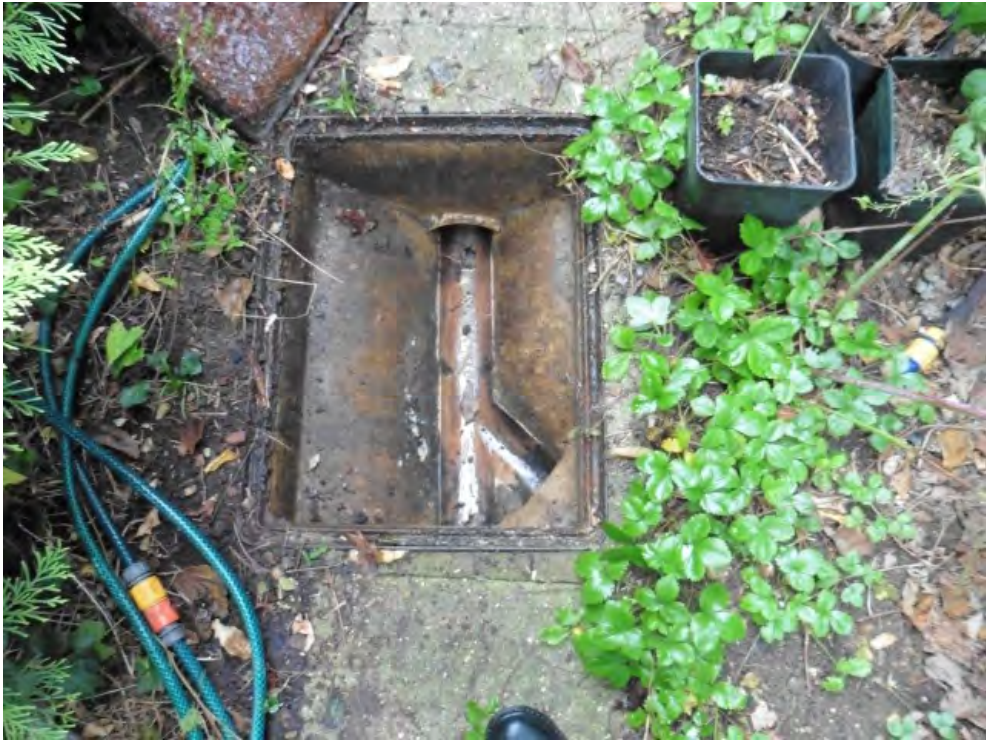
| | <b>6.5 Drainage</b> | <b>Condition<br/>rating</b> | <b>1</b> |
|---|---|---|---|
| <b>Condition</b> | <p>From the inspection carried out it is apparent that waste water is firstly directed to the rear the property whereupon it is directed under the right side path, through the chamber at the front, and from there into the main sewer road.</p> <p>Toilet flush and tap water was seen to run through the drains without any apparent blockages, and the rate of flow suggests that there is sufficient fall on the drains to reduce the risks of blockages.</p> | | |

| | <b>6.5 Drainage</b> | <b>Condition<br/>rating</b> | <b>1</b> |
|---|---|---|---|
| <b>Action<br/>Required</b> | <p>Drains should be regularly inspected to ensure they remain free from blockages, tree root damage or other obstructions.</p> | | |

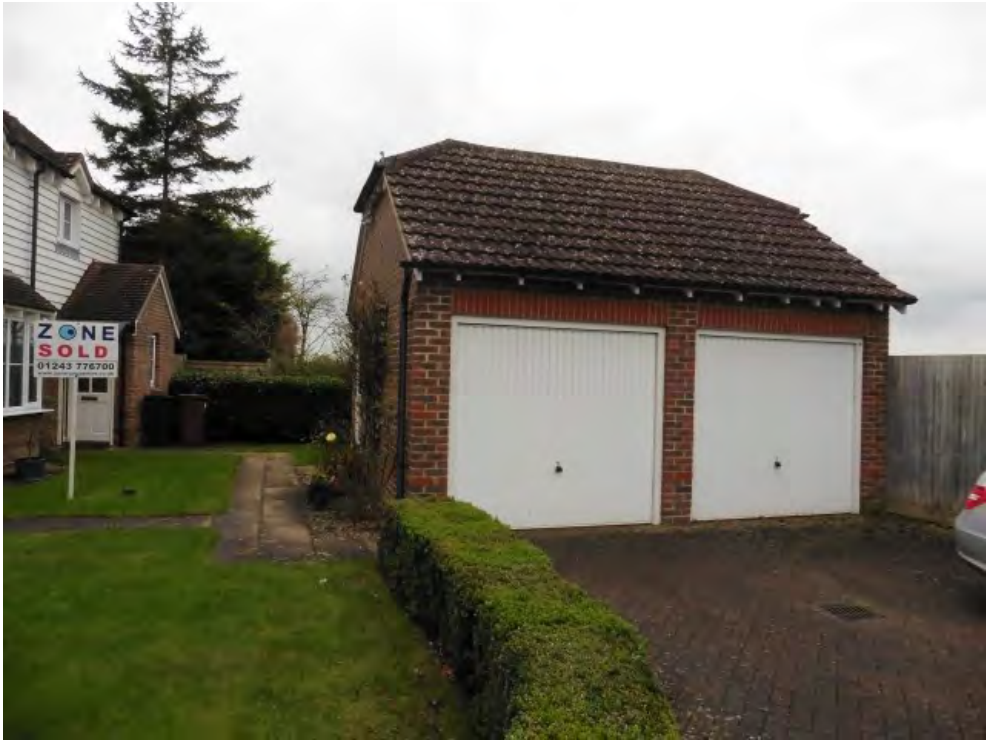
| | <b>7.1 Garaging</b> | <b>Condition rating</b> | <b>1</b> |
|---|---|---|---|
| <b>Condition</b> | <p>The garage was found to be in a stable condition with no evidence of any cracking of the walls of floor which might indicate that it is subject to unusual structural movement such as subsidence or settlement.</p> <p>The roof covering is in a good condition without any undue numbers of slipped or missing tiles.</p> <p>All of the doors were found to operate normally.</p> | | |

| | <b>7.1 Garaging</b> | <b>Condition rating</b> | <b>1</b> |
|---|---|---|---|
| <b>Action Required</b> | <p>Normal maintenance, including regular retreatment of external joinery, is required.</p> <p>Foliage and debris should be removed from the outside walls.</p> | | |
