# SAMPLE SNAGGING SURVEY

An anonymised example demonstrating the scope, photographic evidence and practical detail included in our new-build inspections.

Prepared by Gary Bates ACBE MRPSA BCI  
G&L Residential Building Surveys UK Ltd

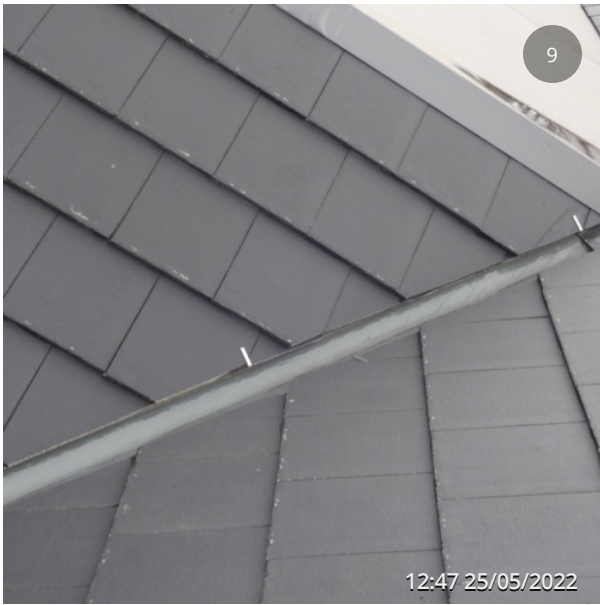
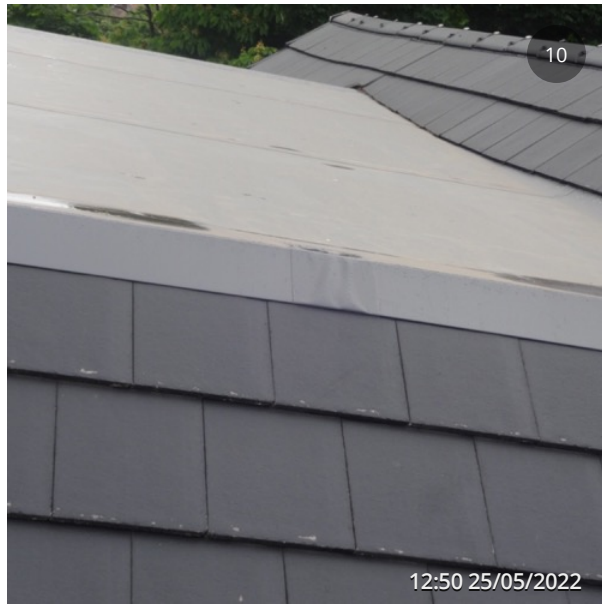
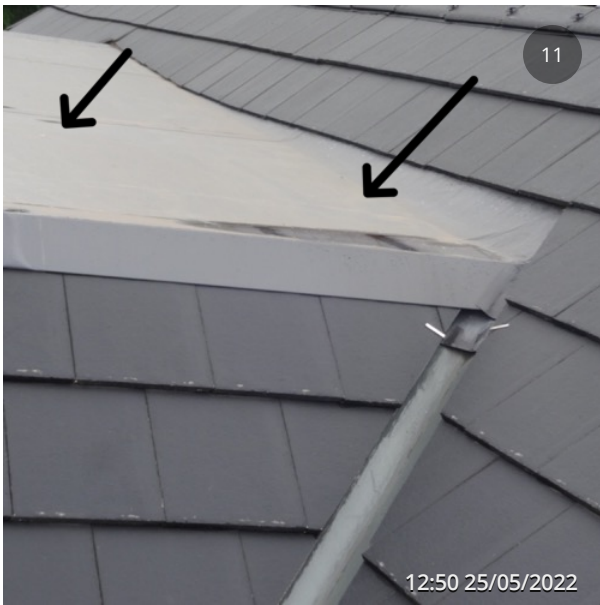
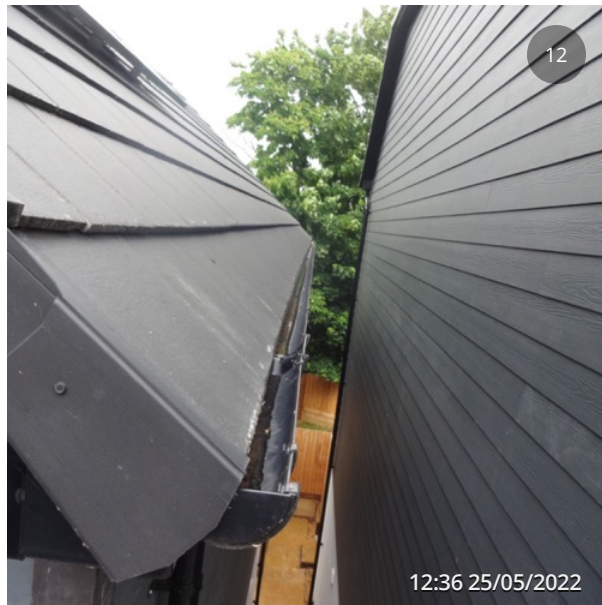
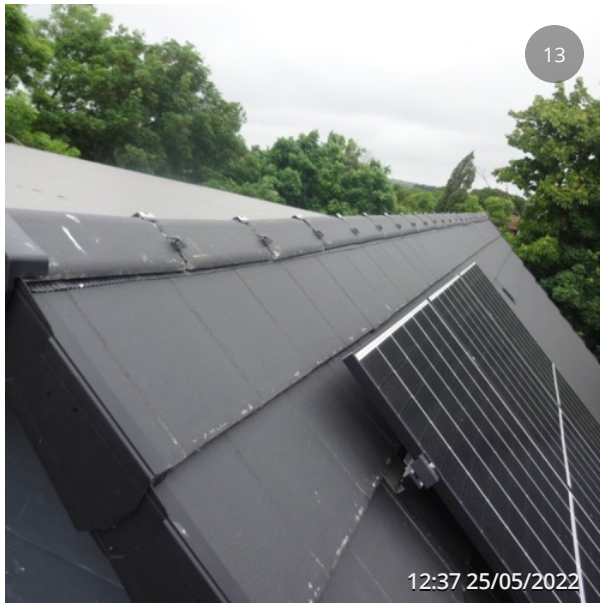
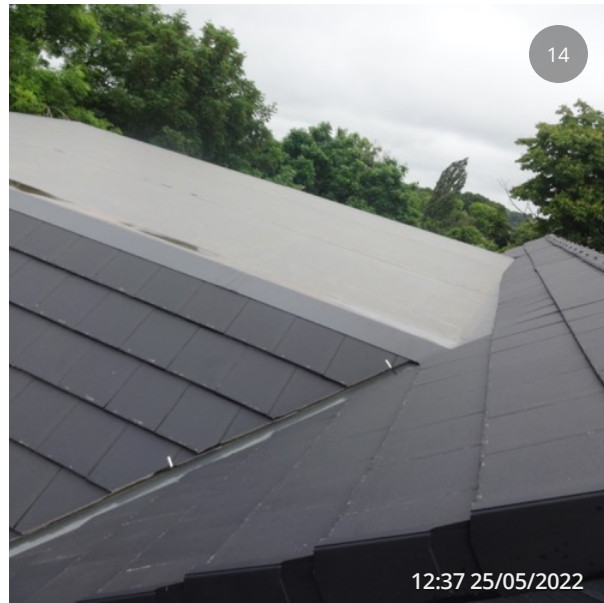
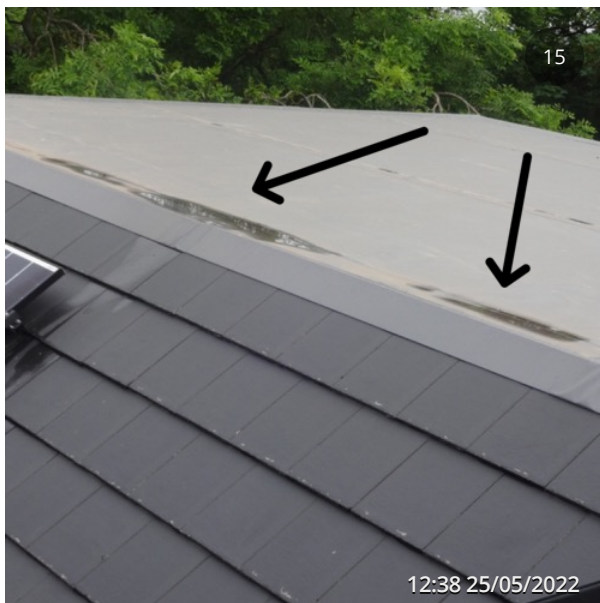
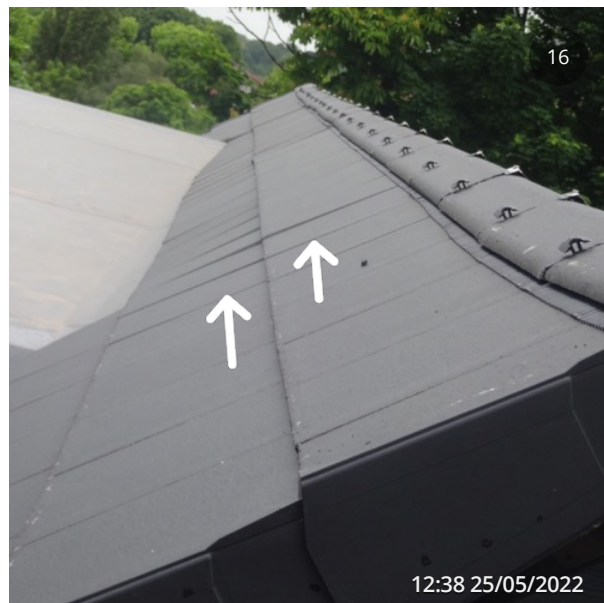
Location: Roof

The valley gutters seem to have been constructed to a poor standard. They had various metal clips that hold the cut tiles into the surrounding tiles of the valleys. We recommend that manufactures guidance is obtained to ascertain if the clips are suitable for this purpose.

There were areas where the tiles are not sitting fully flat that may potentially lead to water ingress to the property.

Minor standing water was noted in the gutters. This suggests either blockage or that they are set to poor falls.

There was some evidence of ponding to the EDPM type flat roof covering that is connected to the main roof and is on the party wall line with the neighbouring property suggesting potentially a defect with the substrate beneath, this can cause irregular stress around the perimeter of the pond causing premature failure.

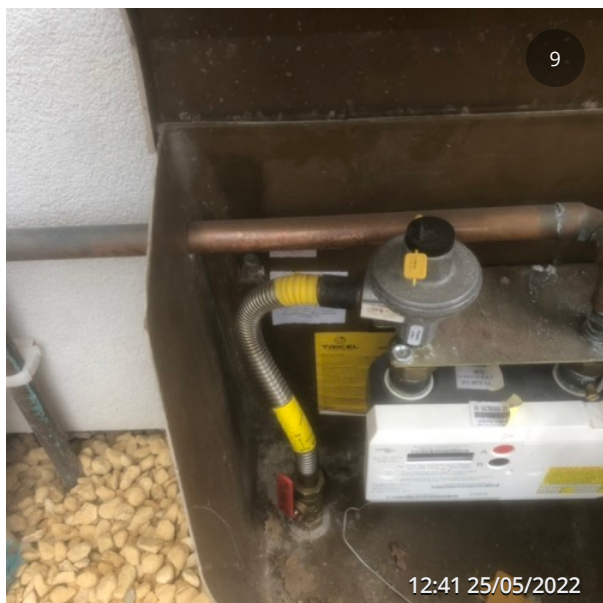
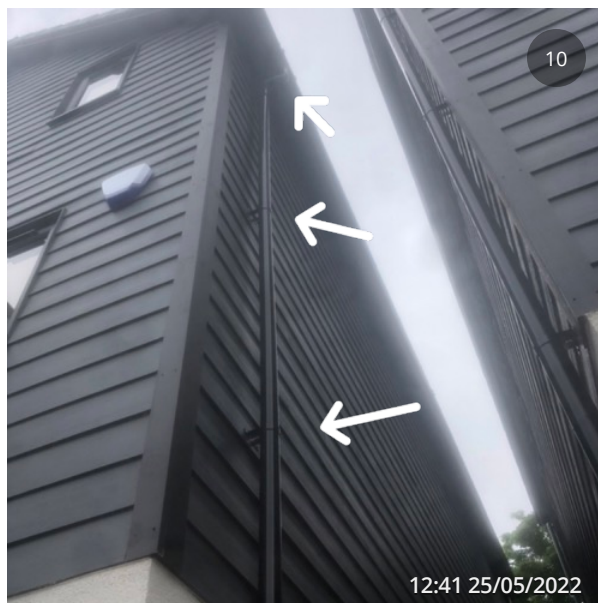
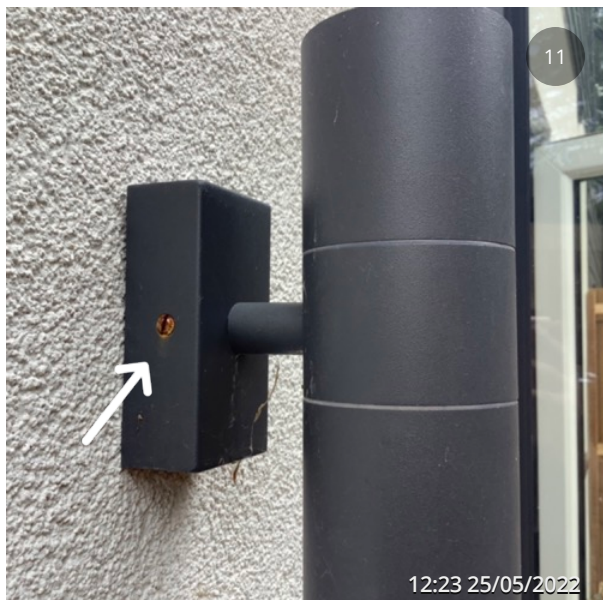
### Location: External Defects

The steel beams around the property that form the fencing and retaining walls have not all been treated and may quickly start to rust and degrade causing potential future failure to these areas.

The gravel area to the left hand side of the entrance path will constantly lose the gravel due to the slope we Recommend perhaps paving or concrete would be more suitable for this area.

The front elevation brickwork was stained and needs an acid type brickwash.

show signs of rust around the screws (have the right screws been used for this fitting?)

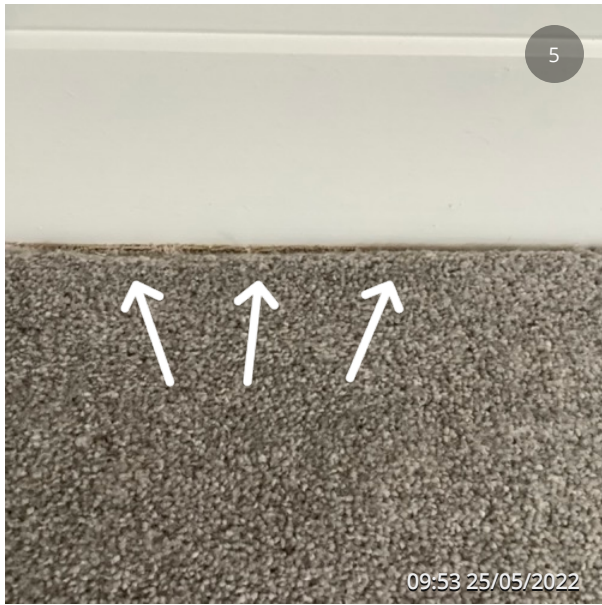
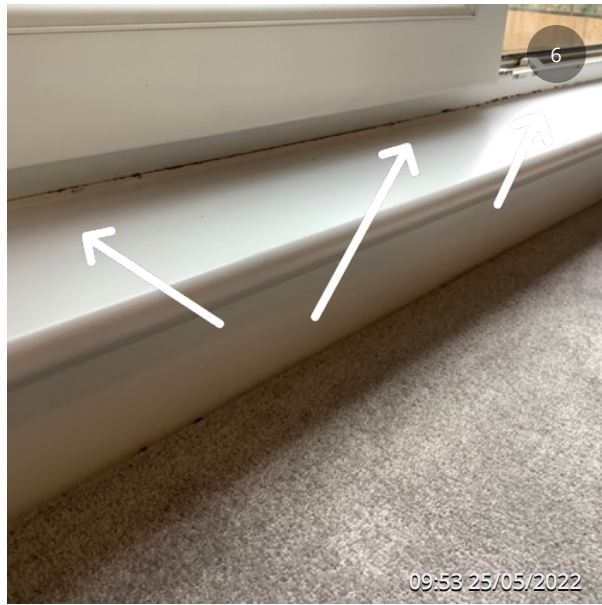
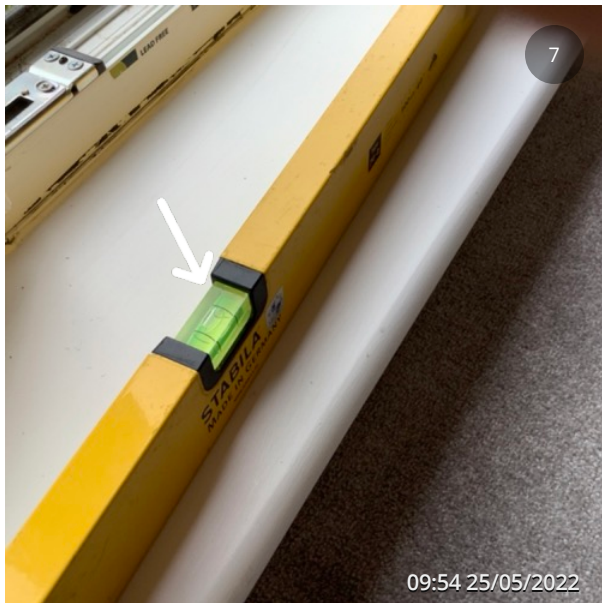
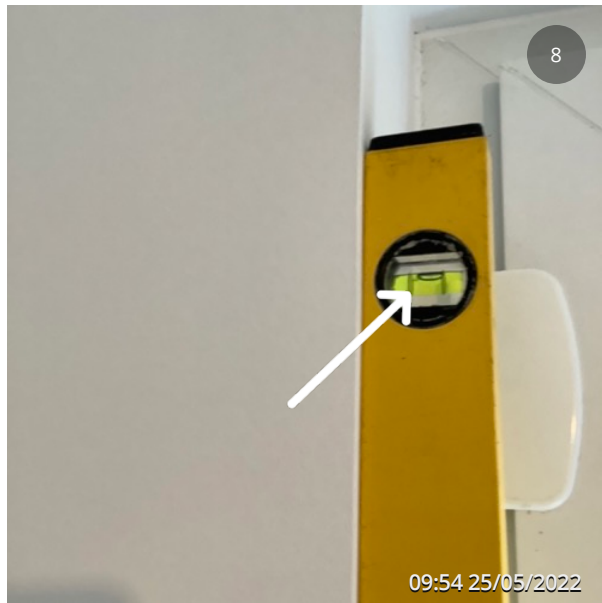
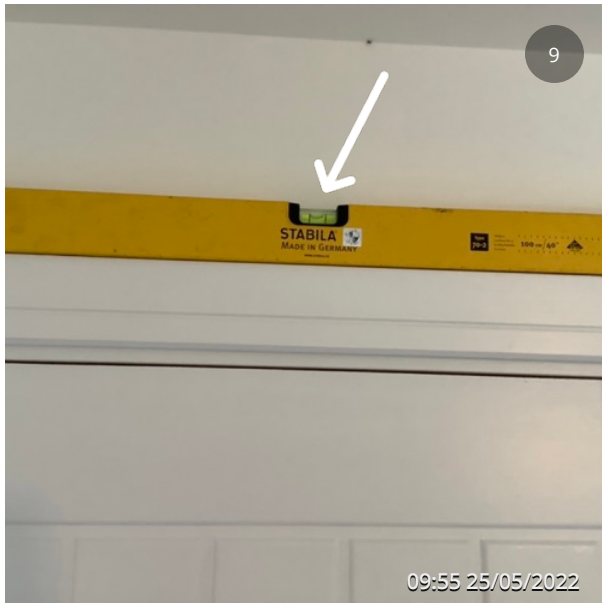
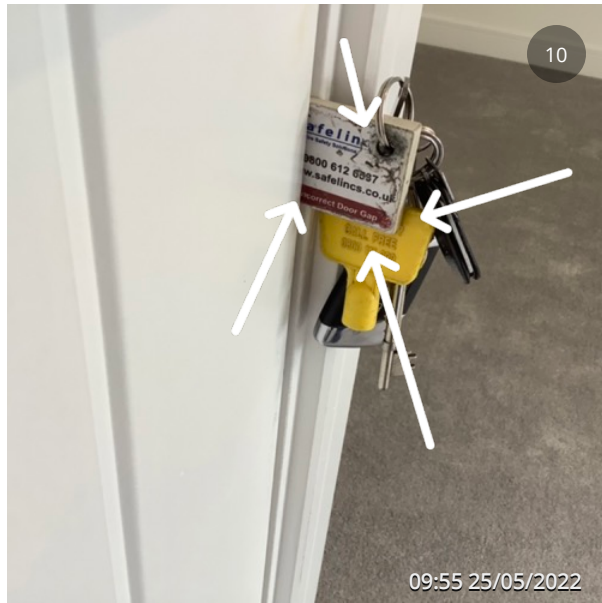
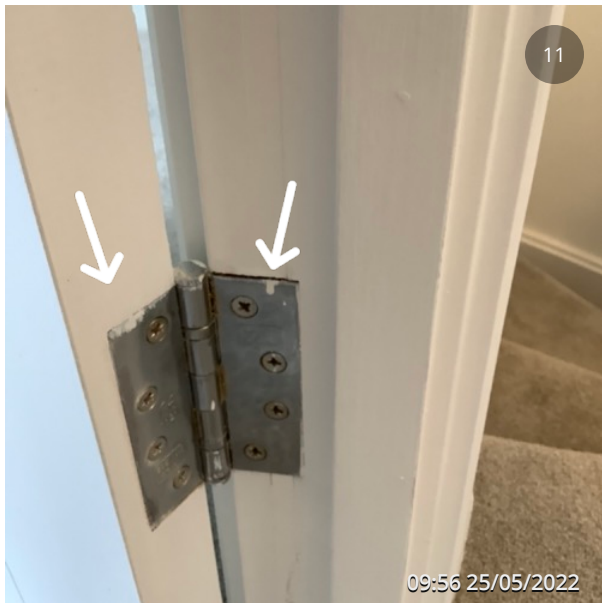
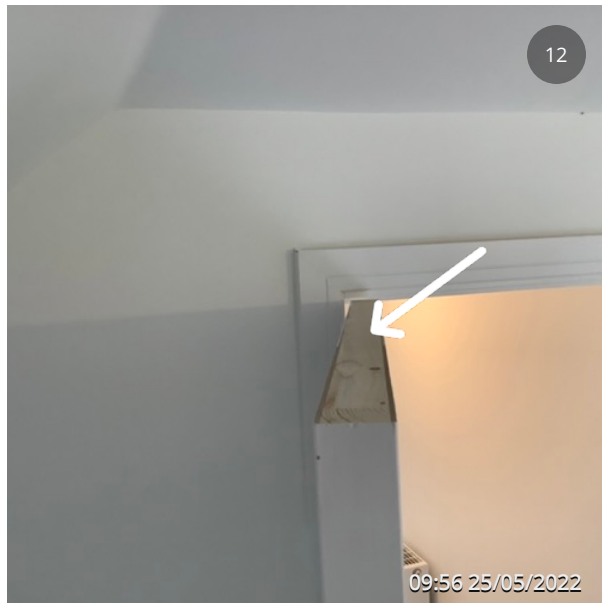
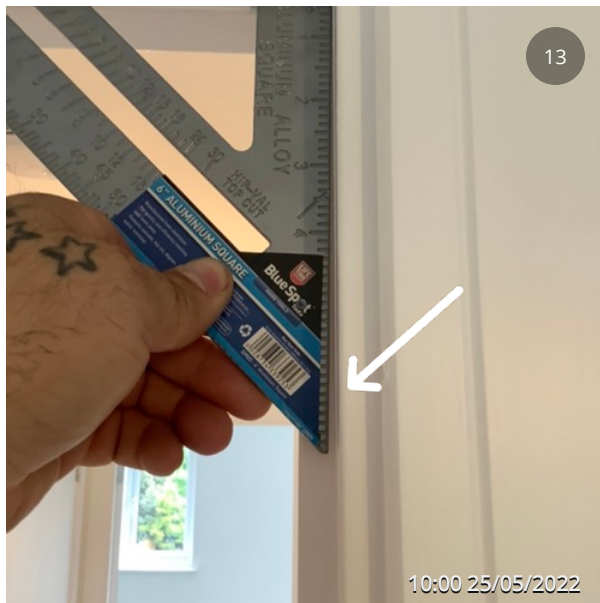
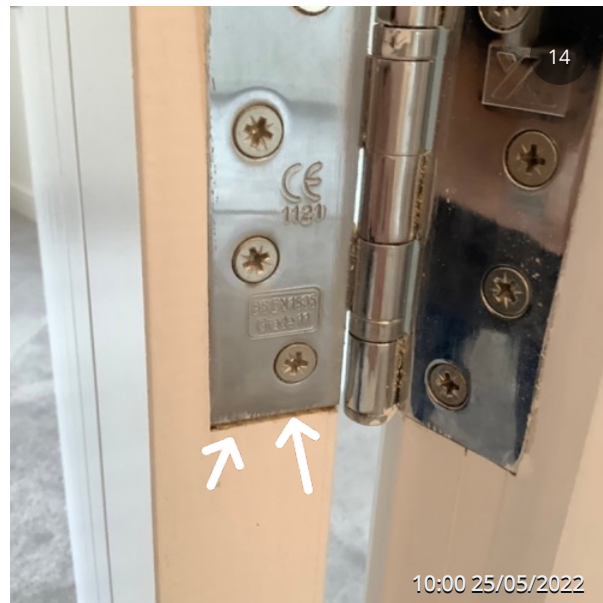
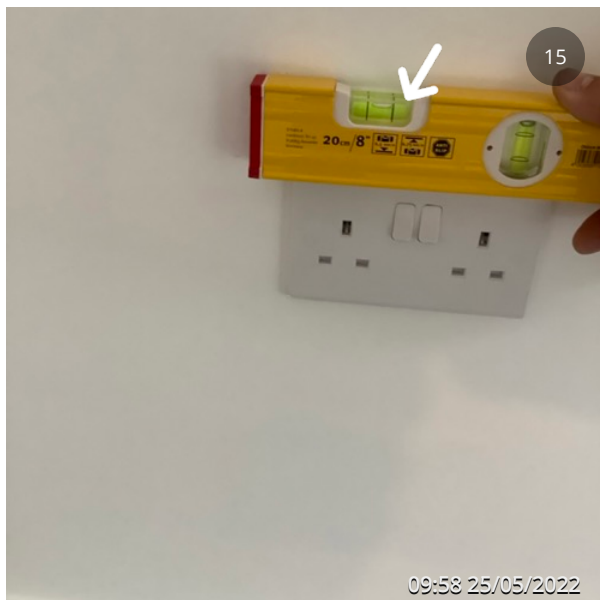
## BEDROOM 1

The main door to the bedroom 1 is a fire door with fitted intumescent smoke seals. They have unacceptable Gaps between the fire door and the door frame. These gaps should never be more than 4mm or less than 2mm. It's recommended to aim for a 3mm gap to ensure adequate room for the intumescent strips to activate in the event of a fire, and for the smoke seal strips to not get damaged by the opening and closing of the door. The bottom of the door had been cut off by an excessive amount (between 10/25mm above the carpet line) this is not acceptable for a fire door. In our opinion it will need replacing with a new fire door that is fitted to the manufactures recommendations. Then re inspected by a professional body after replacement to ensure that the door has been corrected fitted and complies with building regulations.

The top of the door is not painted and may allow moisture ingress into the door.

The door hinges were stained with paint and had rough areas where they had been installed to a poor standard.

At the time of inspection a large 90degree calibrated square was use on all internal and external angles of the walls and it was found the majority of the walls were not square at the time of inspection.

The seal between the low level window cill and the balcony door was split and may cause water ingress.

There were general areas of patch painting around the room that would require decorating.

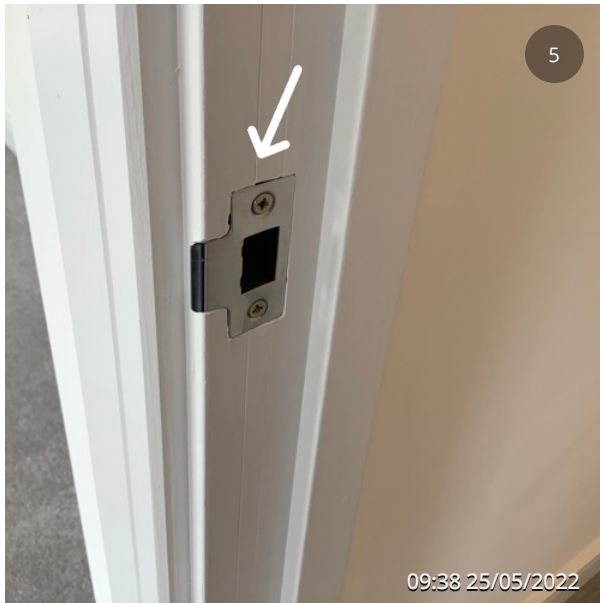
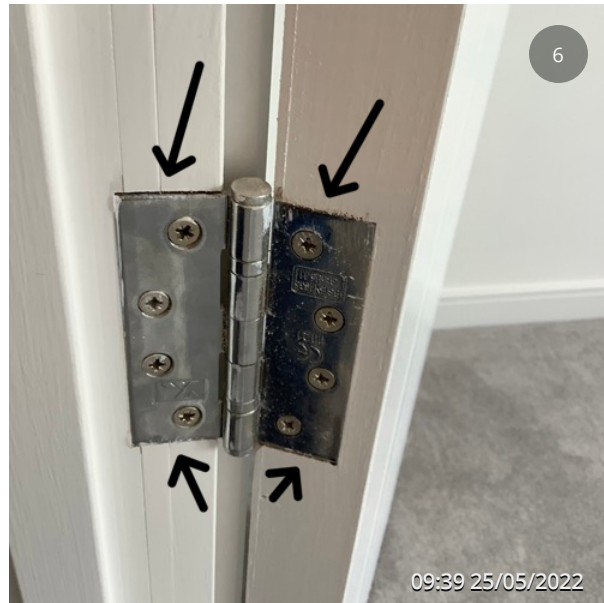
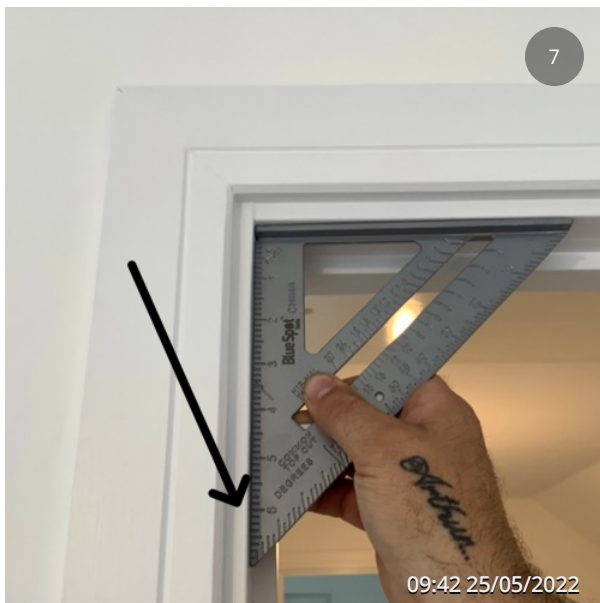
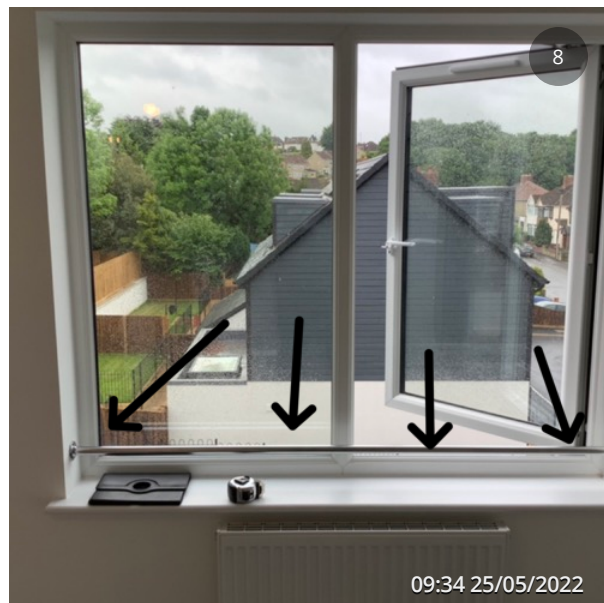
## BEDROOM 2

The Approved Document to Part K provides guidance on the height above floor level at which guarding should be provided

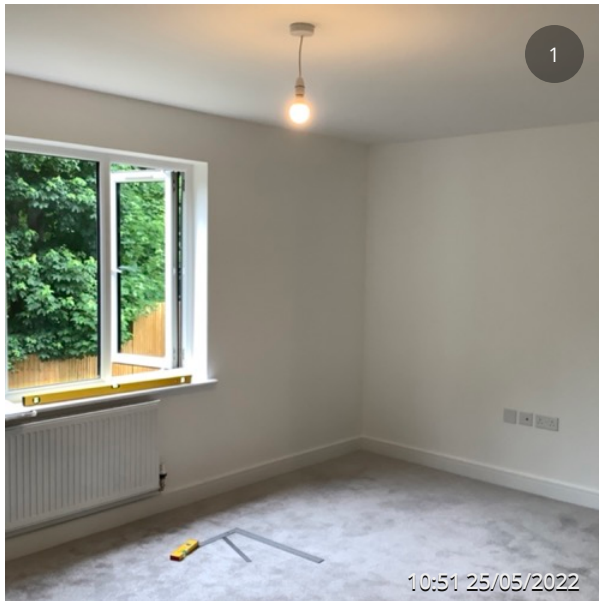
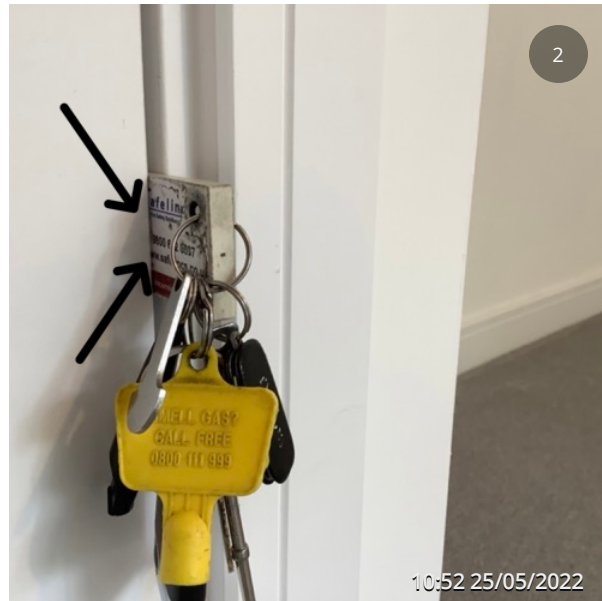
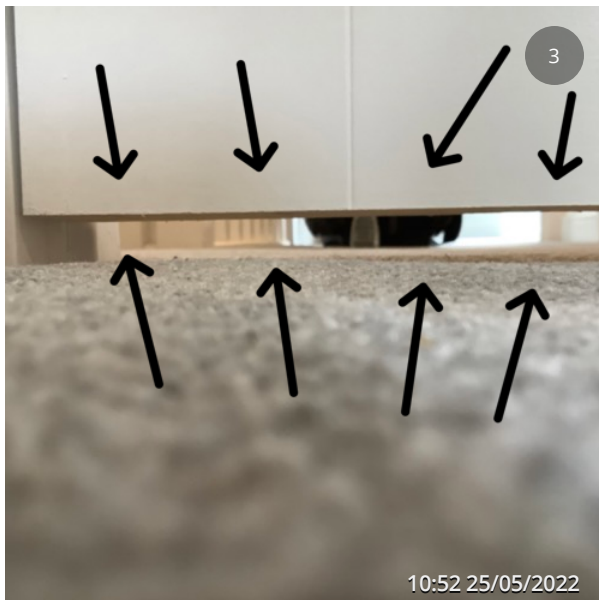
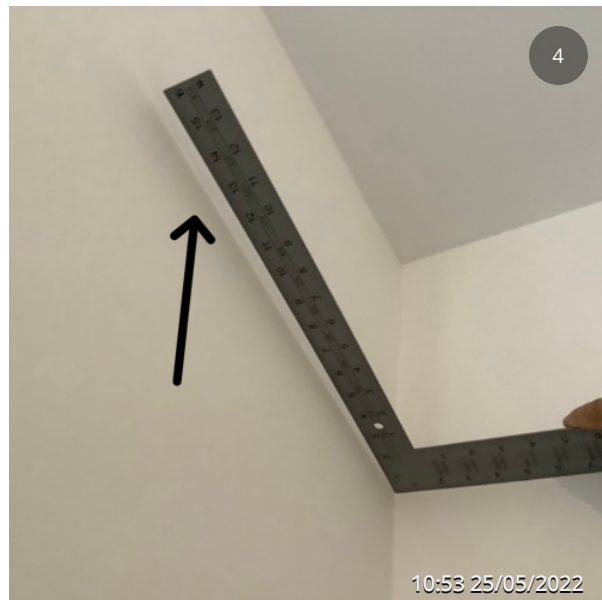
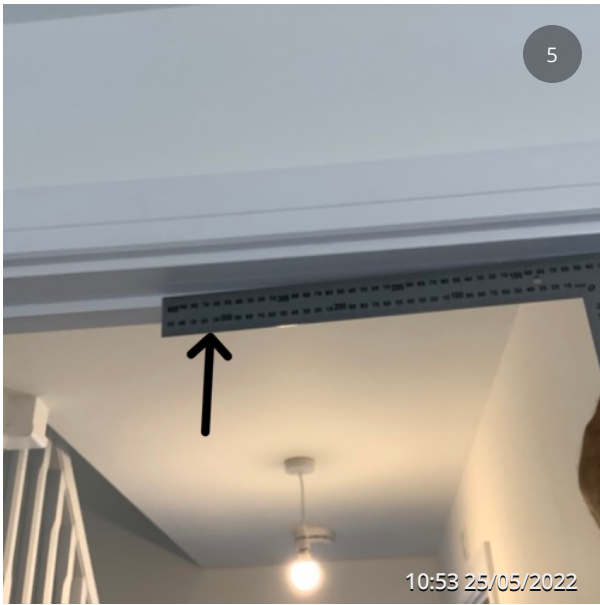
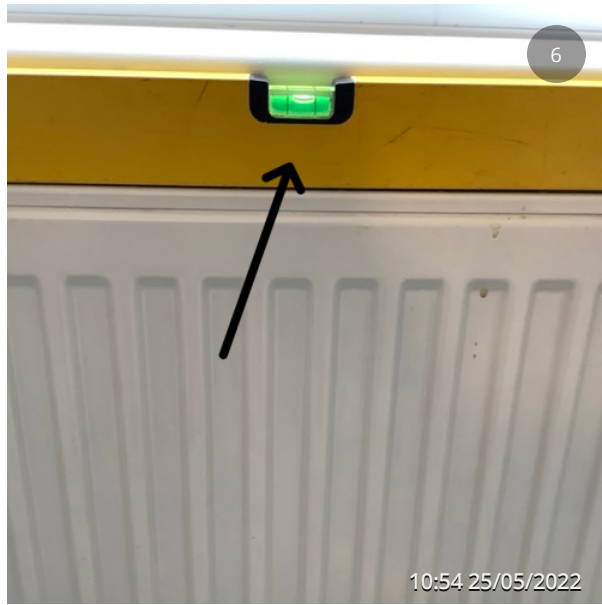
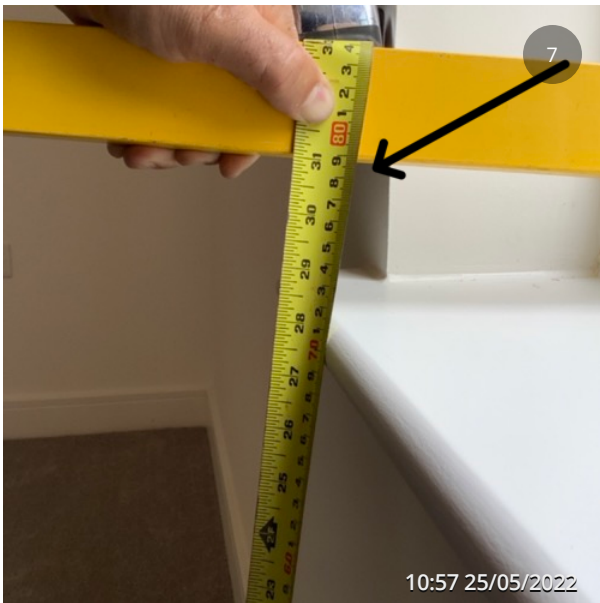
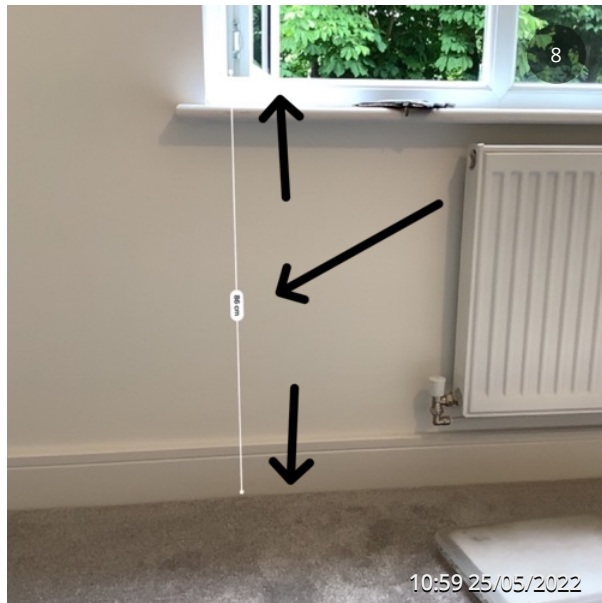
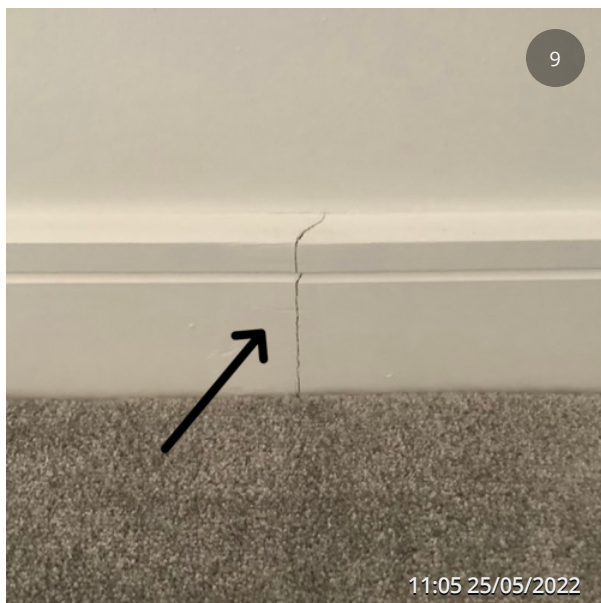
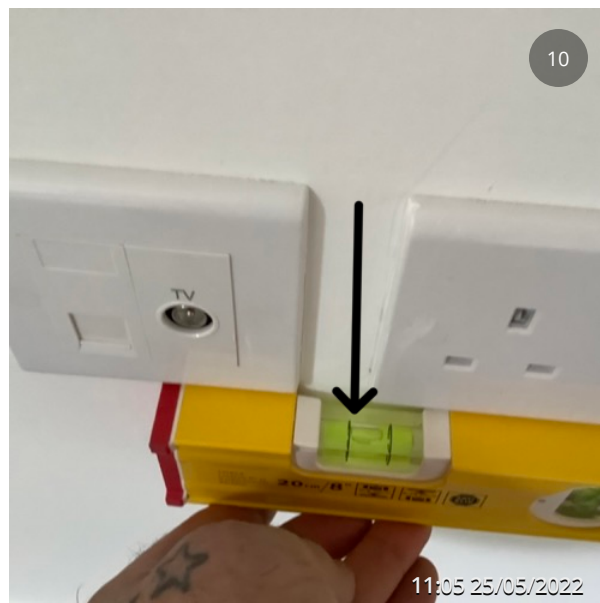
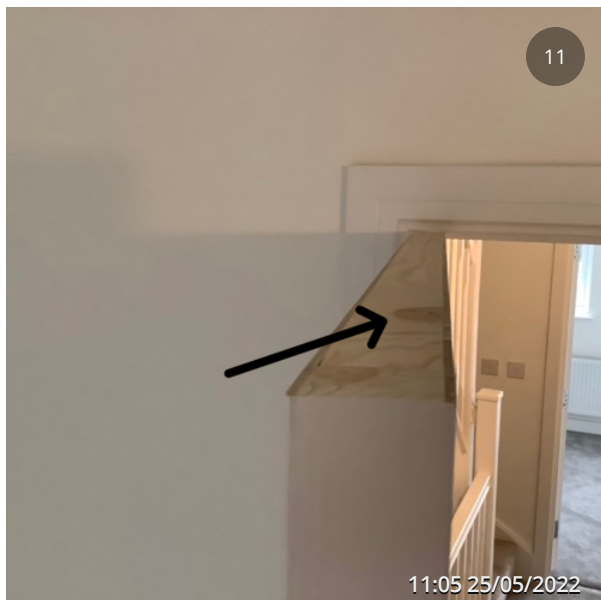
## BEDROOM 3

The main door to the bedroom 3 is a fire door with fitted intumescent smoke seals and have unacceptable Gaps between the fire door and the door frame and should never be more than 4mm or less than 2mm. It's recommended to aim for a 3mm gap to ensure adequate room for the intumescent strips to activate in the event of a fire, and for the smoke seal strips to not get damaged by the opening and closing of the door, the bottom of the door had been cut off by an excessive amount (between 10/25mm above the

carpet line) this is not acceptable for a fire door and in our opinion will need replacing with a new fire door that is fitted to the manufactures recommendations and re inspected by a professional body after replacement to ensure that the door has been corrected fitted and complies with building regulations.

The top of the door is not painted and may allow moisture ingress into the door.

The door hinges were stained with paint and had rough areas where they had been installed to a poor standard.

At the time of inspection a large 90degree calibrated square was use on all internal and external angles of the walls and it was found the majority of the walls were not square at the time of inspection.

The joints between the skirting boards were cracking and need filling and re decorating.

The window height is 795mm and does not comply with building

regulations in respect of the risk of falls, the Approved Document to Part K provides guidance on the height above floor level at which guarding should be provided

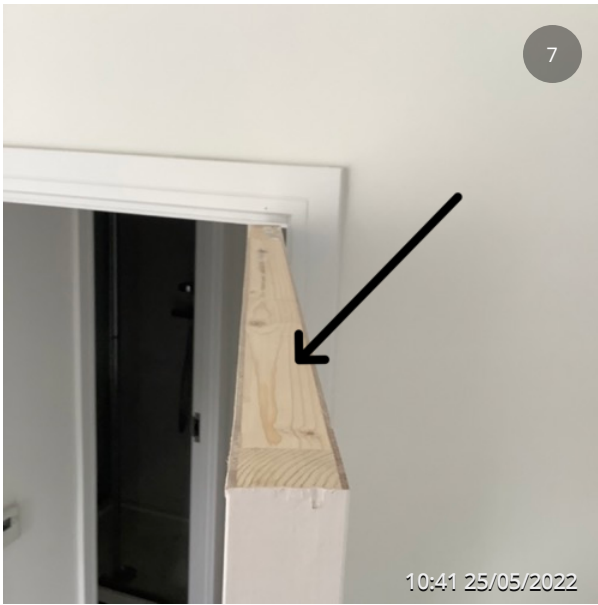
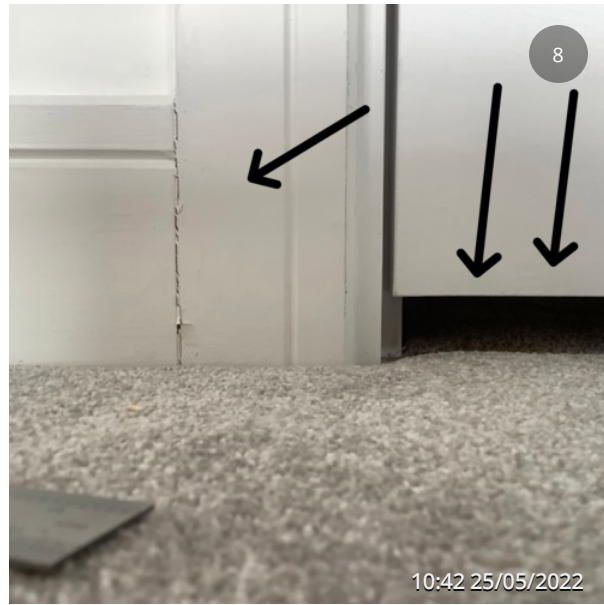
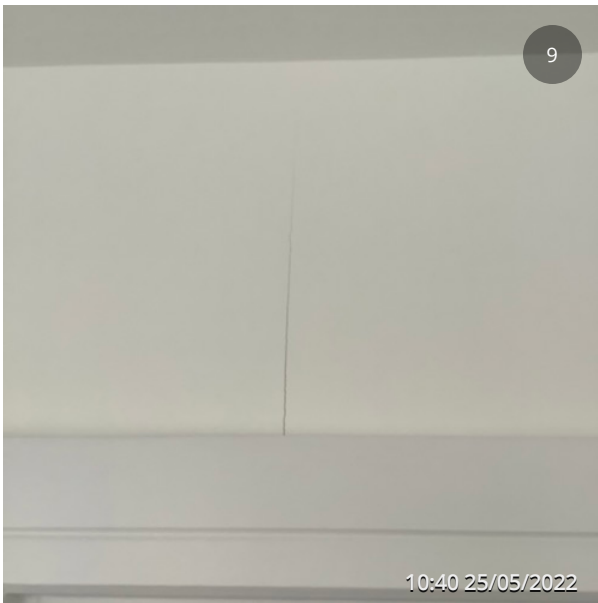
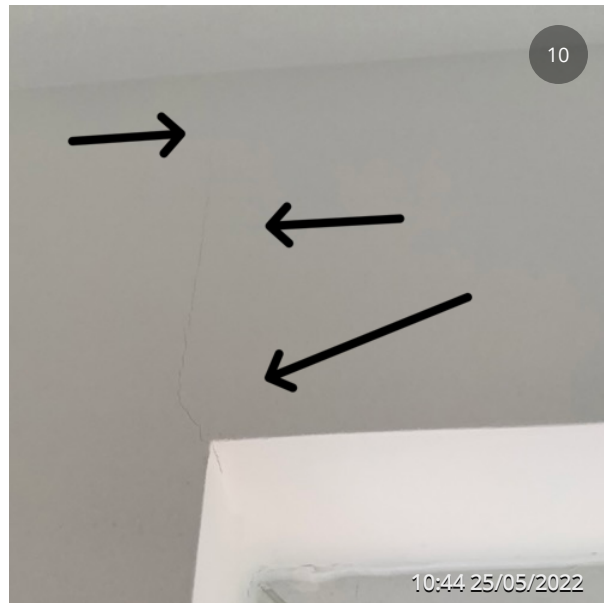
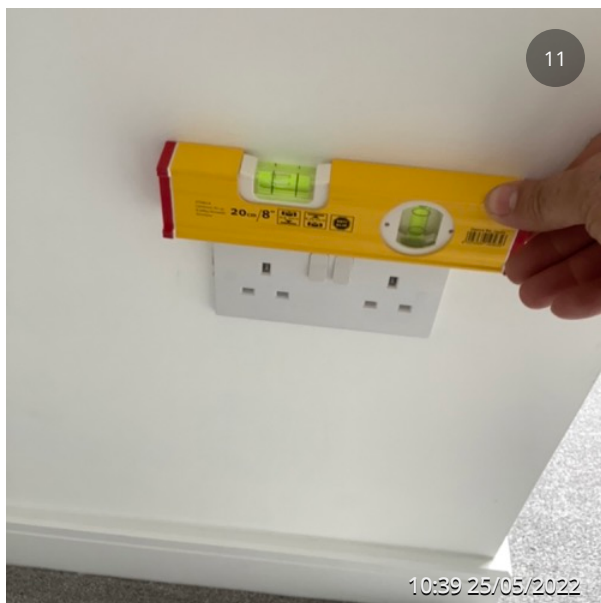
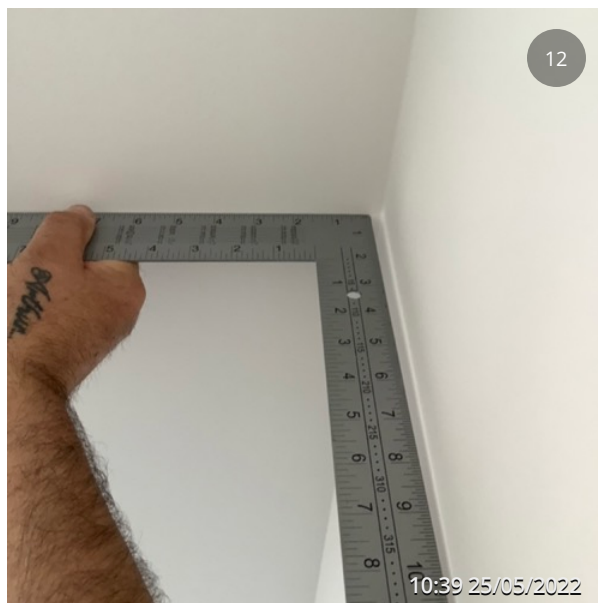
## BEDROOM 4

The main door to the bedroom 4 is a fire door with fitted intumescent smoke seals and have unacceptable Gaps between the fire door and the door frame and should never be more than 4mm or less than 2mm. It's recommended to aim for a 3mm gap to ensure adequate room for the intumescent strips to activate in the event of a fire, and for the smoke seal strips to not get damaged by the opening and closing of the door, the bottom of the door had been cut off by an excessive amount (between 10/25mm above the carpet line) this is not acceptable for a fire door and in our opinion will need replacing with a new fire door that is fitted to the manufactures recommendations and re inspected by a professional body after replacement to ensure that the door has been corrected fitted and complies with building regulations.

There was a section of intumescent smoke seal missing at the top left hand side of the door frame.

The top of the door is not painted and may allow moisture ingress into the door.

on all internal and external angles of the walls and it was found the majority of the walls were not square at the time of inspection.

The joints between the skirting boards were cracking and need filling and re decorating.

Hairline cracking above the door and above the left hand side window lintel was noted that will need repair.

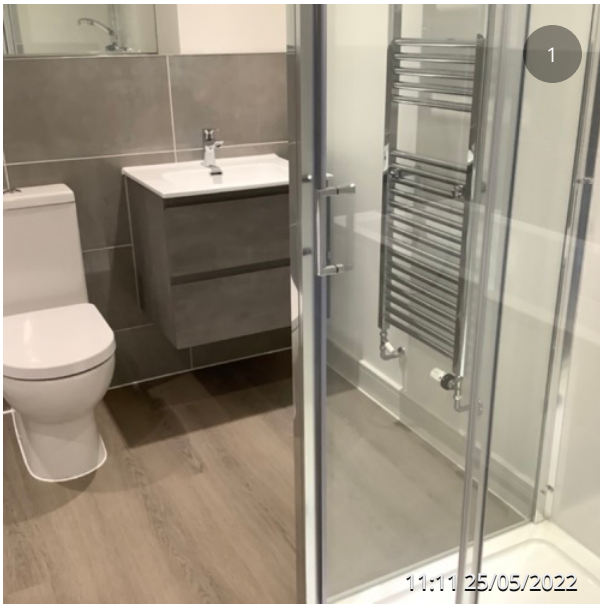
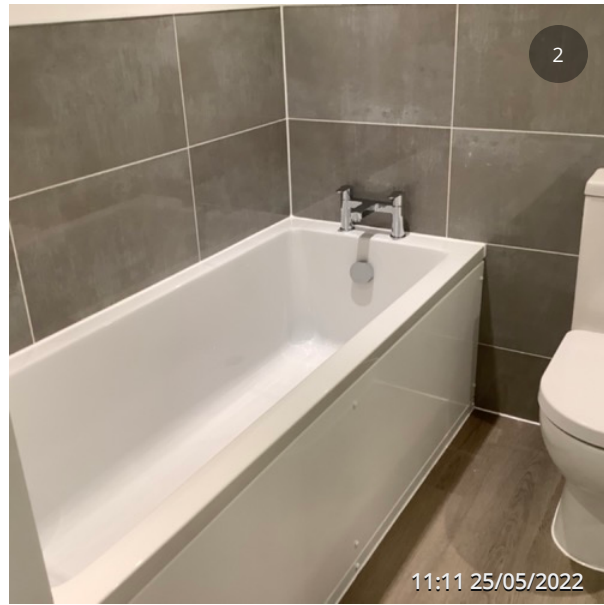
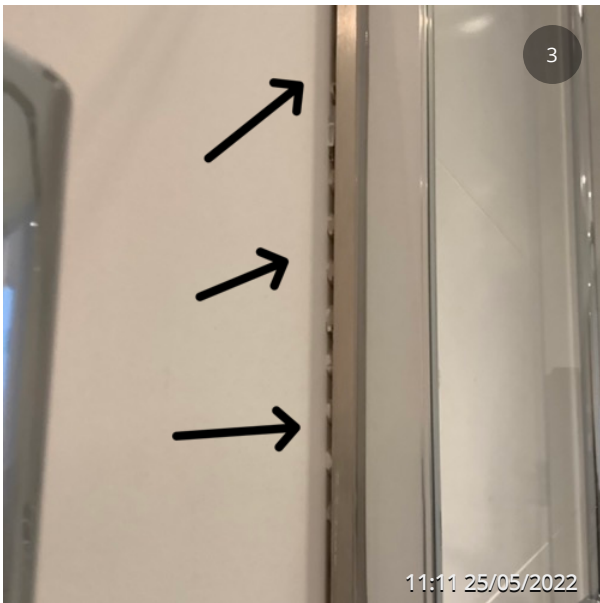
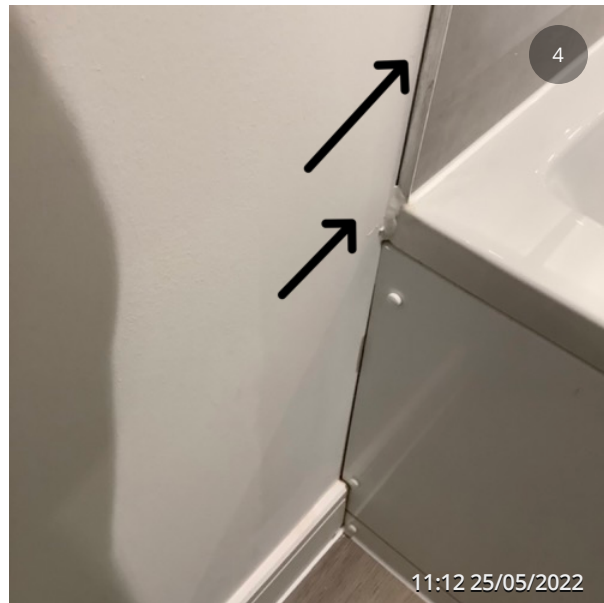
## BATHROOM

Paint on tiles below the sink area.

Paint on towel rail valve.

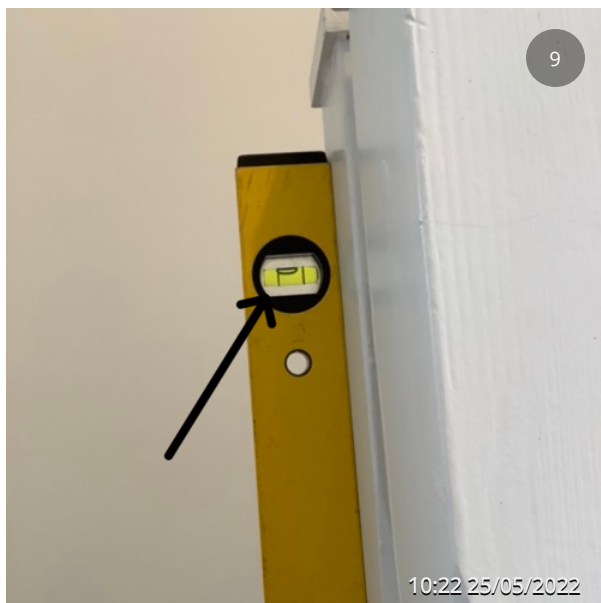
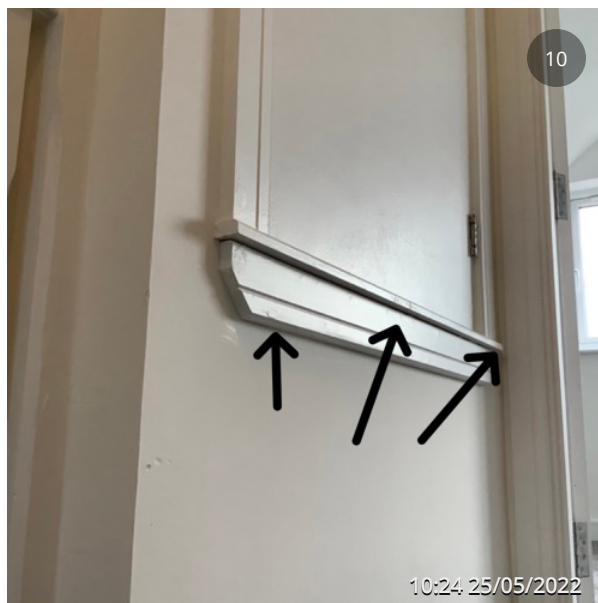
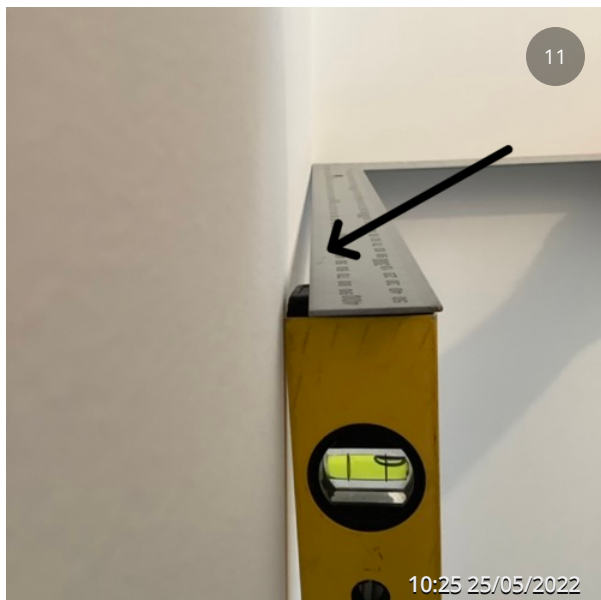
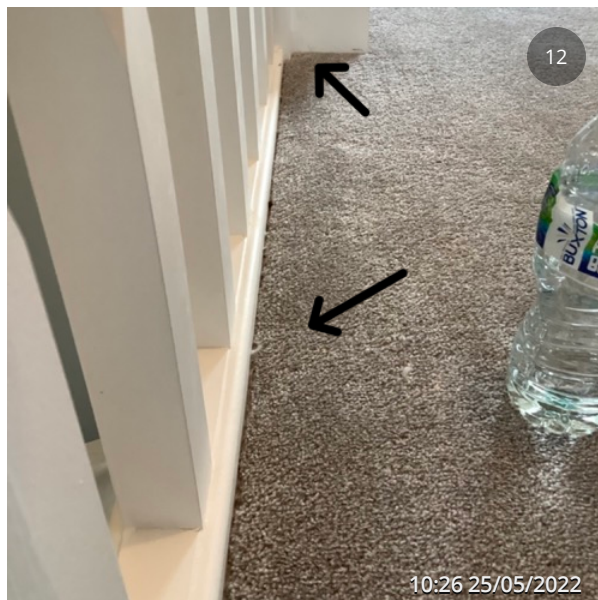
## SECOND FLOOR LANDING AND STAIRCASE

on all internal and external angles of the walls and it was found the majority of the walls were not square at the time of inspection.

The door to the over stairs cupboard has screws missing on the hinges.

The top of the over stairs cupboard door is not painted and may allow moisture ingress into the door.

Painting defects were noted especially around the newel posts and around the woodwork of the over stairs cupboard.
