# SAMPLE SNAGGING SURVEY

An anonymised example demonstrating the scope, photographic evidence and practical detail included in our new-build inspections.

Prepared by Gary Bates ACBE MRPSA BCI  
G&L Residential Building Surveys UK Ltd

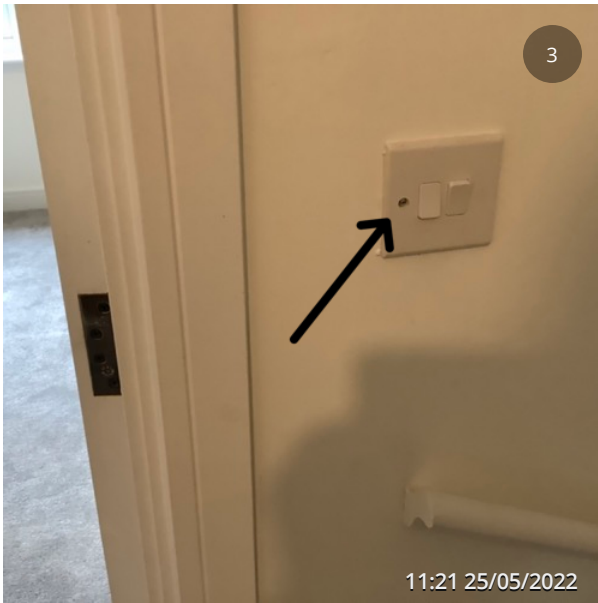
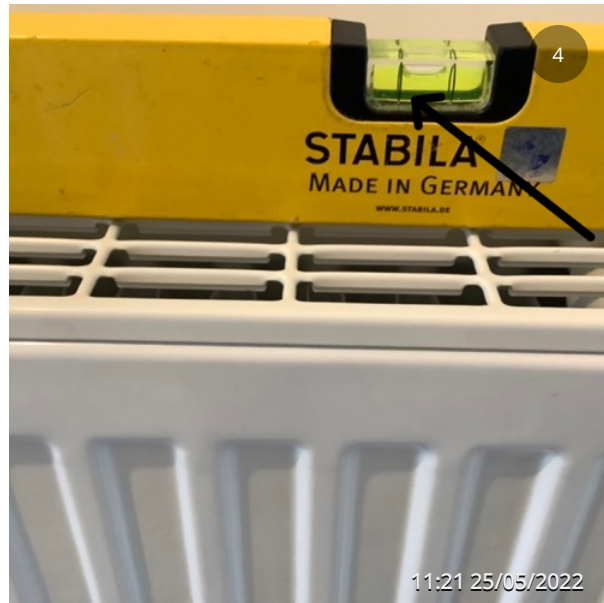
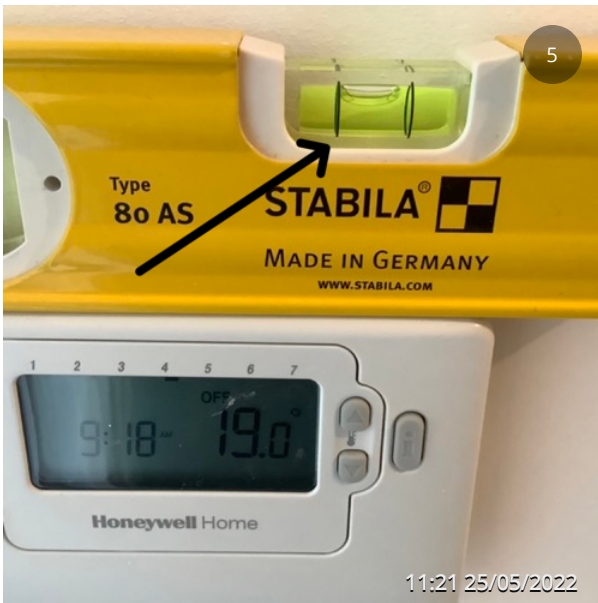
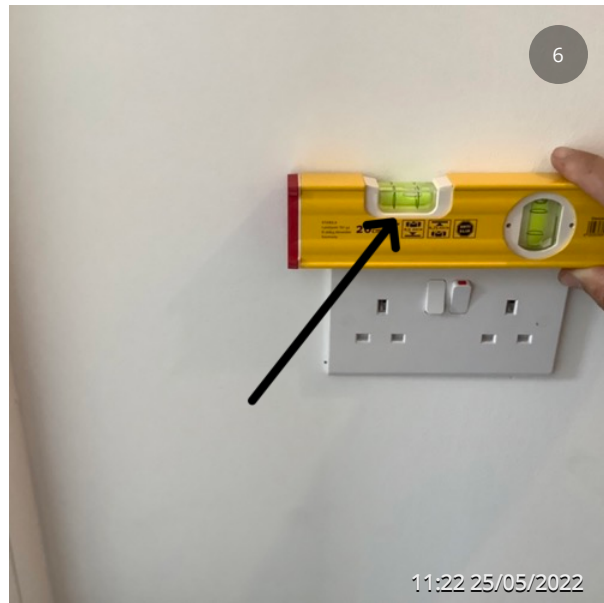
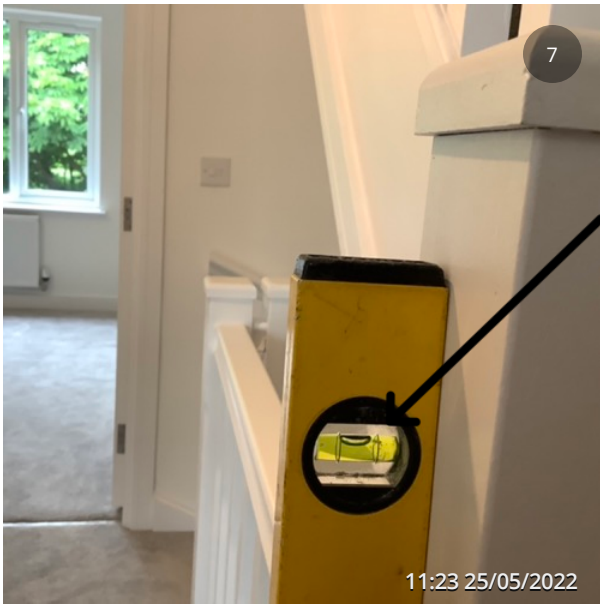
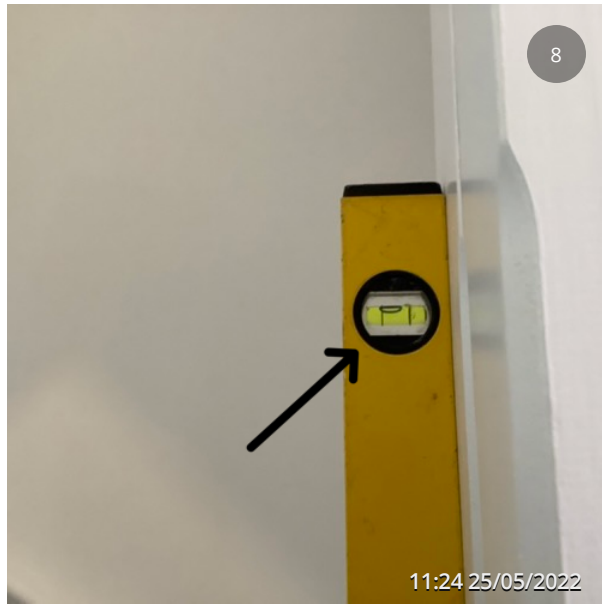
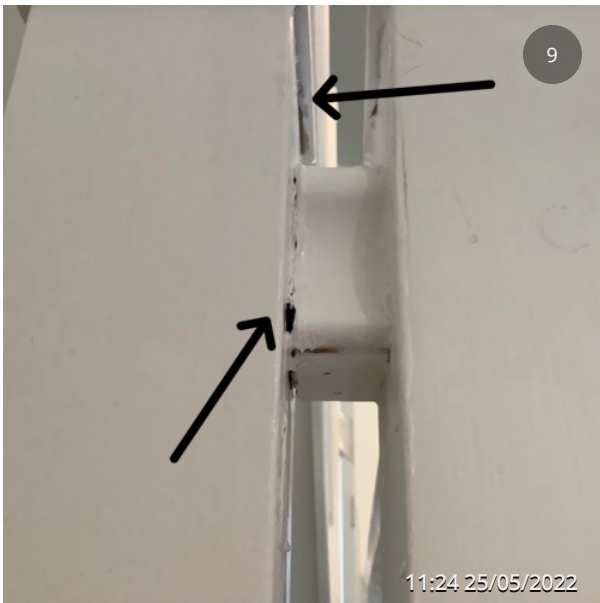
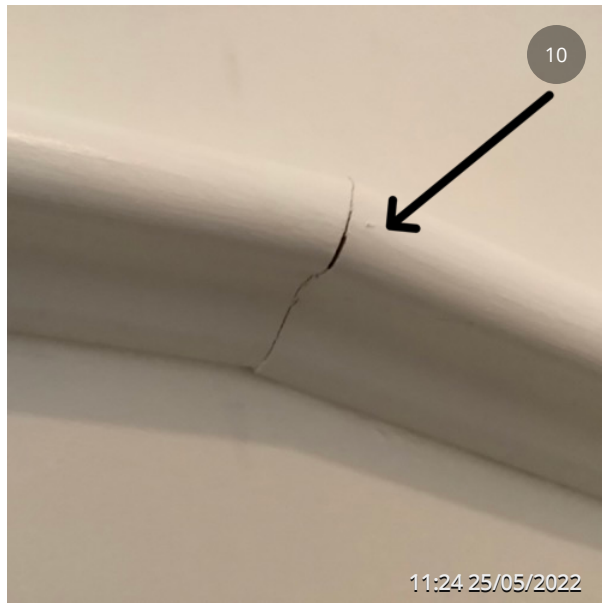
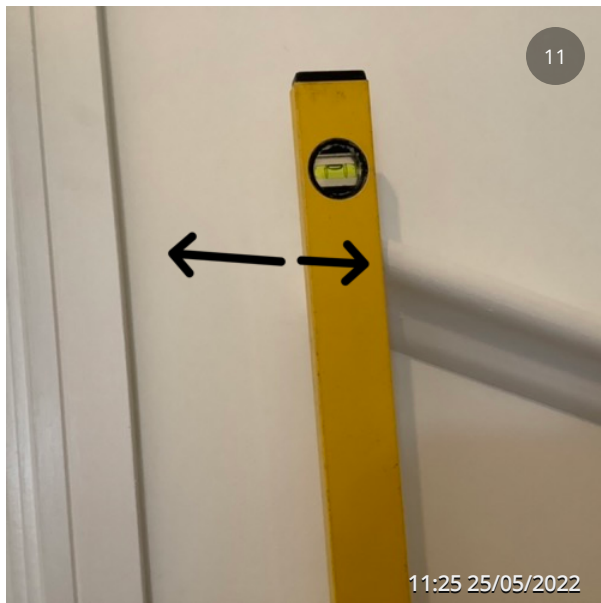
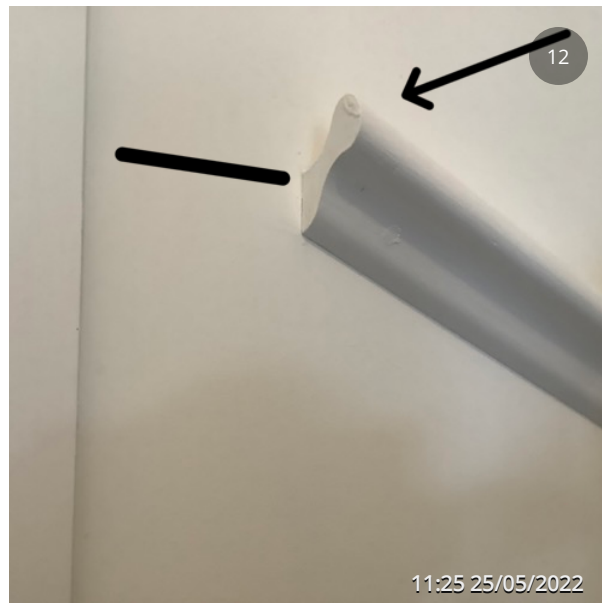
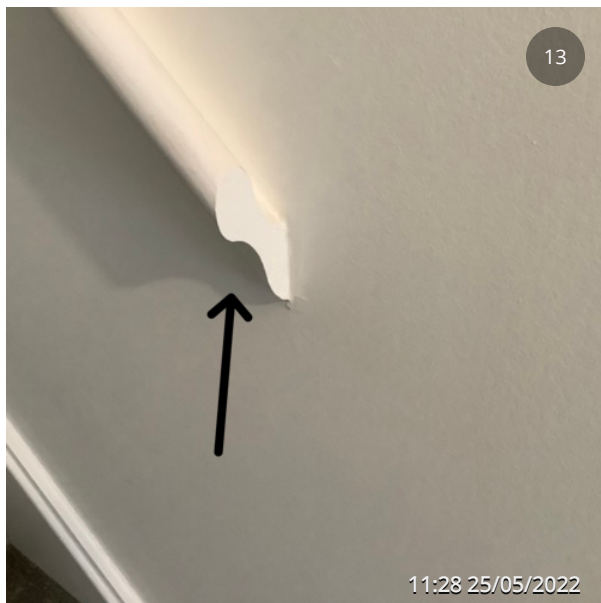
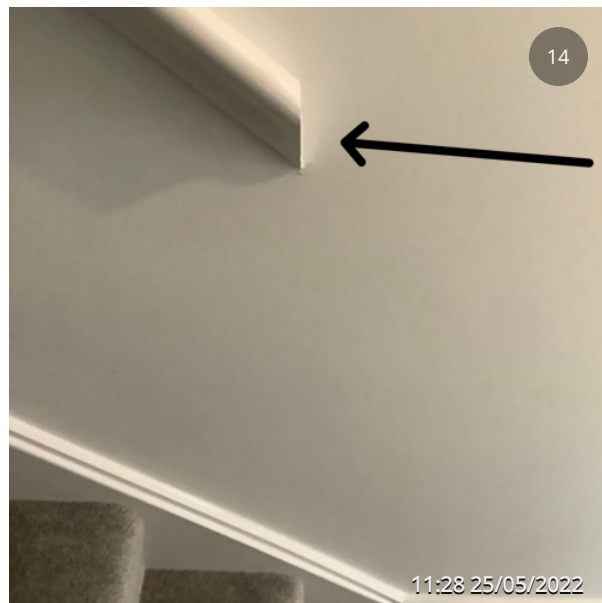
## FIRST FLOOR STAIRCASE AND LANDING

A screw cap is missing to the light switch at the top of the staircase.

Painting defects to the newel posts and handrails were noted.

The hand rail does not comply to building regulations and needs to be extended 300mm past the top and bottom steps of the staircase.

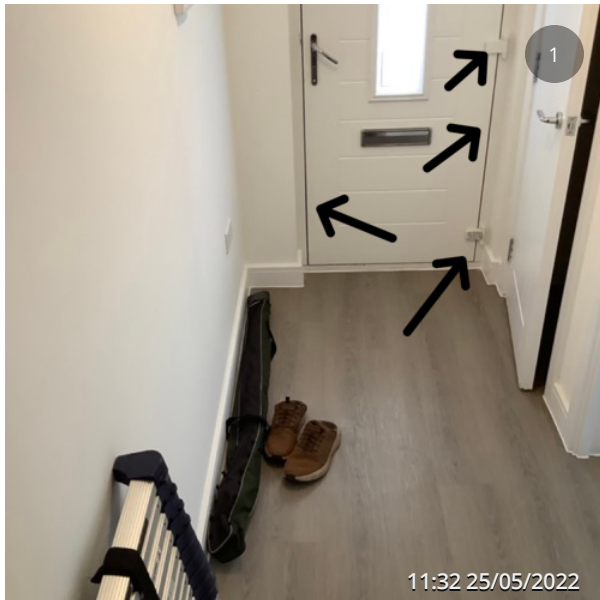
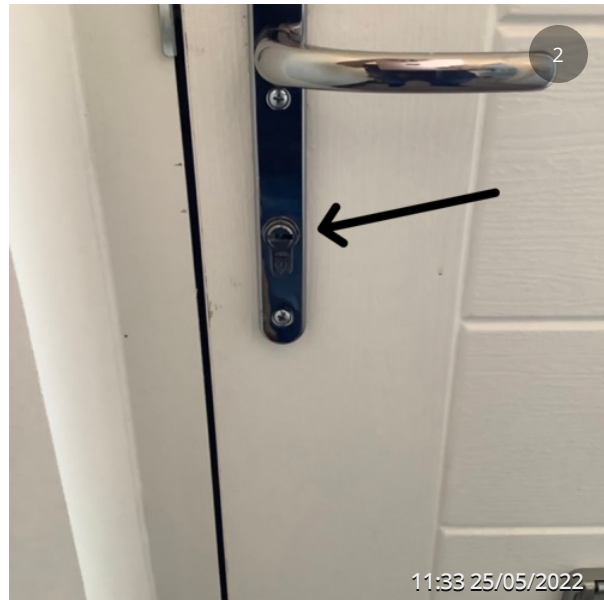
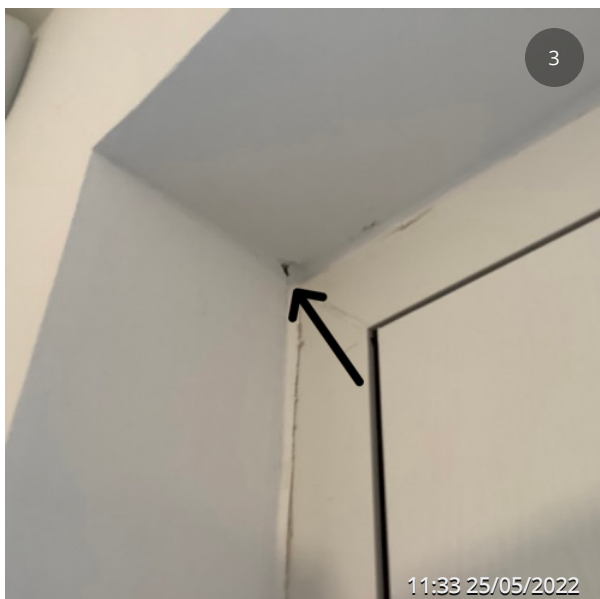
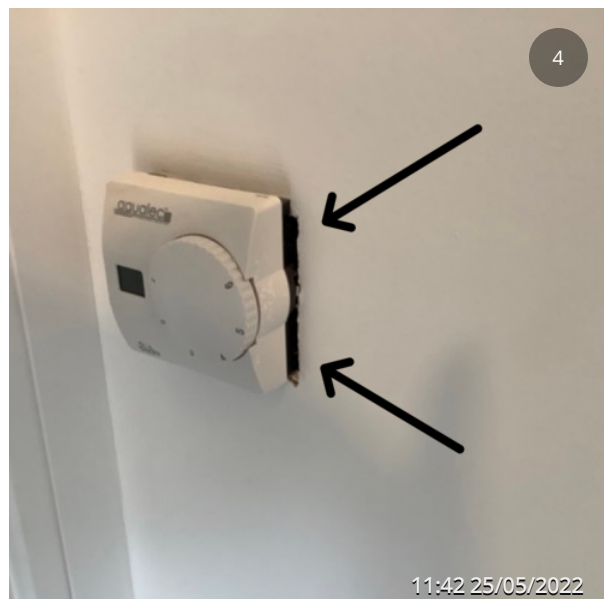
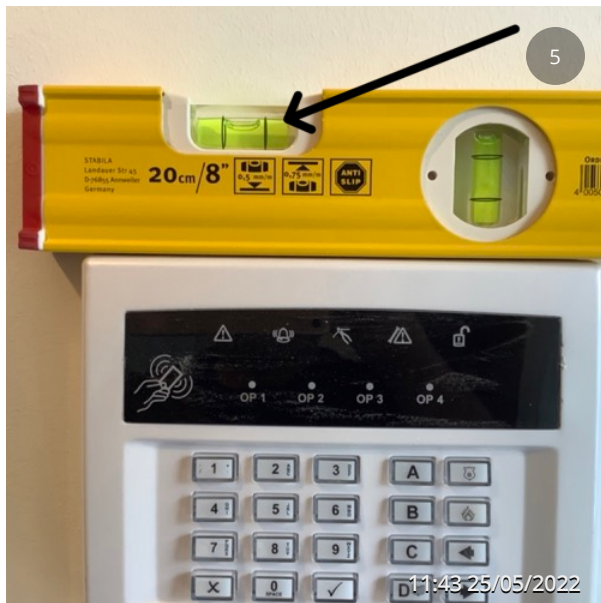
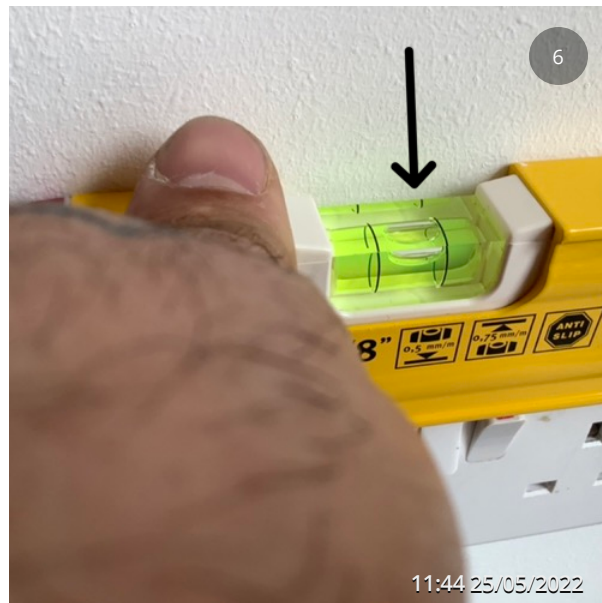
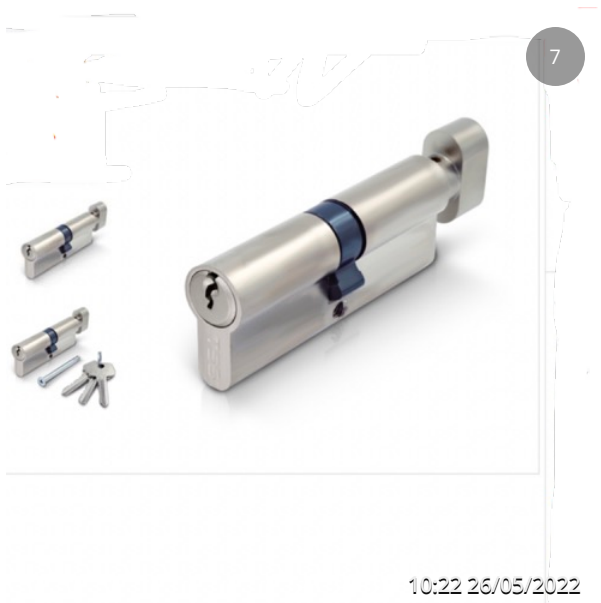
## HALL GROUND FLOOR

Front door is not square in the frame and is hard to open and shut.

The front door lock (from the inside) does not comply with building regulations and needs to be changed for a thumb turn type lock to allow safe egress from the property in the event of an emergency without the need for keys. (Please see picture for example of building regulations compliant thumb turn lock)

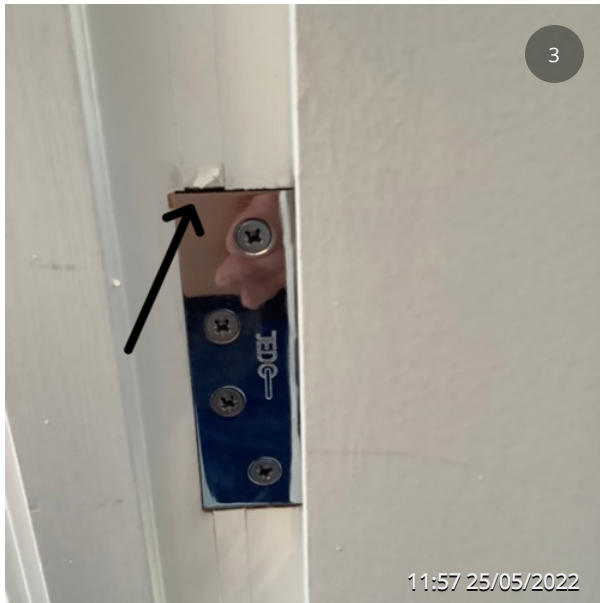
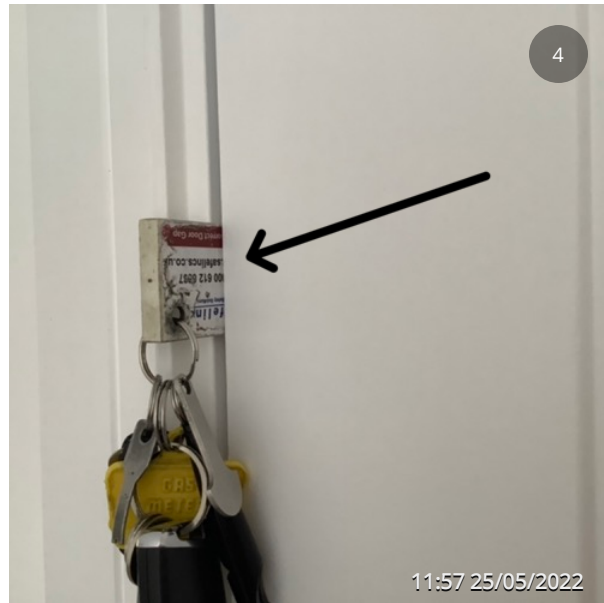
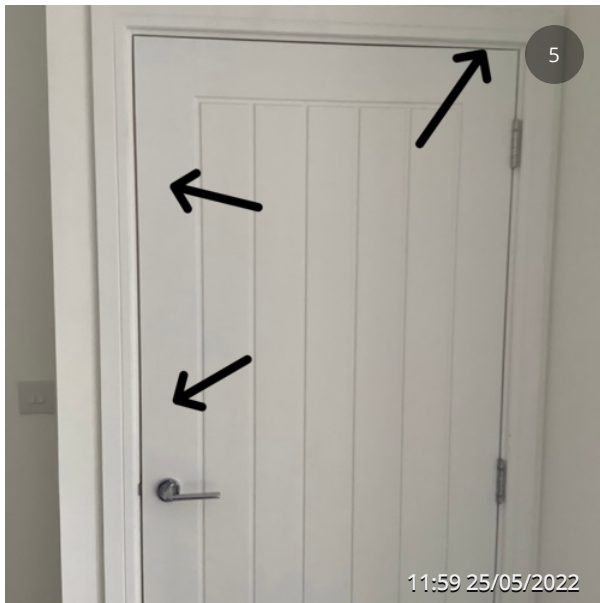
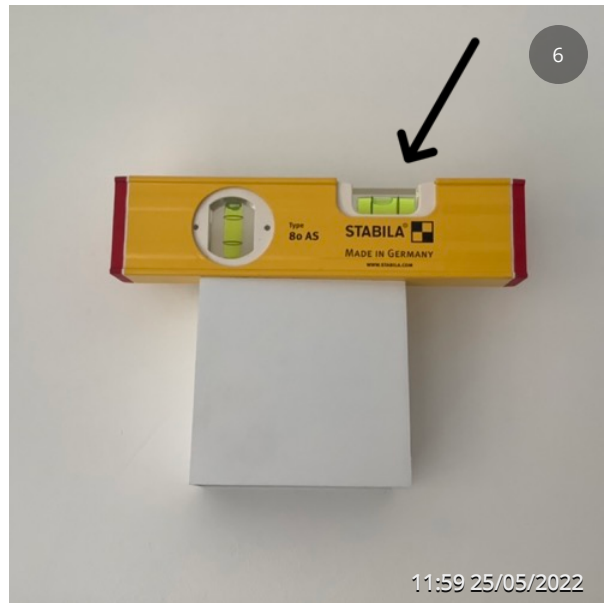
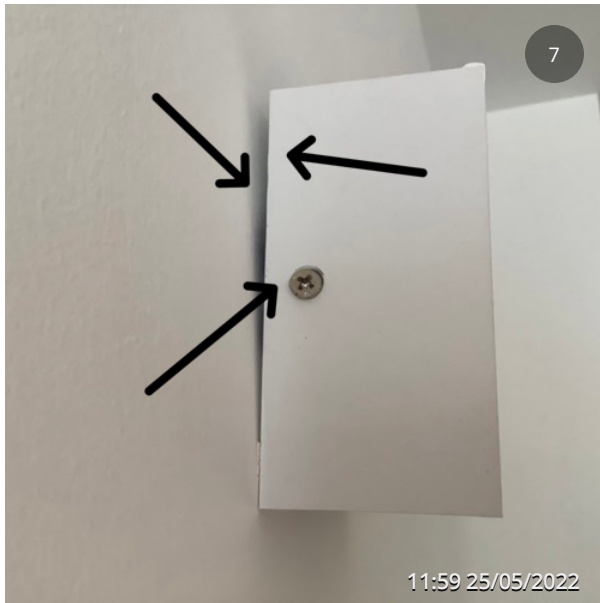
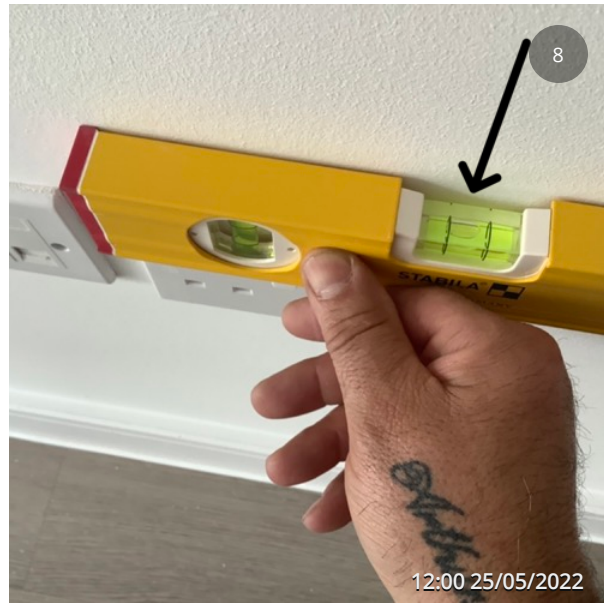
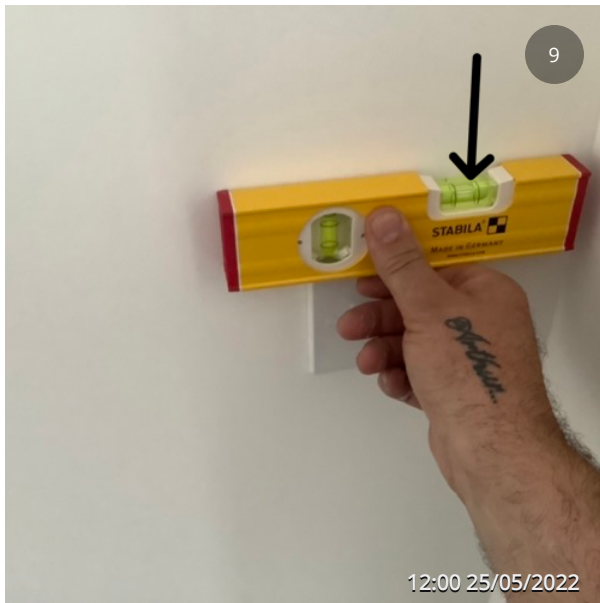
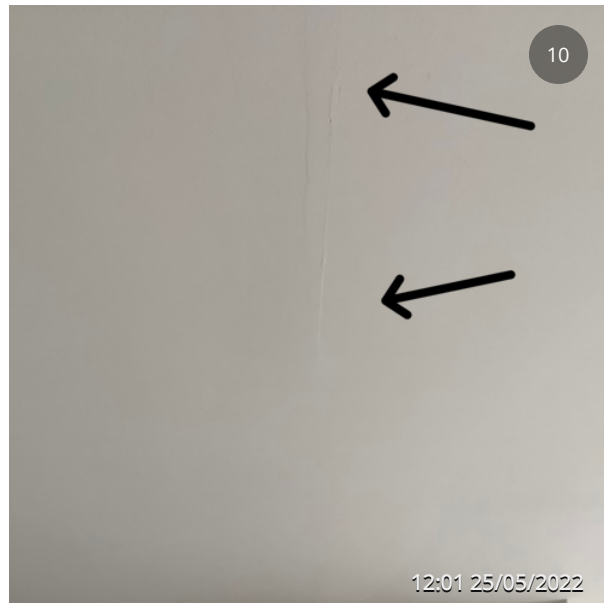
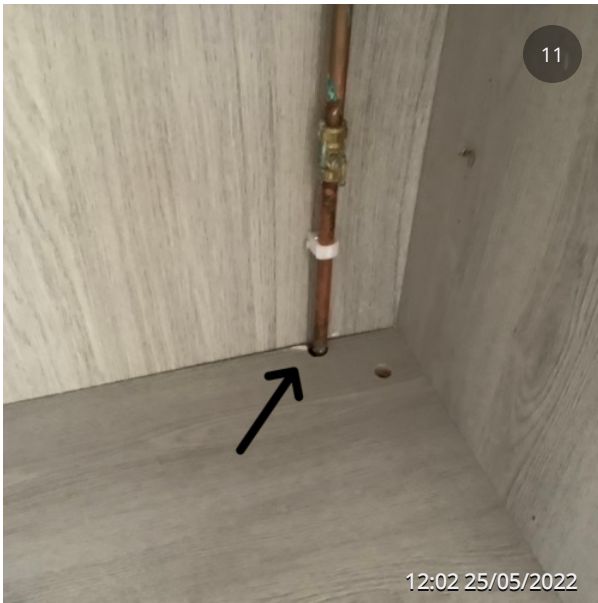
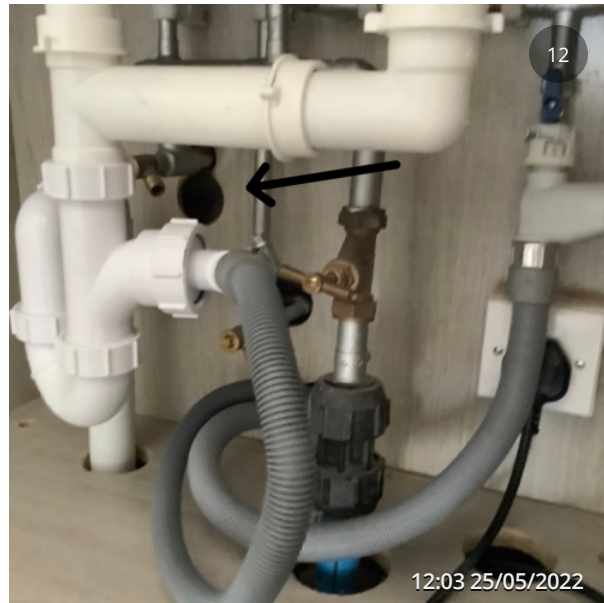
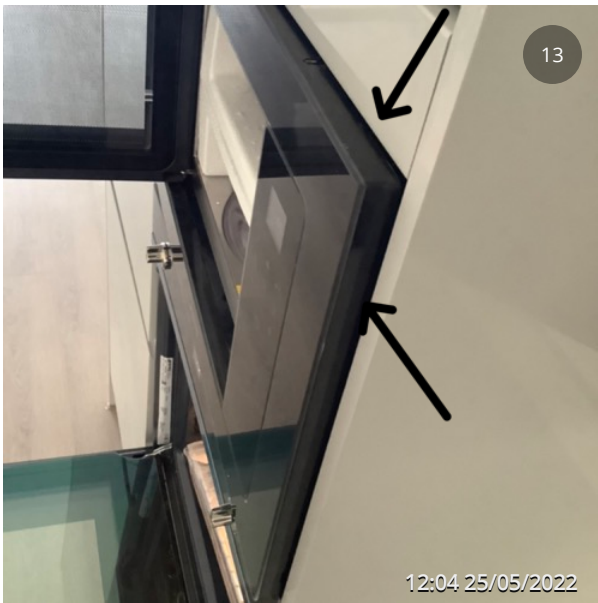
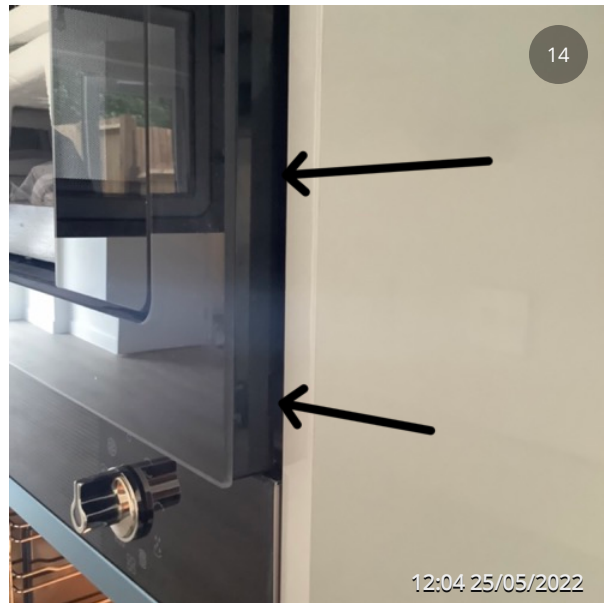
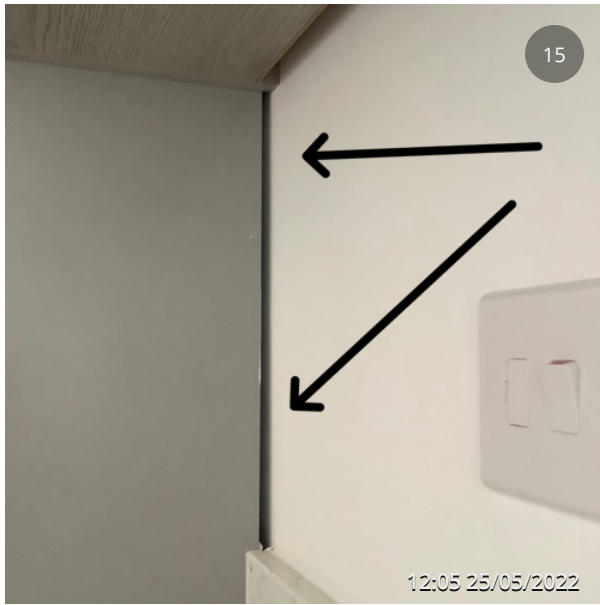
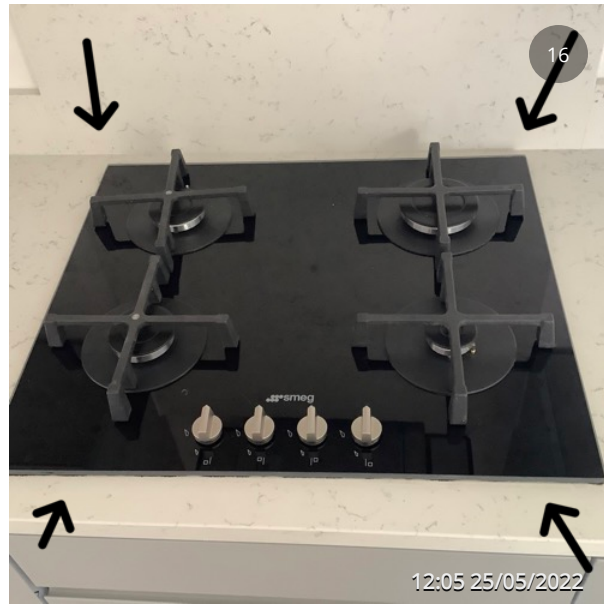
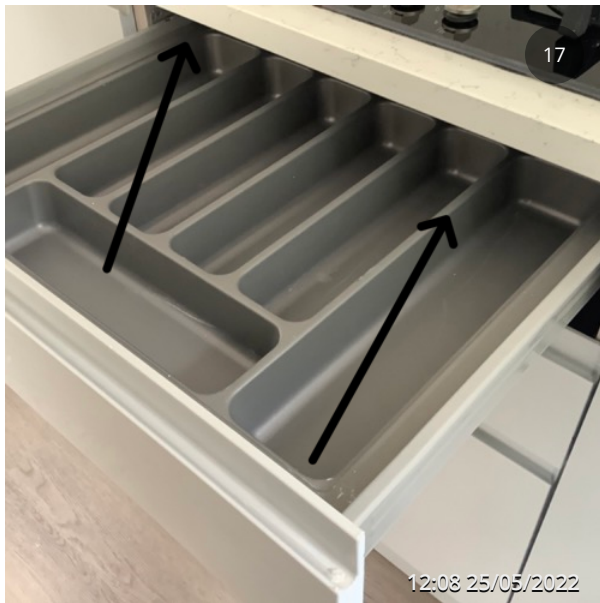
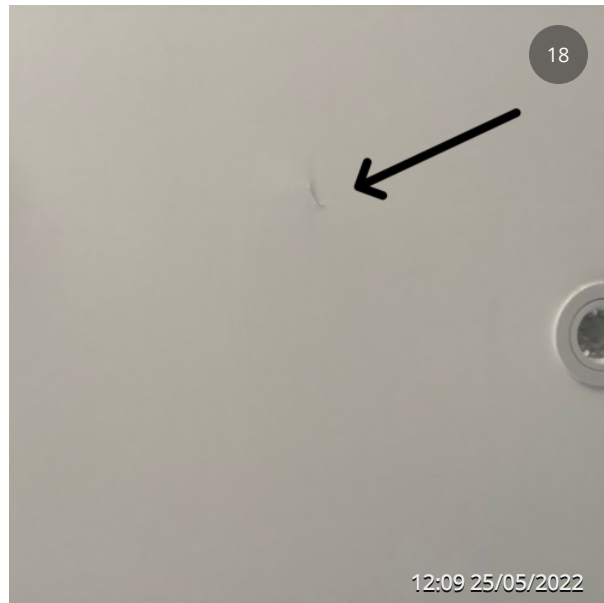
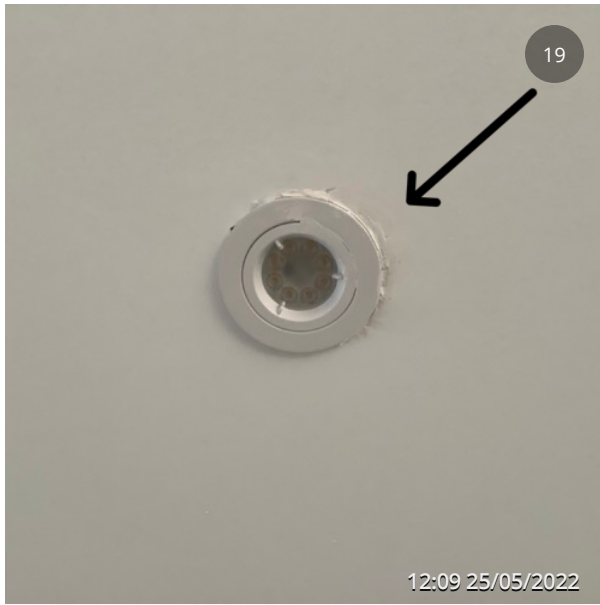
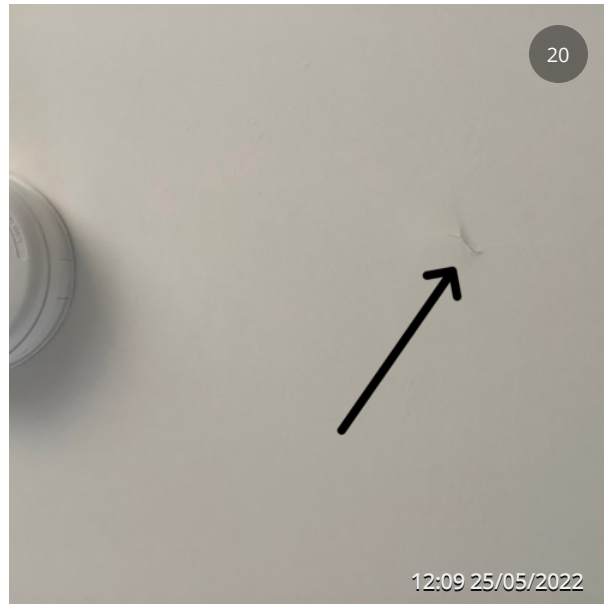
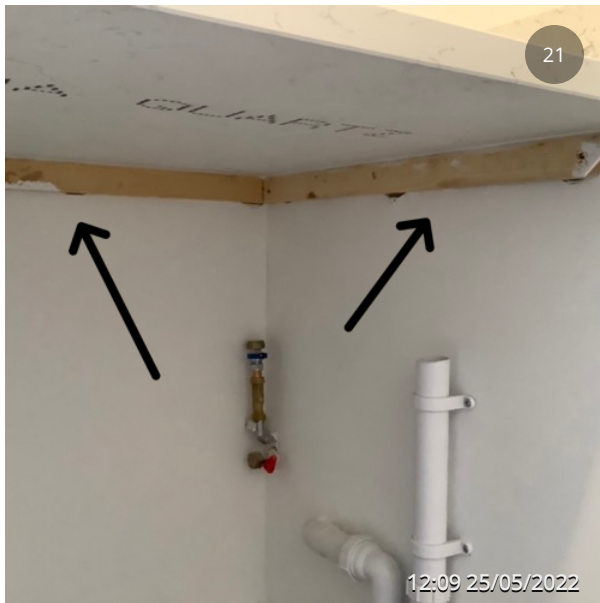
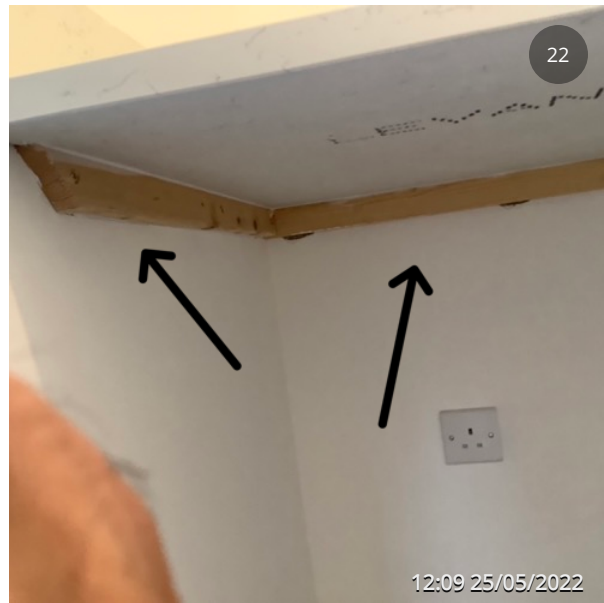
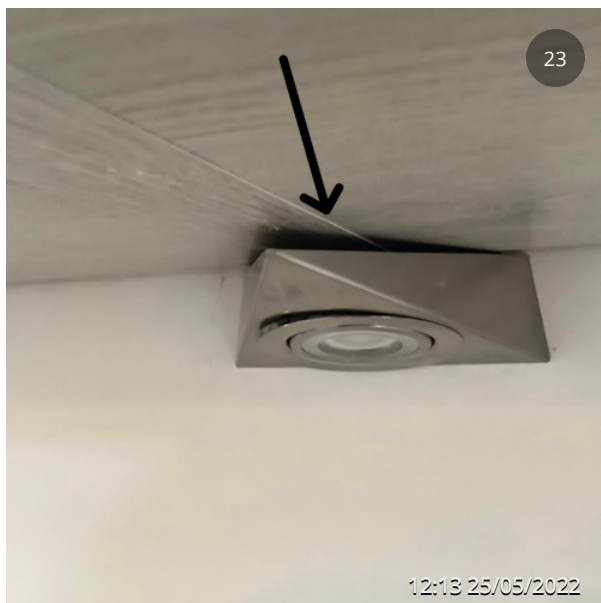
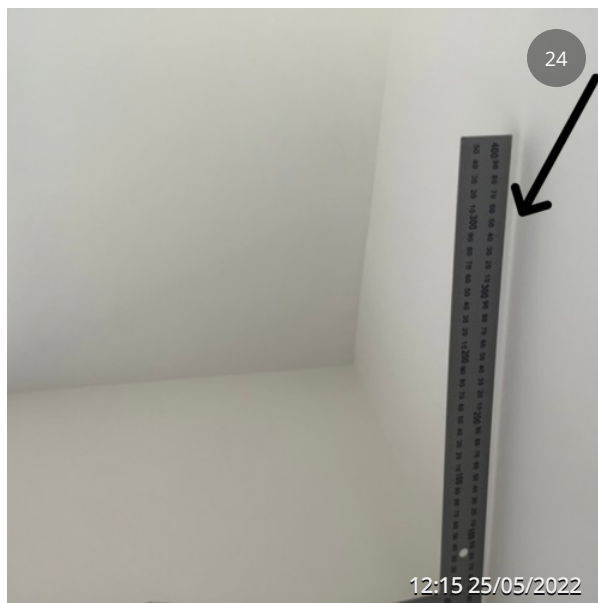
The main door to the kitchen/lounge/utility is a fire door with fitted intumescent smoke seals and have unacceptable Gaps between the fire door and the door frame and should never be more than 4mm or less than 2mm. It's recommended to aim for a 3mm gap to ensure adequate room for the intumescent strips to activate in the event of a fire, and for the smoke seal strips to not get damaged by the opening and closing of the door, the bottom of the door had been cut off by an excessive amount (between 10/25mm above the flooring line) this is not acceptable for a fire door and in our opinion will need replacing with a new fire door that is fitted to the manufactures recommendations and re inspected by a professional body after replacement to ensure that the door has been corrected fitted and complies with building regulations.

The top of the door is not painted and may allow moisture ingress into the door.

The door hinges were stained with paint and had rough areas where they had been installed to a poor standard.

on all internal and external angles of the walls and it was found the majority of the walls were not square at the time of inspection.

There were various painting defects especially around the ceiling area that will need filling and repainting as necessary.

The lights under the kitchen cabinets were loose and not securely fitted.

The small LED wall lights were very loose and not well installed and will need repair or replacement as necessary.

There is a poor quality finish underneath the utility room worktop area.

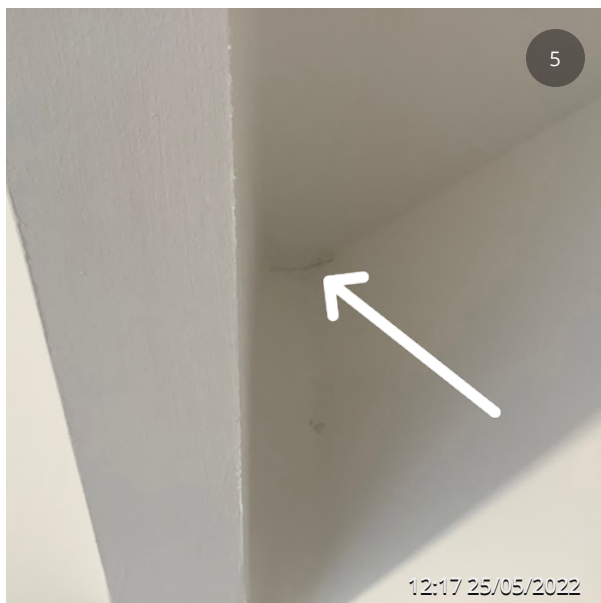
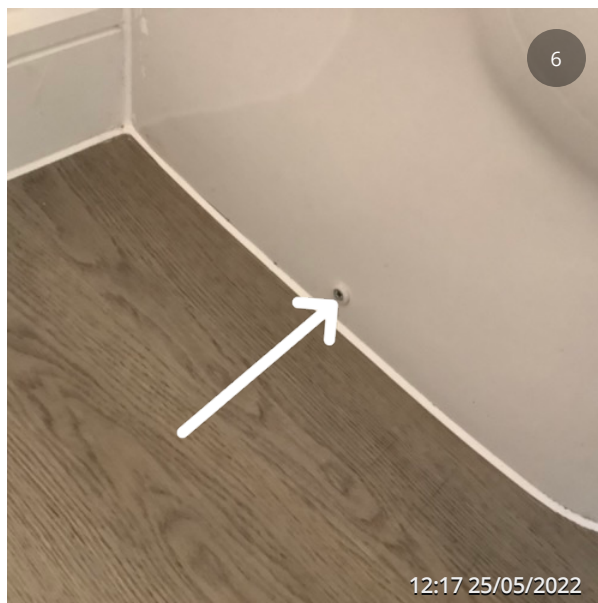
Although the door is not required to be a fire door the door margins had unacceptable gaps between the door and the frame, the bottom of the door had been cut off by an excessive amount and in our opinion needs to be replaced with a new door to be cosmetically correct.

The cover caps were missing on either side of the WC that fixes the WC to the floor.

There were noticeable marks/scratches at the bottom of the WC.

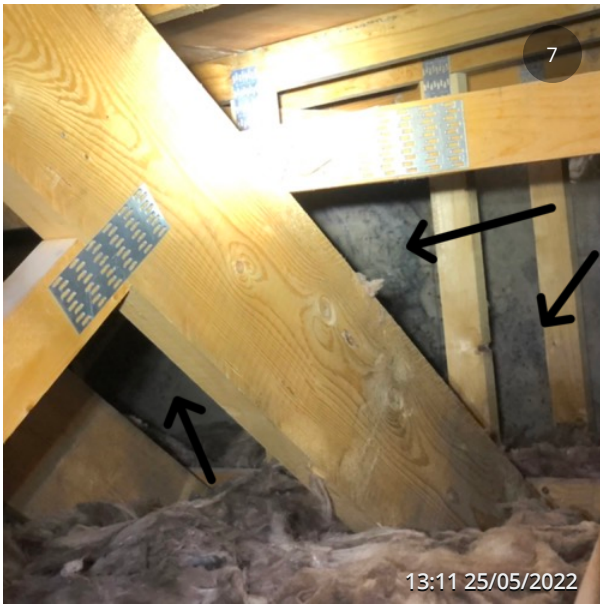
The spandrel panel (this is a fire break in between the neighbouring property's that need to provide substantial fire protection from fire spread in the loft space and is typically constructed of timber and then clad in multiple layers of plasterboard to provide a fire stop) was from the limited view from the attic hatch still wrapped in its plastic transportation material that should have be removed as soon as it is installed during the roof construction, this has not been removed and has caused excessive condensation to build up between the plasterboard and the plastic transportation covering

and has caused excessive mould growth and has damaged the plasterboard and is compromising the fire stopping ability of the spandrel panel and is a significant health and safety risk to both property's, a major repair to the panel is needed and must be carried out to the manufactures specifications and in our opinion re inspected by a competent building control professional.

(Due to the numerous different manufacturers of spandrel panels every manufacturer has different specifications and repair details) the builder will need to provide the panel manufactures details and confirm repair details needed.
